**Digitale und konventionelle Fertigungsprozesse
vollkeramischer Einzelzahnkronen im Vergleich**

Dissertation
zum Erwerb des Doktorgrades der Zahnmedizin
an der Medizinischen Fakultät der
Ludwig–Maximilians–Universität zu München

Mechanical performance of cement- and screw-retained all-ceramic single crowns on dental implants

Load bearing capacity, fracture mode, and wear performance of digitally veneered full-ceramic single crowns

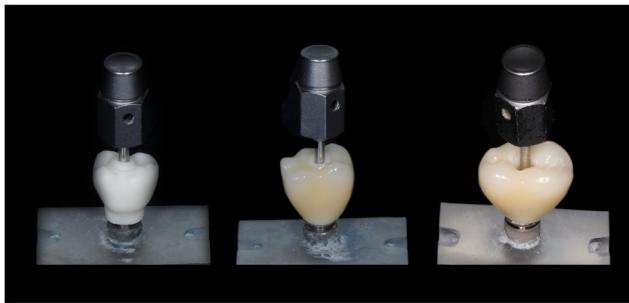
Fig. 1 Modified zirconia coping (MZL) with occlusal zirconia collar and reduced screw access hole before (left) and after veneering (middle), for comparison conventional screw-retained crown (SZL) with narrowed screw-driver in situ (right) illustrating the differences in width of the SAHs of the specimens

At first, a standard zirconia coping (IPS e.max ZirCAD, Ivoclar Vivadent AG) was designed full-contour, reduced by 0.8 mm and milled for ten times. Also, the SAH was manually refinished. Every coping was veneered in the traditional layering technique (IPS e.max Ceram, Ivoclar Vivadent AG) according to the manufacturer's recommendations with accurate control of the shape.

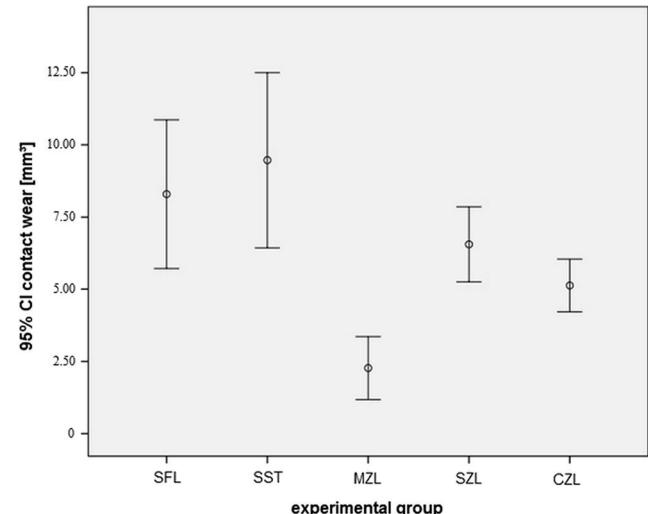
Fig. 3 Contact wear of different experimental groups in mm³

For the specimens of CZL group mean substance loss of 5.13 mm³ (SD: 1.28mm³) was found. The deficit of volume for SZL group was 6.56 mm³ (SD: 1.70 mm³), for MZL group 2.27 mm³ (SD: 1.52 mm³). Crowns of SST group wore 9.47 mm³ (SD: 3.95 mm³) of volume and the specimens of SFL group showed a difference of 8.29 mm³ (SD: 3.59 mm³).

The results of the one-way analysis test showed statistically significant ($p < 0.001$) differences between the five experimental groups regarding the contact wear behavior, the Student-Newman-Keuls test declared three statistically significant differing subgroups (Table 2: Multi-comparison posthoc test (Student-Newman-Keuls) declared three statistically significant ($p < 0.05$) homogenous subgroups concerning contact wear; mean values and significance for groupings are displayed). Crowns fabricated with the modified zirconia coping (MZL group) showed significantly ($P < 0.001$) lowest contact wear compared to all other groups. Based on these findings and highest significance for grouping, the Mann-Whitney U-test displayed in a pairwise comparison the significant differences between the three declared subgroups representing the types of veneering (Li = group SST + SFL; Mod = group MZL; Con = group CZL + SZL) whereas lithium disilicate veneered crowns (Li) showed significantly ($P = 0.006$) highest contact wear (Table 3: Mann-Whitney U-test showing a pairwise comparison of the three subgroups concerning contact wear with statistical significant differences between the groups).

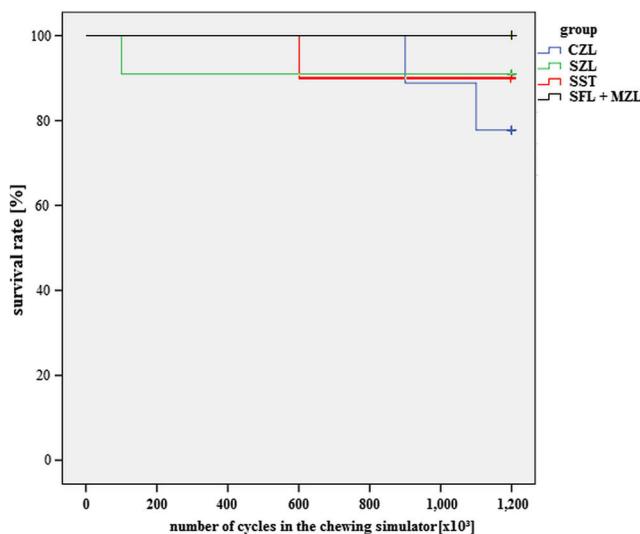
Fig. 2 Survival rates during dynamic loading for all experimental groups displayed in a Kaplan-Meier estimator survival function

During cyclic loading two abutment fractures (SST group at approx. 600.000 cycles and SZL group at approx. 100.000 cycles) and two chipping events occurred (all of CZL group). The Kaplan-Meier estimator displayed the survival function. These specimens were excluded from fracture strength testing.

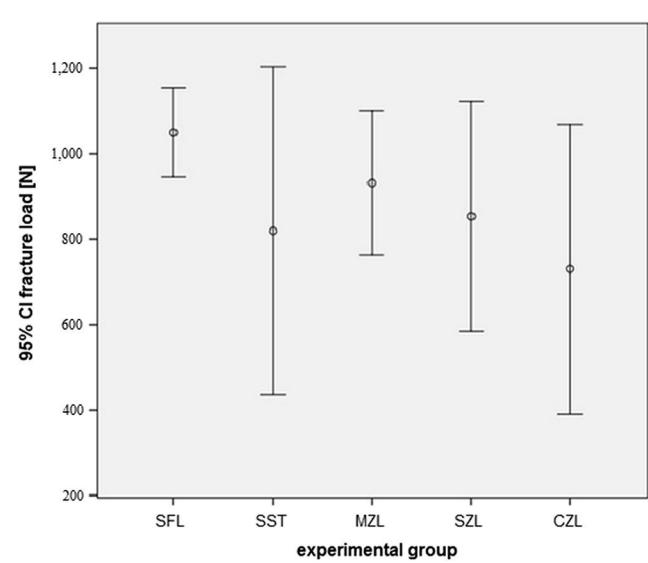
Fig. 4 Fracture load of different testing groups

There was no statistically significant influence at the mean fracture load recorded between the tested groups, the end of the fracture load testing was described above.

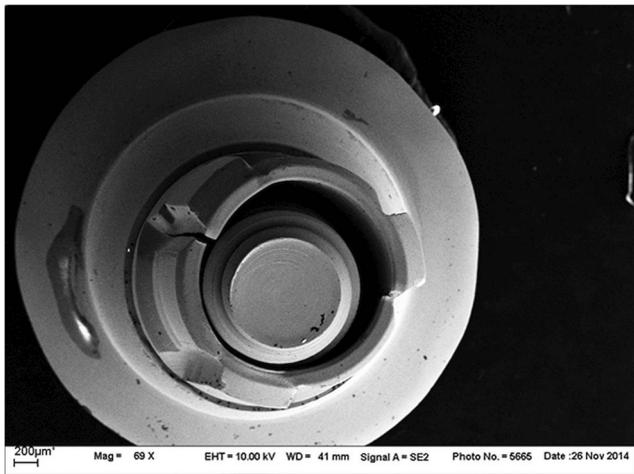
Fig. 5 SEM image of a damaged implant abutment after fracture load testing displaying a cleft on the left and a crack on the right cam and elliptic deformation on the intern implant-abutment connection

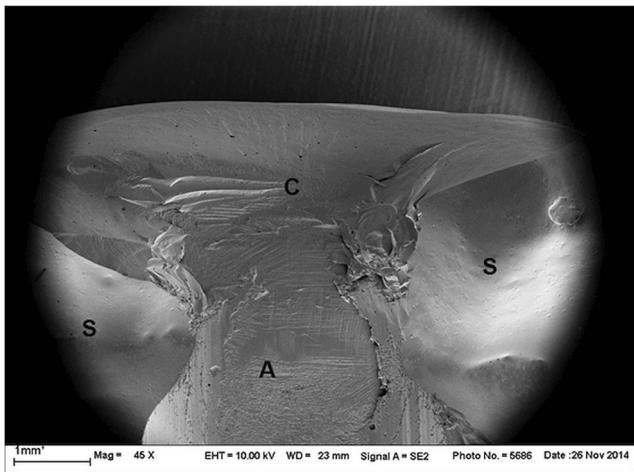
Fig. 6 SEM picture of a cohesive chipping fracture during cyclic loading (CZL) with smooth and glazed surface areas (S), a well-defined abrasive area (A) with visible traces and scratches and a nonhomogeneous chipping area (C) with blasting of the veneering and exposure of air pockets within the veneering layer

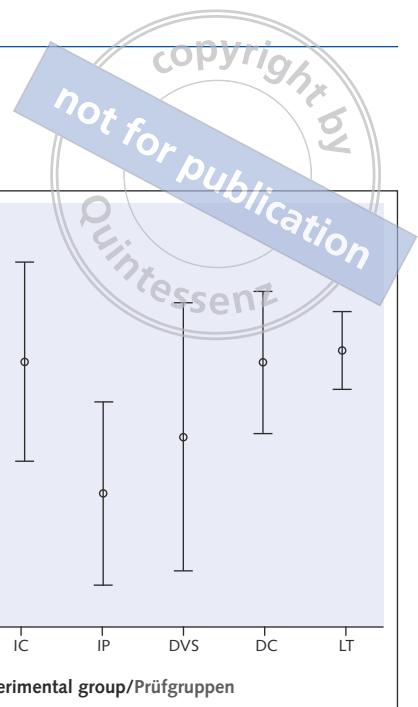
**Fig 2** Volumetric contact wear of the crowns.

Abb. 2 Volumetrischer Verlust der Testkronen.

Normality could be assumed. The one-way ANOVA exhibited no statistically significant differences between the groups ($P = 0.171$) with regard to the volumetric substance loss.

Es konnte eine Normalverteilung angenommen werden; in der einfaktoriellen ANOVA waren keine statistisch signifikanten Unterschiede zwischen den Gruppen ($p = 0,171$) hinsichtlich des Volumenverlustes erkennbar.

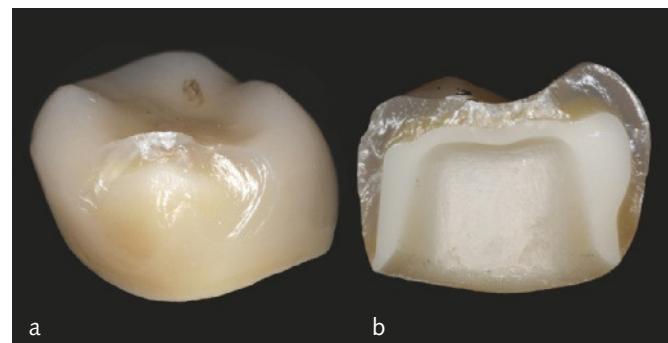
Fig 4a and b Two crowns of the DVS group suffered cohesive (a) and total (b) fracture.

Abb. 4a und b Zwei Kronen der DVS-Gruppe präsentieren die kohäsive (a) und vollständige Fraktur (b).

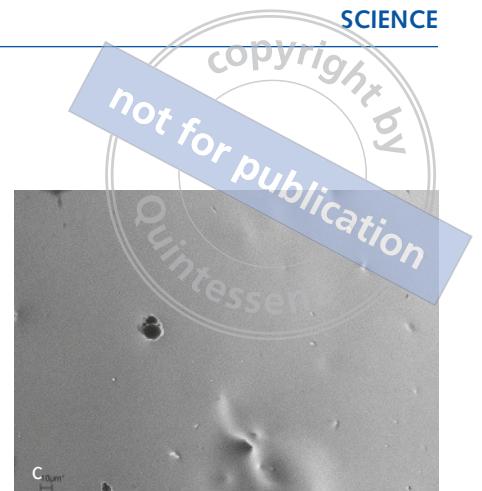
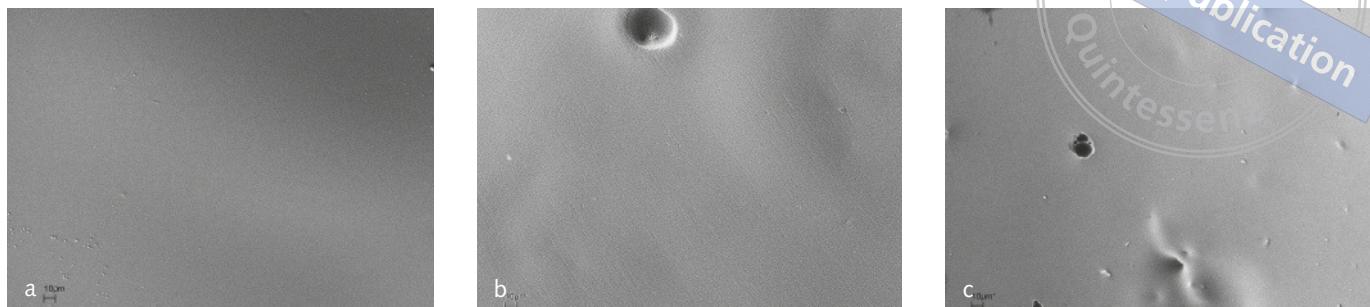
Fig 5a to c SEM images of the surfaces of different experimental groups (magnification of 1000x): CO group with smooth surface (a); DC group with clear brush marks (b); LT group with porosities (c).

Abb. 5a bis c REM-Oberflächenaufnahme der verschiedenen Prüfgruppen in 1.000-facher Vergrößerung: CO-Gruppe mit glatter Oberfläche (a); DC-Gruppe mit deutlich sichtbaren Pinselstrichen (b); LT-Gruppe mit Porositäten (c).

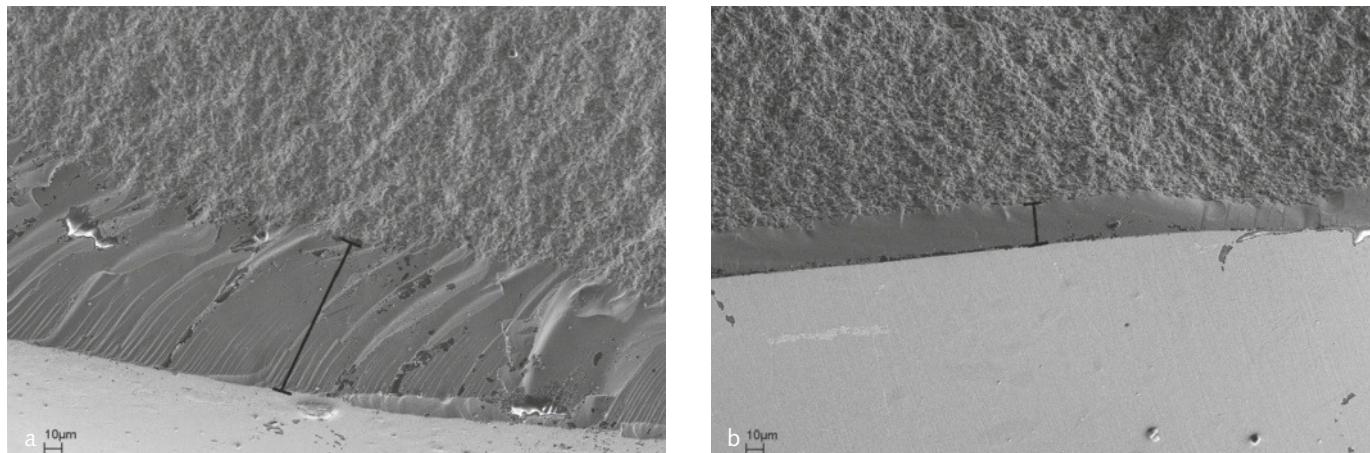
Fig 6a and b SEM images after fracture, displaying the glazing mass thicknesses of a CO (a) and IP (b) group specimen (magnification of 1000x).

Abb. 6a und b REM-Aufnahme nach Bruchversuch mit sichtbarem Glasurmasseanteil einer CO-(a) und einer IP-Krone (b) in 1.000-facher Vergrößerung.

be assumed that more glazing material was applied (Fig 6). Since glazing material is less wear resistant, a higher loss of substance occurred.²⁸ As the vertical loss is highly dependent on the occlusal design of the cusps and fosses and the contacts of the antagonists,²⁰ the authors of the present study decided to compare the volumetric loss, since this parameter appears to be a more reliable indicator. The observed contact wear measurements are in accordance with the literature where a comparable experimental setup was chosen.^{20,29-31} Differences from other studies can be explained by the use of a different antagonist material, variant chewing cycles, or variational occlusal load application that have a statistically significant influence on the results.²¹ Nevertheless, the Ivo-

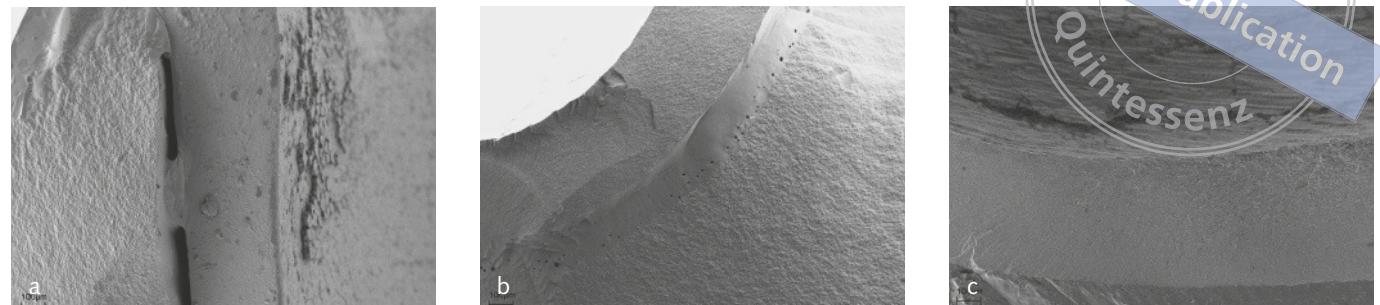
Fig 7a to c SEM images of fractured crowns from the IP, IC, and CO groups (a to c) showing the joining gap (magnification 200x).

Abb. 7a bis c REM-Aufnahmen von frakturierten IP- (a), IC (b)- und CO-Kronen (c) mit dargestelltem Fügespalt in 200-facher Vergrößerung.
