**The historical topography of a provincial Byzantine
city in Thrace:**

Vize (Bizye)

Inauguraldissertation
zur Erlangung des Doktorgrades der Philosophie
an der Ludwig-Maximilians-Universität München

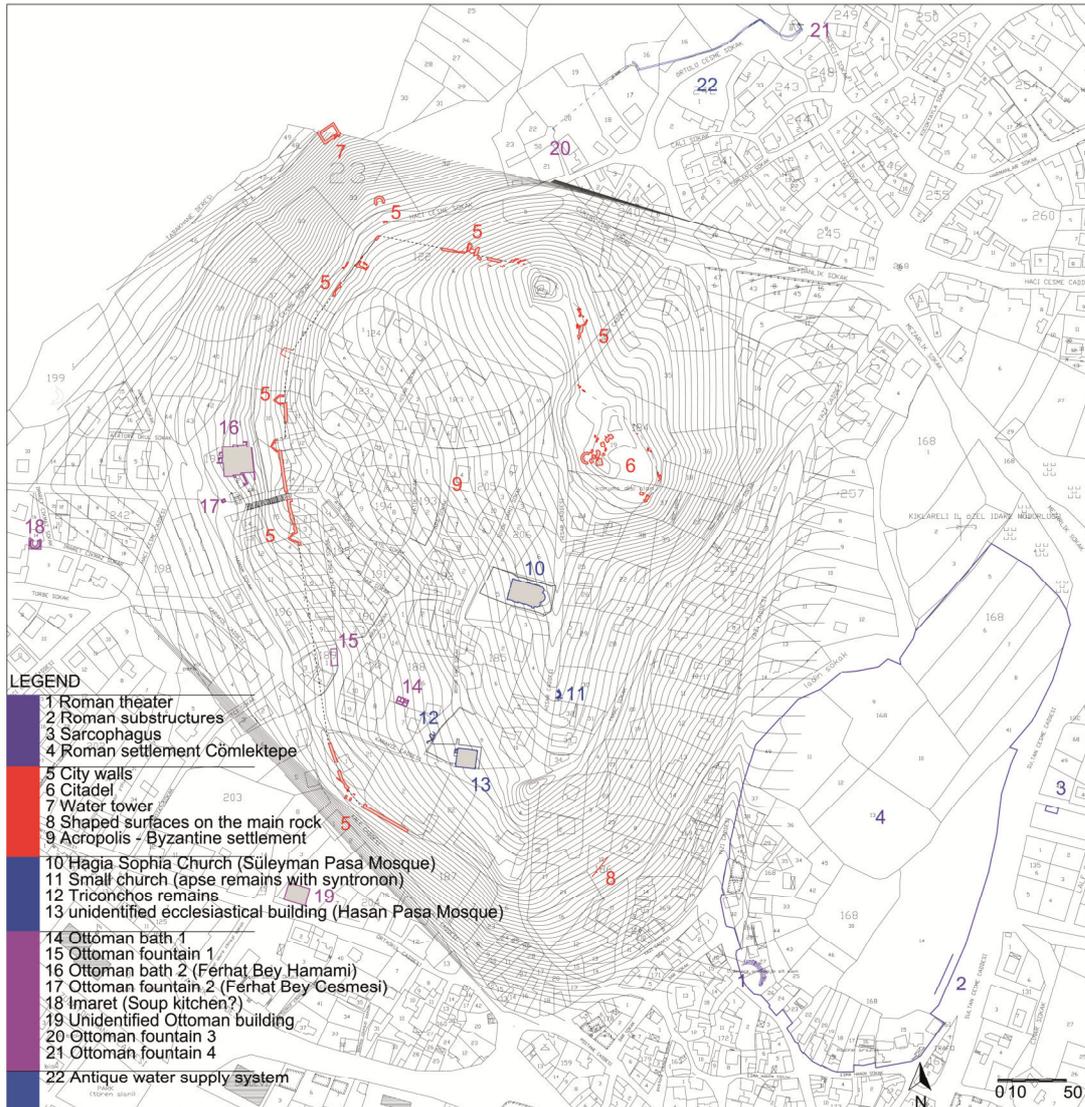
Figure 3.44 : The topographical plan of Vize, showing Roman, Byzantine and Ottoman remains and monuments, drawing by author (2013).

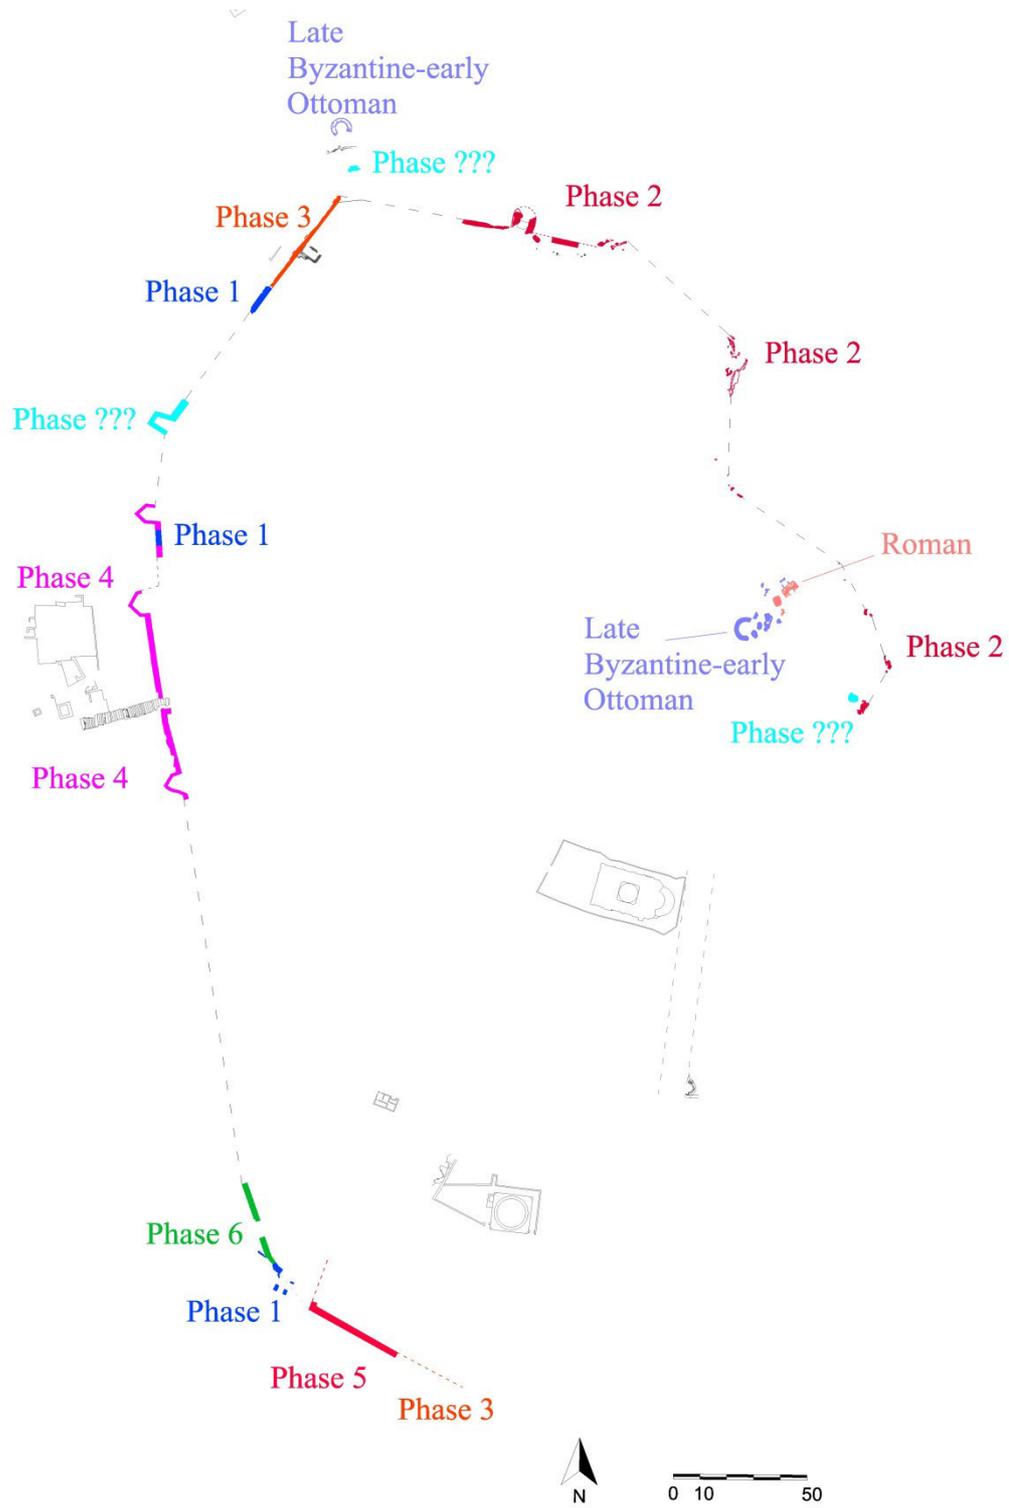
Figure 3.51 : The construction phases of the walls of Vize, plan, drawing by author (2014).

It must also be emphasised that the construction materials are mostly deteriorated and require special treatment and analysis for dating. Furthermore, since more than half of the walls are missing, and the preserved parts have lost their original shapes, a typological approach cannot answer all of our questions.

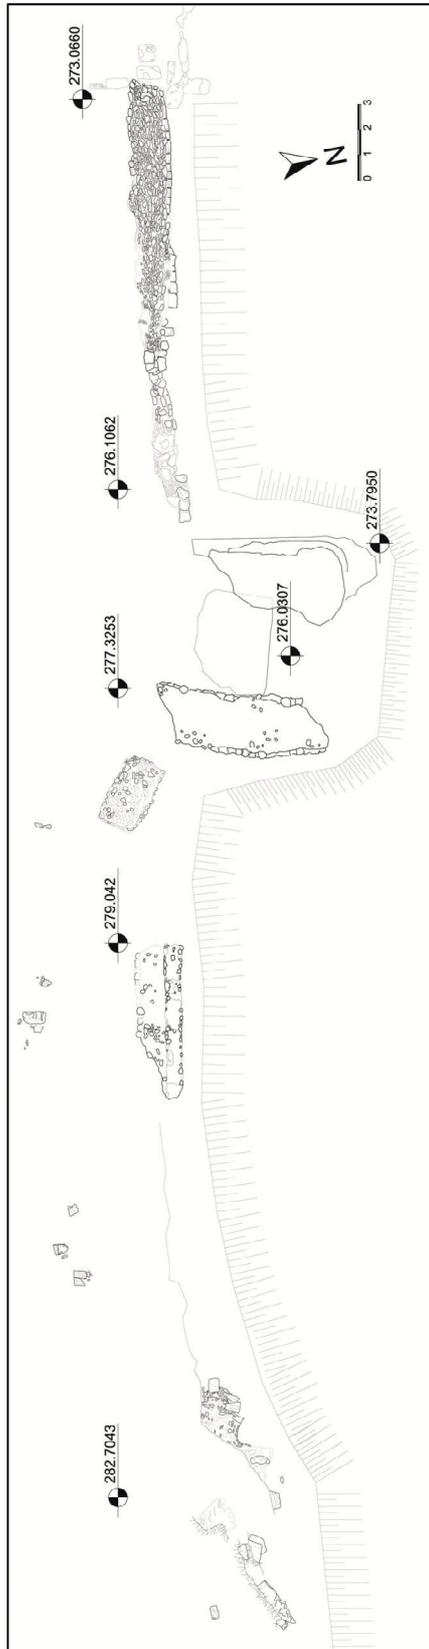
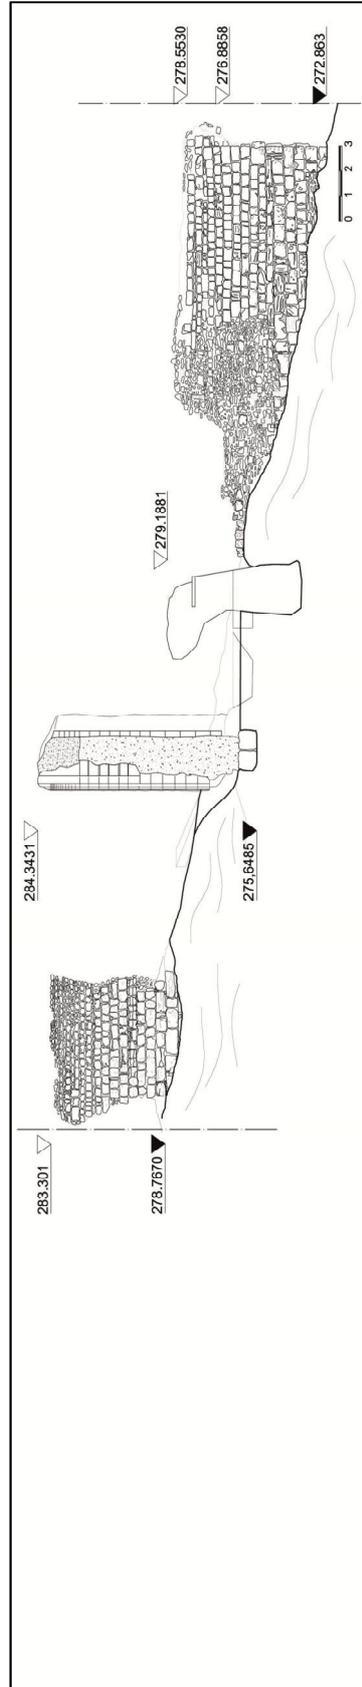
irregular alternating broad and narrow courses are applied. In W3, narrow courses on the upper parts are used for levelling of irregular stones, which proves that these stones are secondary material (Figure 3.72). The inner façade coating of W2 is not present anymore (Figure 3.73). The preserved inner coating of W3 shows that the inner facades are made up of much smaller stones (Figure 3.74). Although the walls seem to have been built with very thin joints, in some parts of the façade of W2 irregularly arranged joint mortars are observed. W3 does not have any mortar joints. The rubble core is made up of big gravel pieces and a beige homogeneous mortar. Except for the joint mortars, no brick is used in this phase.

Figure 3.69 : Independent walls, W2, T2, W3, plan, drawing by author (2014).

Figure 3.70 : Independent walls, W2, T2, W3, elevation from north, drawing by author (2014).

The construction technique of W2 and W3 is stone-faced rubble core which is sometimes arranged in alternating broad and narrow courses on the façade. Uses of levelling courses with small fieldstones are also observed in both walls (Figure 3.72). No joint mortar is applied in this relatively careful masonry, except for some areas of W2, which may indicate a repair phase. These walls were built with secondary material, which seem to have been taken from older ruined walls or insignificant buildings, but obviously not from monuments such as temples, etc. No bricks were used in the masonry.

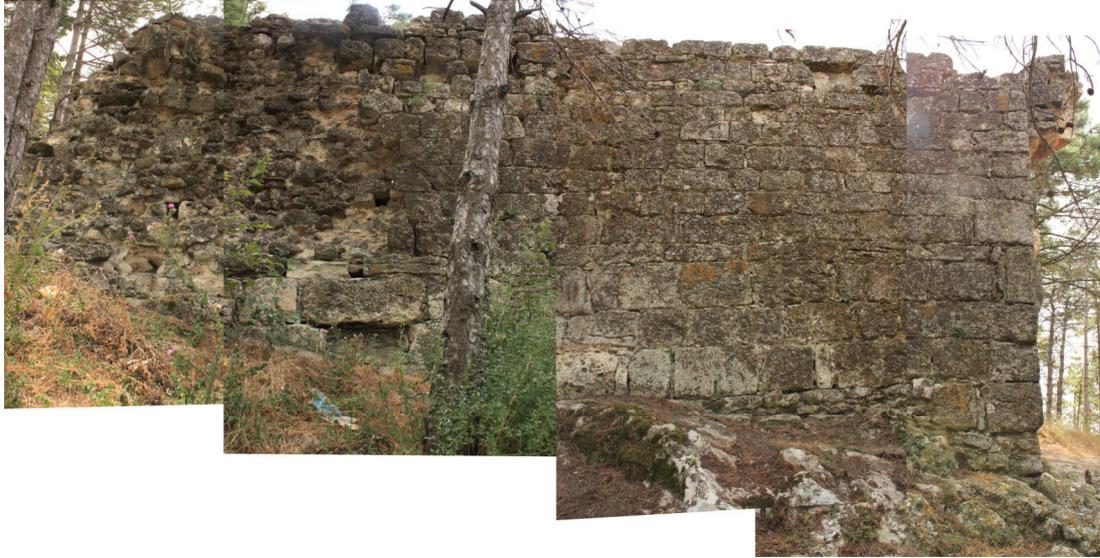
Figure 3.71 : W2 north (outer) façade, photo by author (2012).

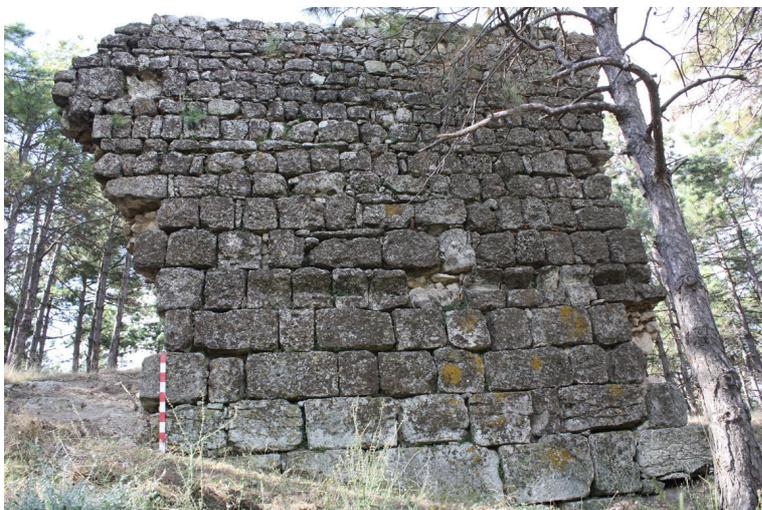
It is possible to observe the wall walk and the parapet on the top of W3. This is the only preserved wall walk in the curtain walls of Vize.

Figure 3.72 : W3 north (outer) façade, image by author (2012).

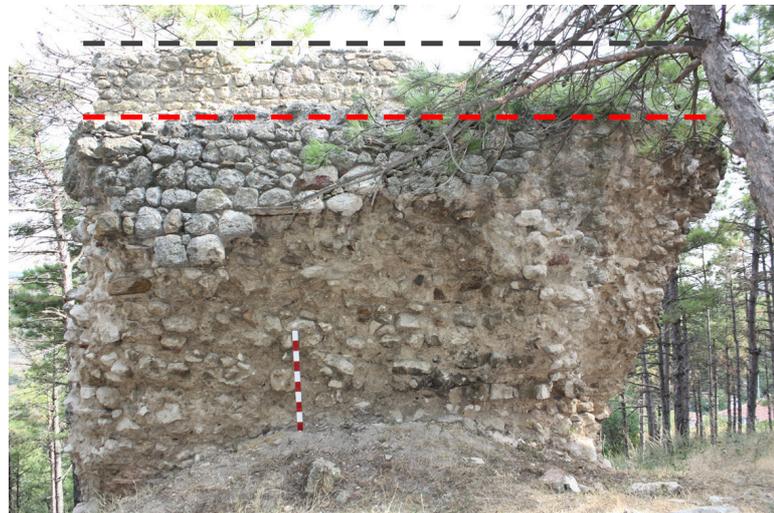
Figure 3.74 : W3, wall walk and the parapet on the south (inner) façade, image by author (2012).

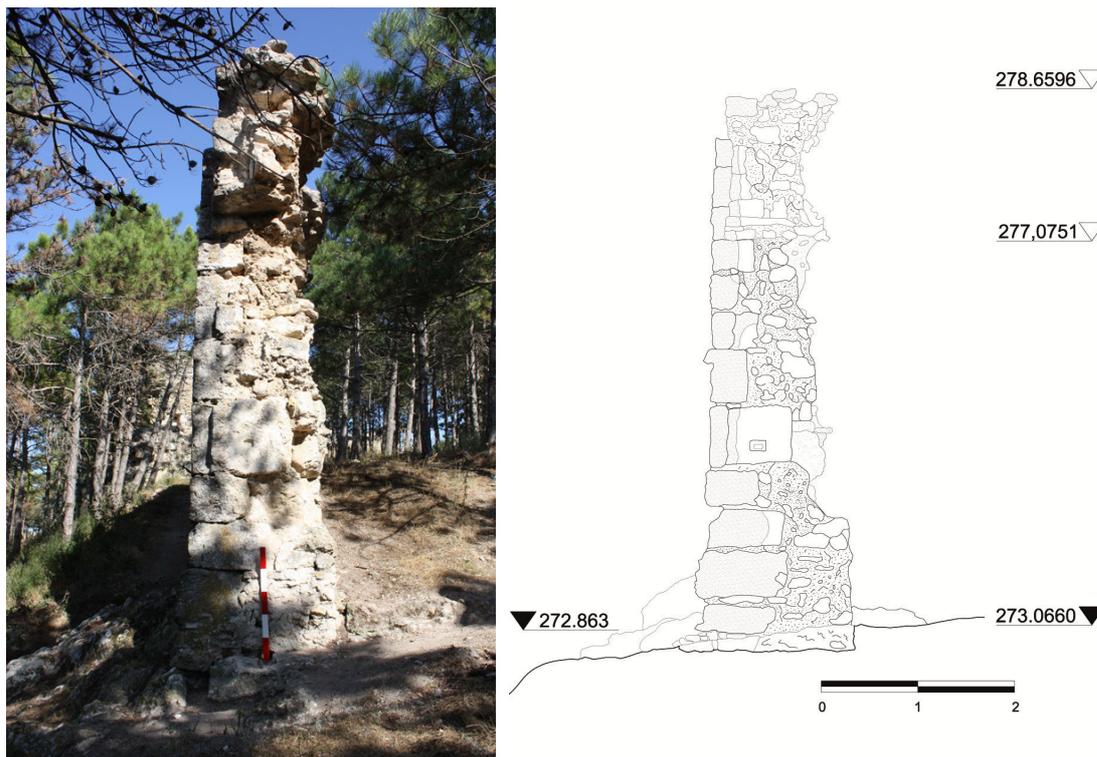
Figure 3.75 : W2 west side, traces of a probable gate, image by author (2012).

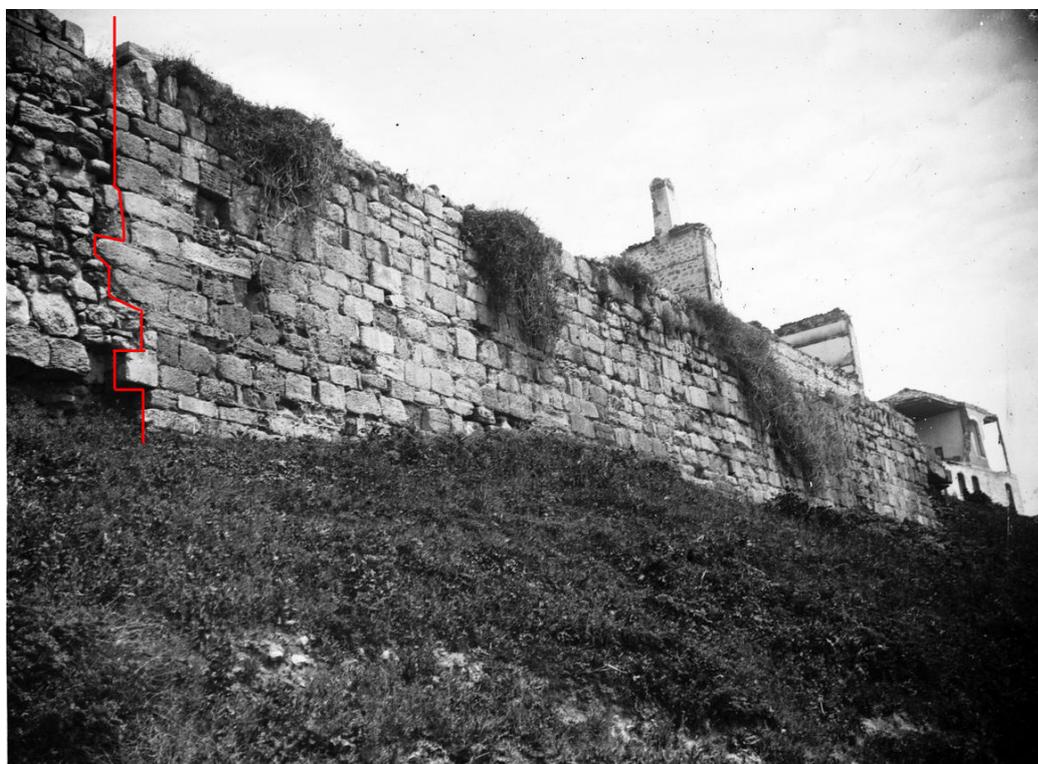
Figure 3.108 : W4.2, repair phase on the left, Gipson archive, Sofia (1912–13).

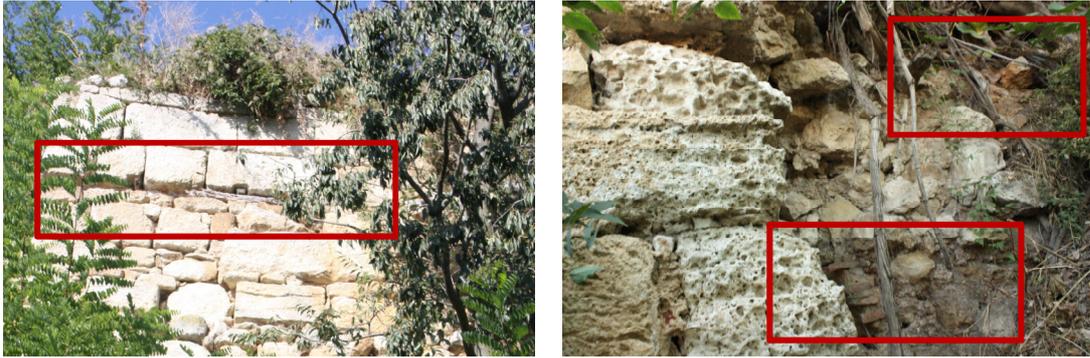
Figure 3.109 : W4.2, upper part on the NW corner, the wooden beam, image by author (2011).

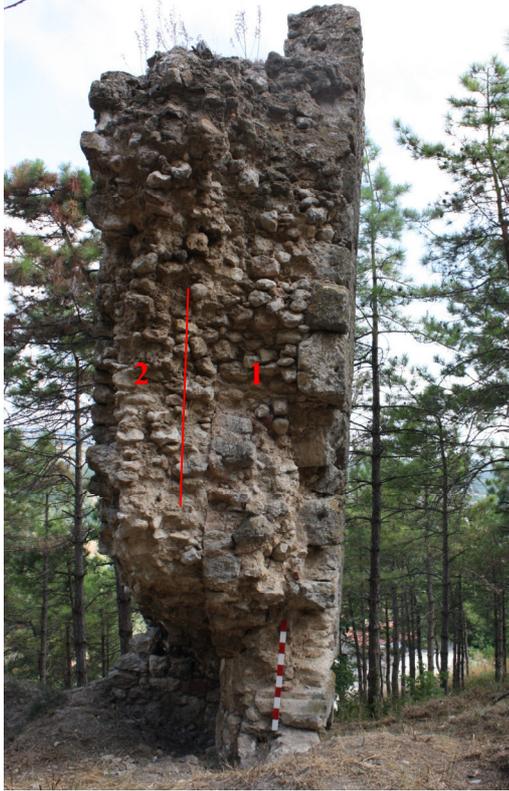
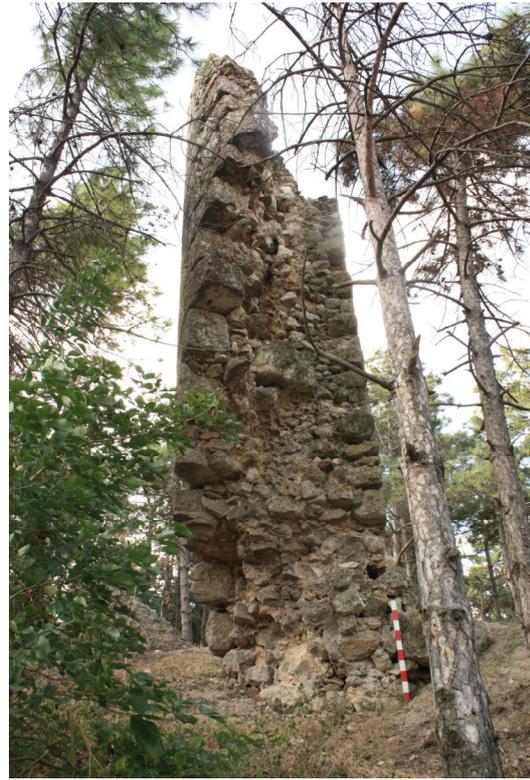
Figure 3.131 : T2.1, section, two different distinguishable phases, image by author (2011).

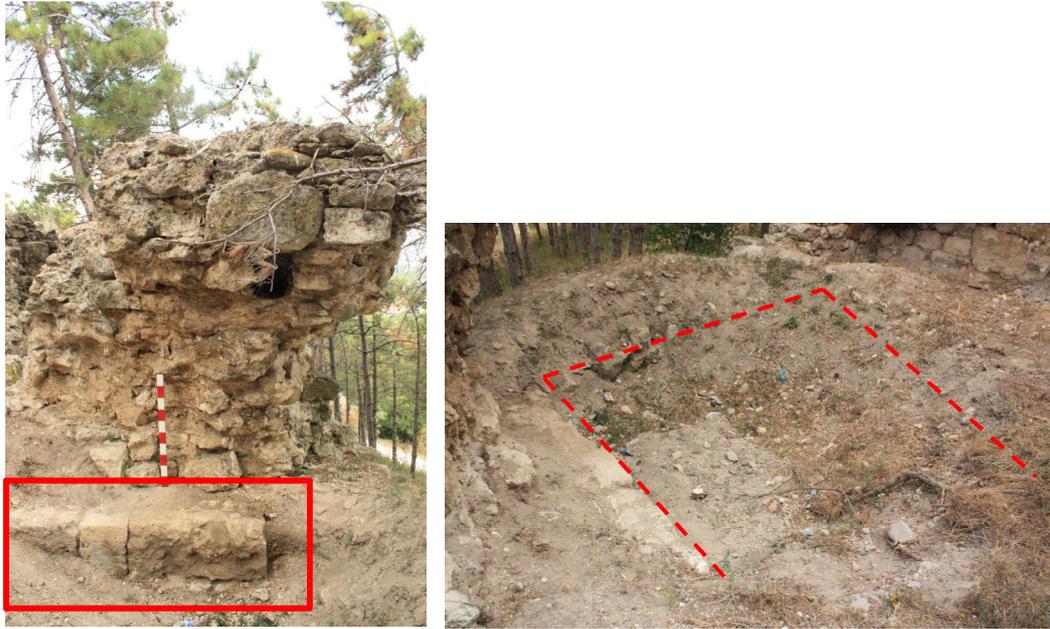
Figure 3.135 : T2.2, inner façade and the foundation stones of the earlier phase, image by author (2011)

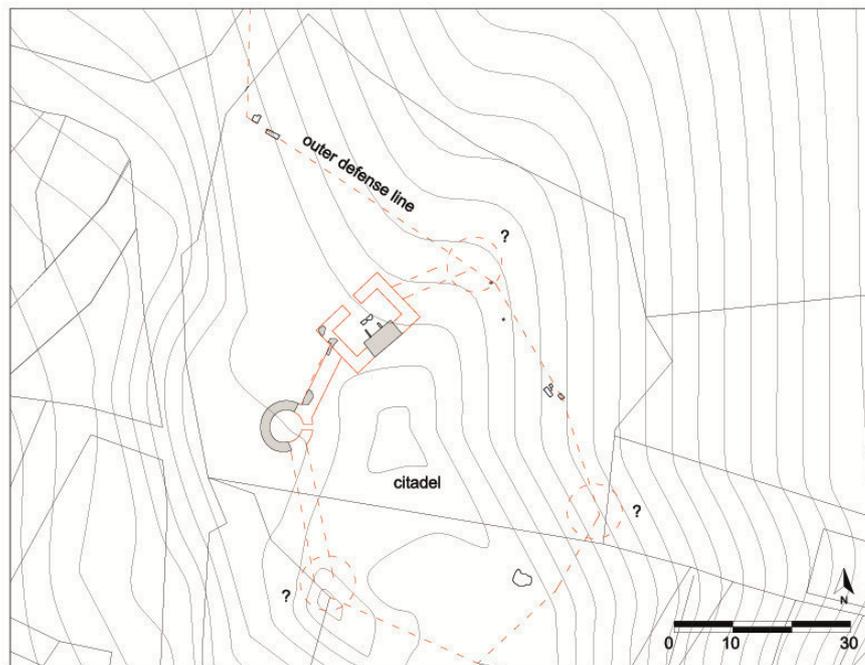
Figure 3.180 : Citadel of Vize, Phase A, drawing by author (2014).

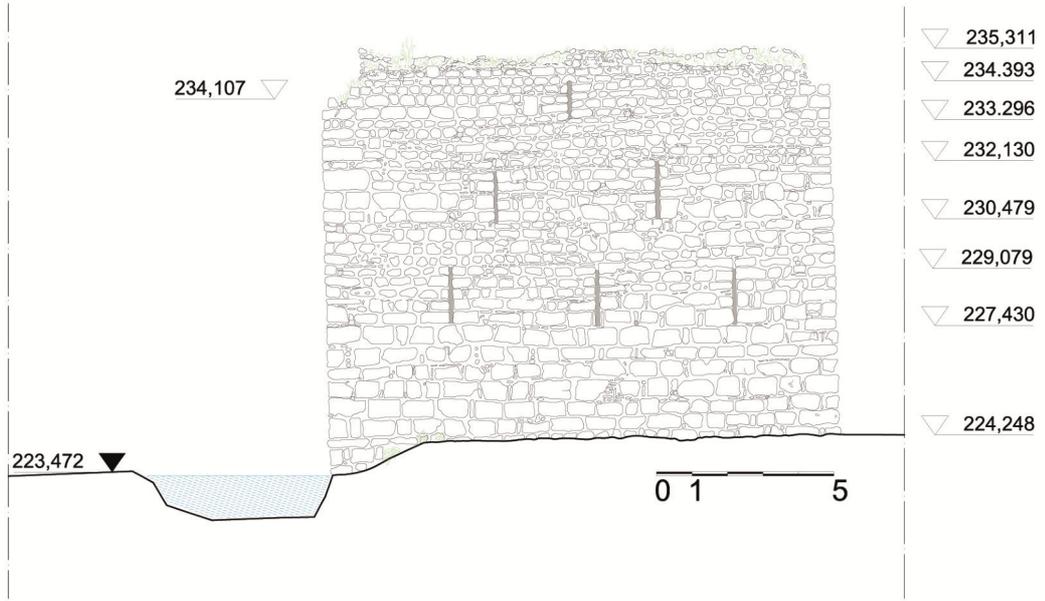
Figure 3.196 : WT, NW façade, drawing by M. Çavdar and author (2013).

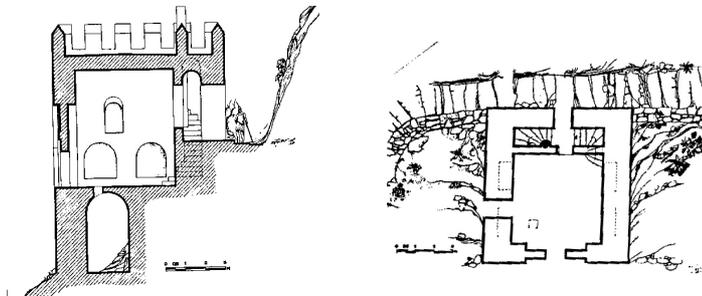
Figure 3.229 : Tower of Karytaina, Greece, section showing a cistern in the basement and plan, after Moutsopoulos (1997).

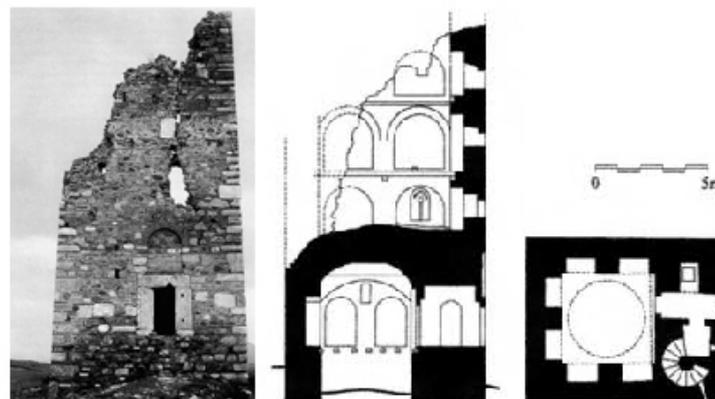
Figure 3.230 : Tower of Mariana, Greece, 1373s. Exterior view, section and plan. On monastic property, originally had six floors, after Bogdanovic (2012).

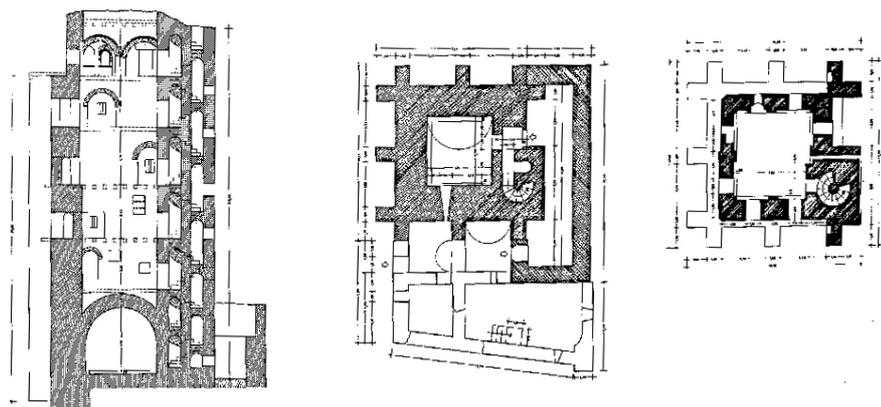
Figure 3.231 : Tower of King Multin, Mount Athos, Greece, 1300s. Section and plans. Associated with the defences of Chelandri Monastery, originally had seven floors with a chapel at the top floor, was covered with a pyramidal wooden roof, after Curčić (1997).

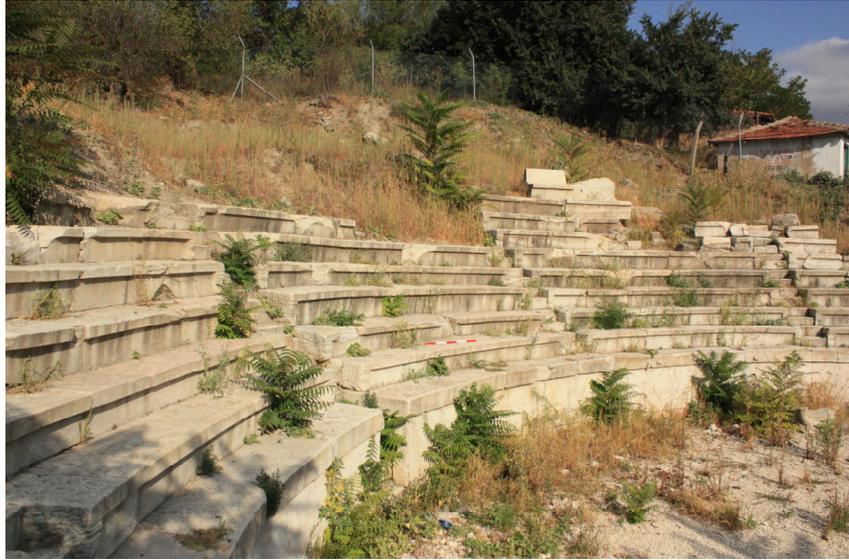
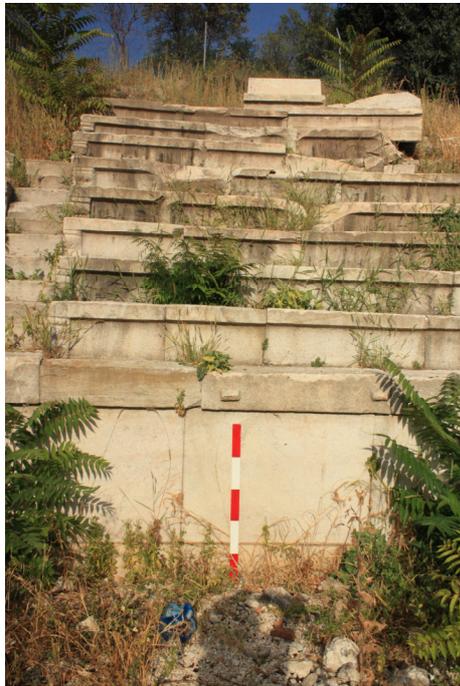
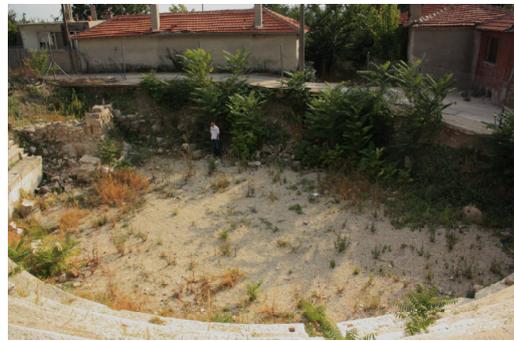
Figure 4.11: Vize theatre, 1, 2- cavea, 3- skeneia foundations under the street, 4- an upper row seat, images by author (2011).
