# **Long-term biotribological evaluation of total hip and knee arthroplasty implants**

Thesis  
Submitted for a Doctoral degree in Human Biology  
at the Faculty of Medicine, Ludwig-Maximilians-Universität zu München

by  
Ana Laura Puente Reyna

2019

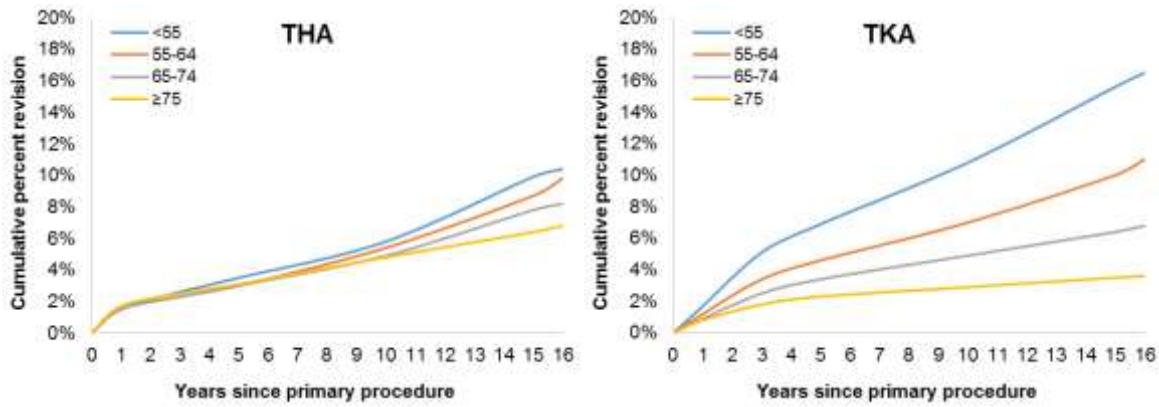
Figure 1: Cumulative percentage for revision of primary THA and TKA (with a primary diagnosis for osteoarthritis) classified by patient's age. Adapted from the Australian National Joint Replacement Registry 2017 [12].

Even though joint replacements are highly successful during their first decade of use, follow-up studies as well as registry data have shown a decrease in their survival rates during the second and third decade of clinical performance, where the survival rates can drop to 70 - 80% [12–17]. Moreover, studies have demonstrated that young patients have an enhanced risk of requiring a revision surgery starting the second decade after the primary procedure, especially young men who underwent a TKA [5,7,12,15,18] (Figure 1).

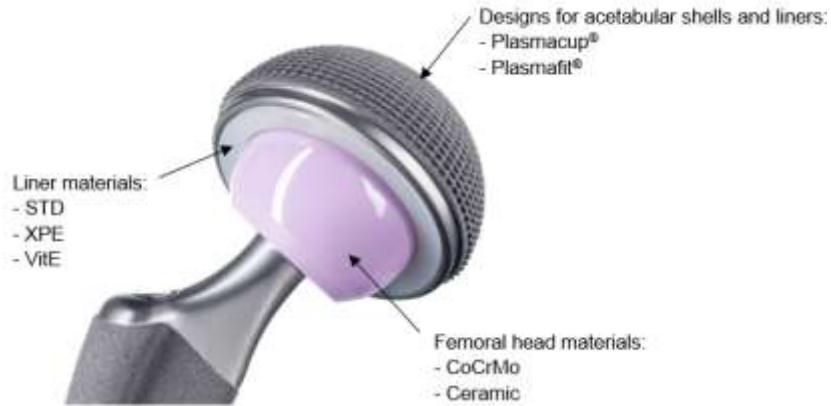
Figure 2: Schematic presentation of the different materials and designs investigated.

by ethylene oxide; and highly cross-linked and vitamin E (0.1%) blended polyethylene (VitE) which was cross-linked by an electron beam (80 kGy) and sterilized by ethylene oxide. The polyethylene liners were articulated in combination with acetabular shells made out of Ti6Al4V alloy and modular heads made out of ceramic or cobalt-chromium. A schematic presentation of the components is shown in Figure 2.

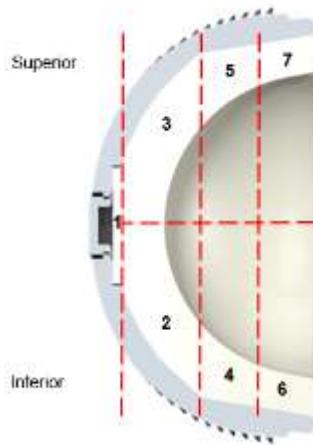
*Figure 3: Sketch from a cross section of a P-Fit liner with its titanium alloy shell and backside sections for wear analysis. Adapted from Puente Reyna et al. [63].*

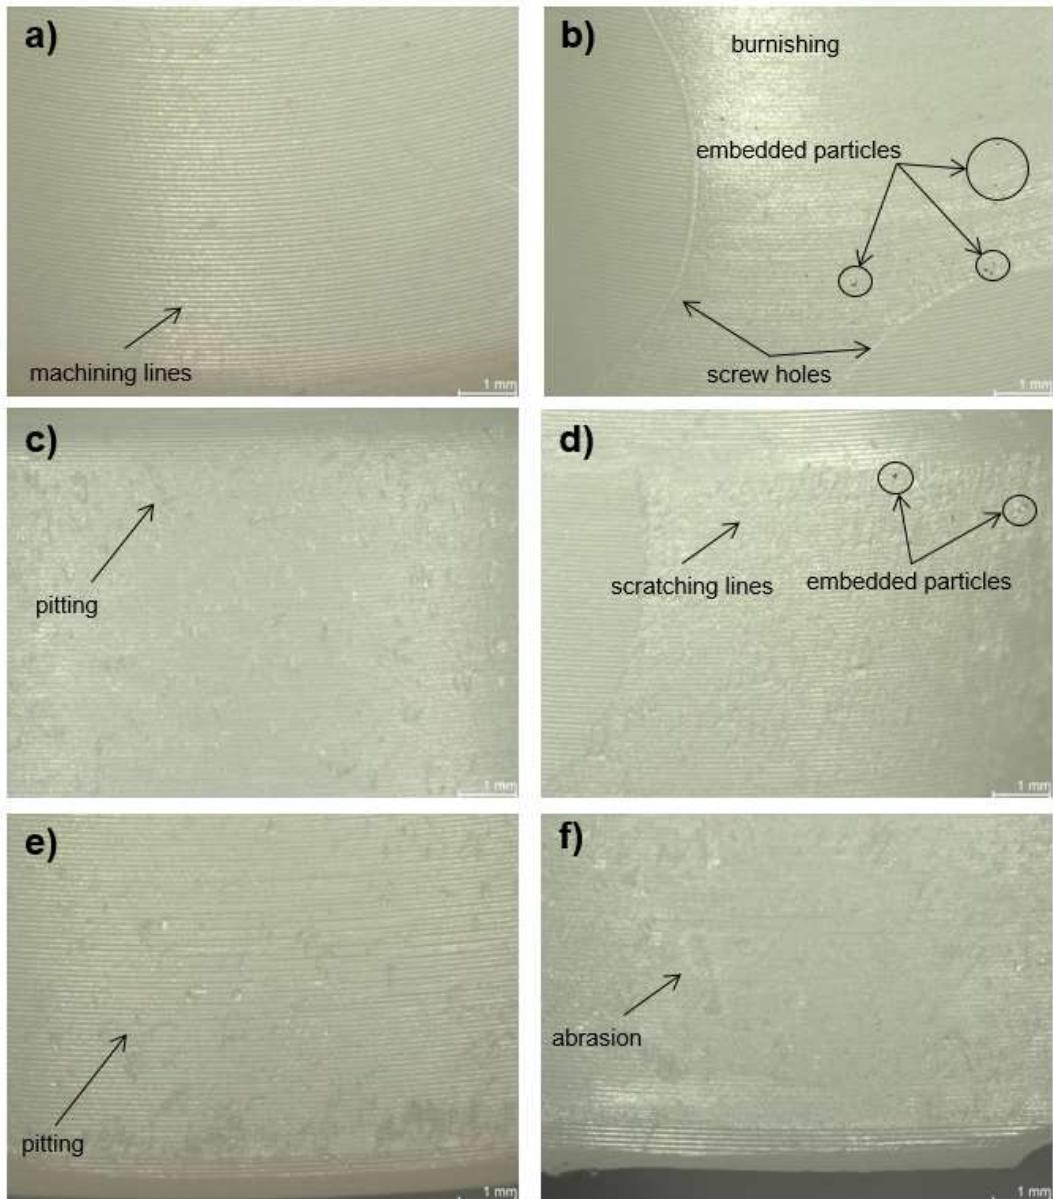
Figure 4: Photographs taken with a stereo light microscope from a  $P\text{-}CupS_{PW\ STD}^*$  retrieved liner after 37 months in situ; (a) Section 2: Machining lines clearly visible with no major wear marks; (b) Section 3: Screw holes visible but not palpable, with machining lines clearly visible and the periphery scratched and burnished with embedded particles; (c) Section 4: Pitting and machining marks still visible; (d) Section 5: Area with embedded particles and covered with scratches, machining marks partially visible; (e) Section 6: Small pitting visible; (f) Section 7: Area with abrasion marks. Adapted from Puente Reyna et al. [63].

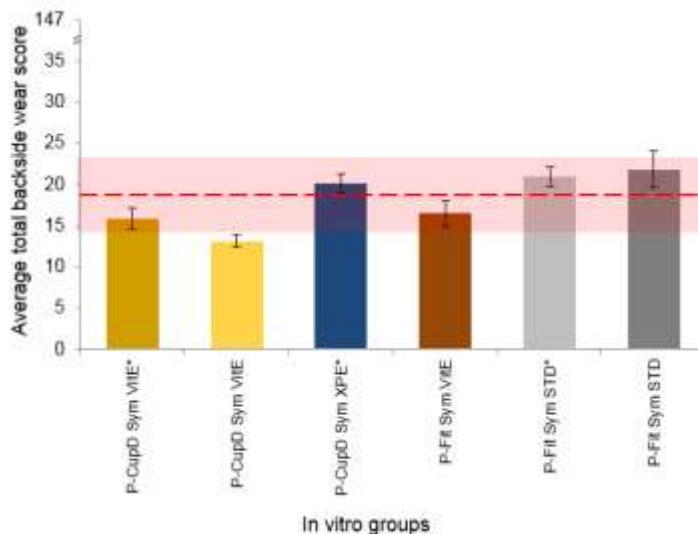
Figure 5: Summary of the average total backside wear score for in vitro tested liners. The dashed red line represents the average total backside wear score for the retrieved liners, while the red shadow shows the 95% confidence interval. The groups with “\*” were articulated against CoCr femoral heads and the others against ceramic femoral heads. Maximum total backside wear score possible = 147. Adapted from Puente Reyna et al. [63].

The total backside wear score for the in vitro tested liners ranged from  $13.17 \pm 0.75$  to  $21.83 \pm 2.23$ , being 147 the maximum total backside wear score possible (Figure 5). The STD and XPE liners showed statistically higher total backside wear scores compared to the VitE liners and the total backside wear score was approximately the same for the in vitro and retrieved liners.

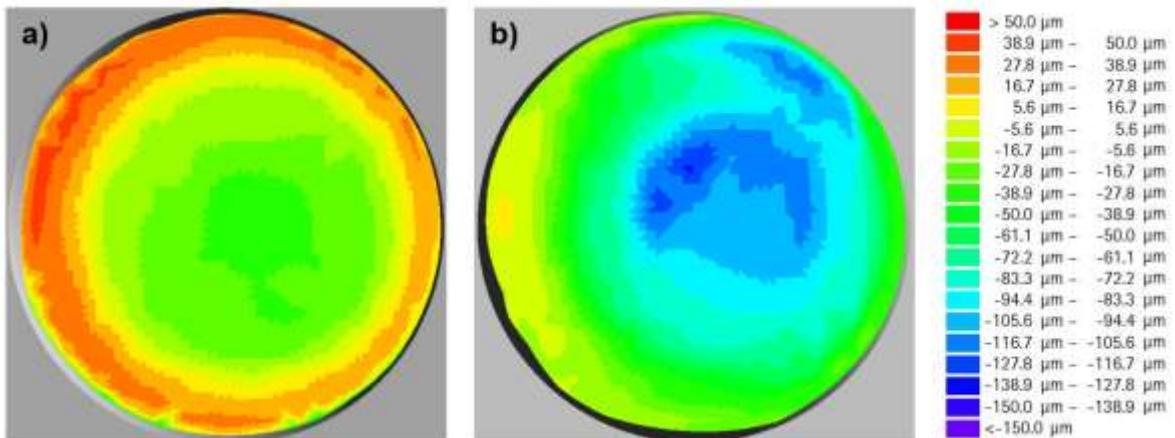
Figure 6: (a) Geometrical changes after 20 million cycles of a “Reference” liner subjected only to axial load (creep) and (b) a “Wear simulated” liner subjected to axial load and movement (creep and wear). Adapted from Puente Reyna et al. [67].

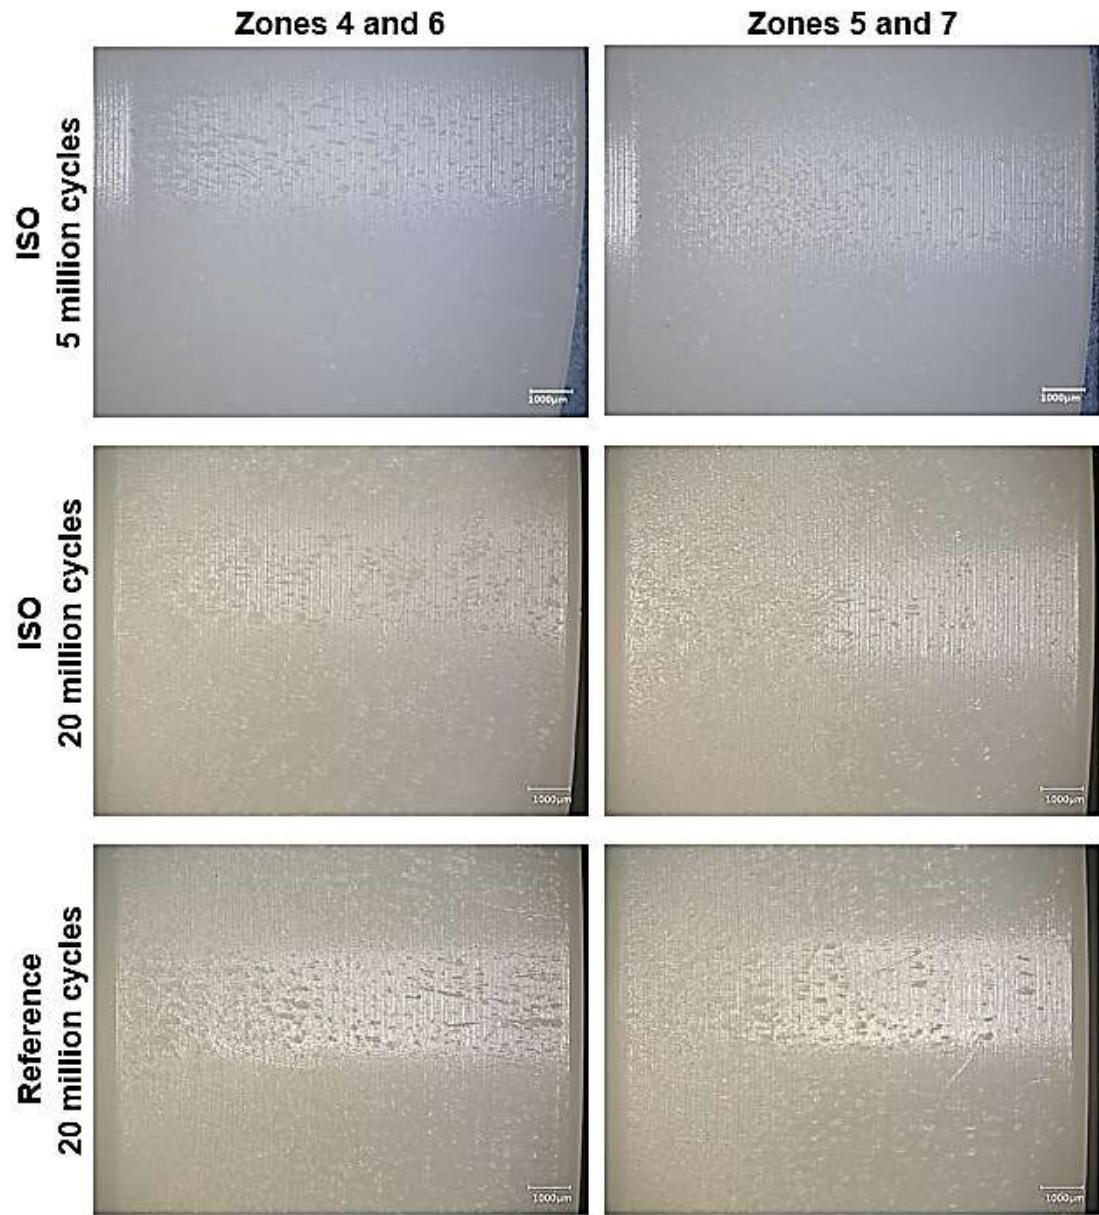
*Figure 7: Representative images of backside zones 4 to 7 of a “Wear simulated” liner after 5 and 20 million cycles (axial load and movement) and a “Reference” liner after 20 million cycles (only axial load). Small scratches in the direction of insertion and removal were clearly seen. Even though the images correspond to the same “Wear simulated” liner, the color difference was due to a different white balance configuration of the microscope. Adapted from Puente Reyna et al. [67].*

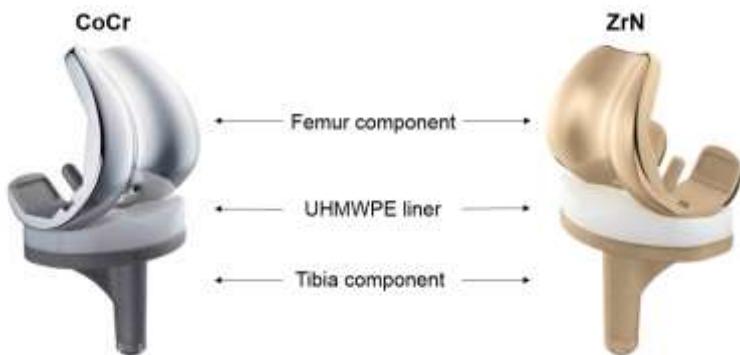
Figure 8: Schematic representation of the implant components of the CoCr and ZrN groups.

The wear tests were performed using medium size AS Columbus® DD (Aesculap AG, Tuttlingen, Germany) femoral and tibial components with a ZrN multilayer coating (ZrN group), in comparison with the clinically established cobalt chromium version Columbus® DD (CoCr group). UHMWPE liners (size T3, height 10 mm) machined from GUR 1020, packed under nitrogen atmosphere and sterilized by electron beam irradiation ( $30 \pm 2$  kGy) were used as gliding surfaces. A schematic representation of the implant components is shown in Figure 8. Wear simulation was performed on a load controlled knee wear simulator capable of reproducing the loads and movements of highly demanding activities (HDA). The applied load and motion profiles were based on in vivo measurements obtained from patients with instrumented implants [53] and normalized to represent a patient weight of 100 kg [76]. These profiles were applied in a combination of 40% stairs up, 40 % stairs down, 10% level walking, 8% chair raising and 2% deep squatting for 5 million cycles.

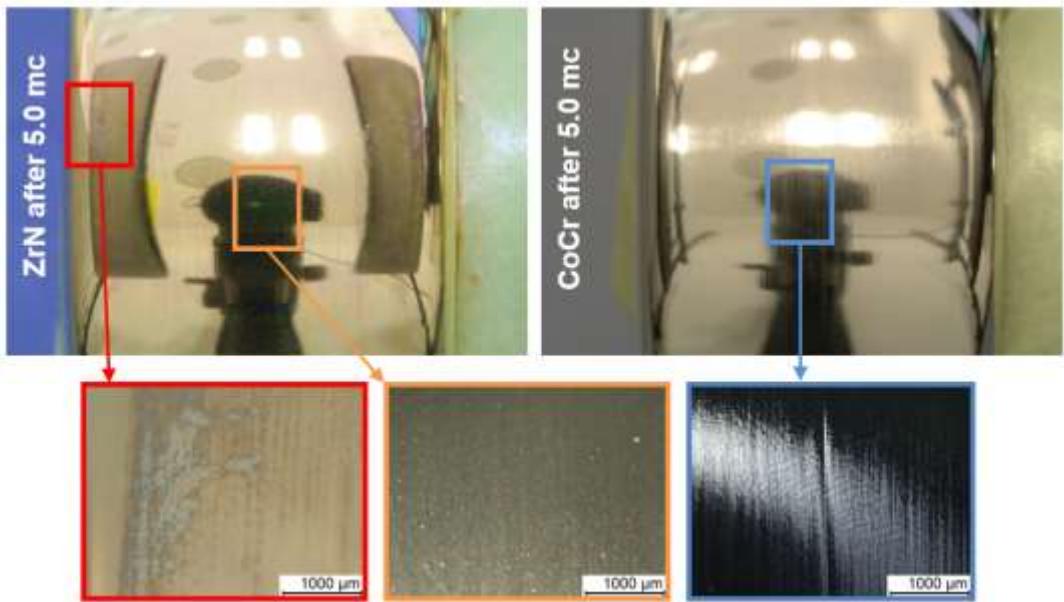
Figure 9: Wear characteristics of the femur components after 5 million HDA cycles. The ZrN femurs remained polished after the wear simulation, demonstrated by the clear reflection of the camera and lights, and neither scratches nor layer breakage were seen at the center of the articulation area. However, oxidation marks at the edges and in the articulation area were seen after 5 million HDA cycles (highlighted in red). On the other hand, slight scratches were seen at the articulation area of the CoCr femurs (highlighted in blue), demonstrated by the blurred reflection of the camera and lights. Obtained from Puente Reyna et al. [83].

The results showed a significant wear rate reduction in the ZrN group ( $1.01 \pm 0.29$  mg/million cycles) in comparison with the uncoated CoCr group ( $2.89 \pm 1.04$  mg/million cycles) ( $p = 0.04$ ). Regarding the ZrN multilayer coating, the articulation surface of the ZrN coated femurs remained polished after the testing period, whereas the uncoated femurs showed characteristic wear scratches at the articulation surface (Figure 9). Furthermore, the metal ion release from the ZrN coated implants was reduced by up to three orders of magnitude in comparison with the CoCr implants (Figure 10) and the cobalt ion concentration remained below 1  $\mu\text{g/l}$  starting the 2 million HDA cycles. These results demonstrated that the ZrN multilayer coating was able to keep its integrity even under a highly demanding activities knee wear simulation, as neither scratches nor delamination of the coating were seen.

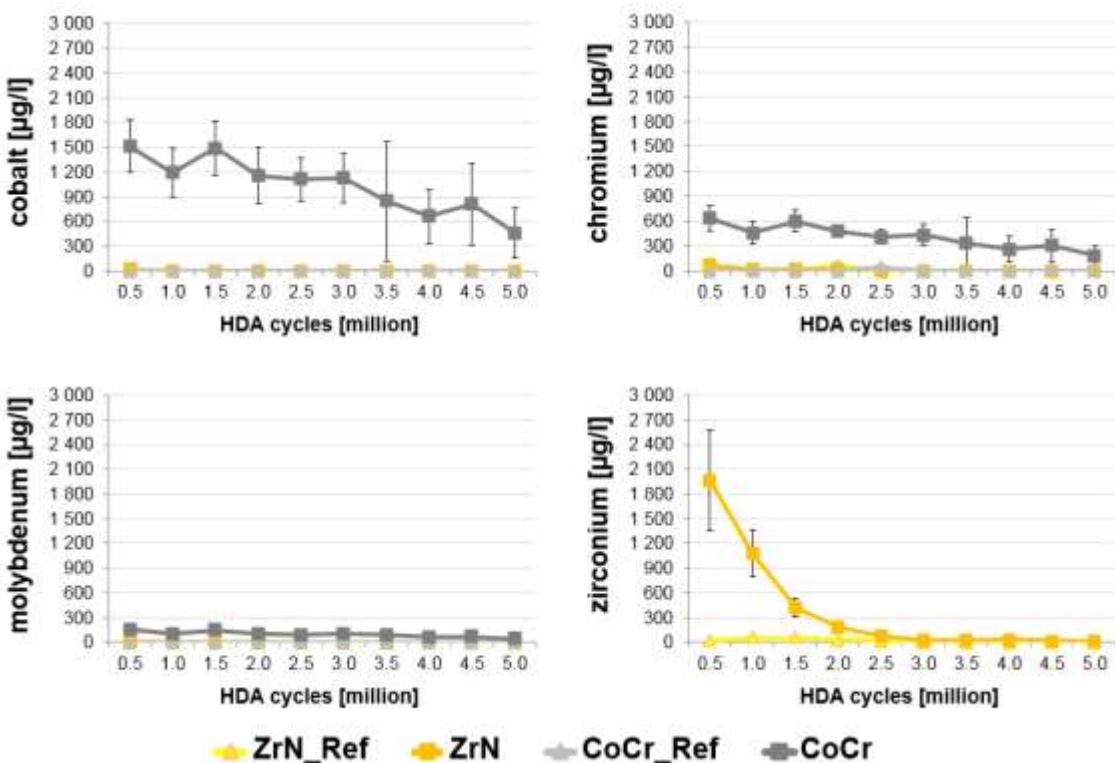
Figure 10: Metal ion concentration analysis of the ZrN and CoCr groups (subjected to axial load and movement) and their references (Ref = subjected just to axial load) during 5 million HDA cycles. The reference stations represent basic ion contamination of the environment and ion release by corrosion of the implant, whereas the wear testing groups additionally include the articulation-induced metal ion release. Obtained from Puente Reyna et al. [83].

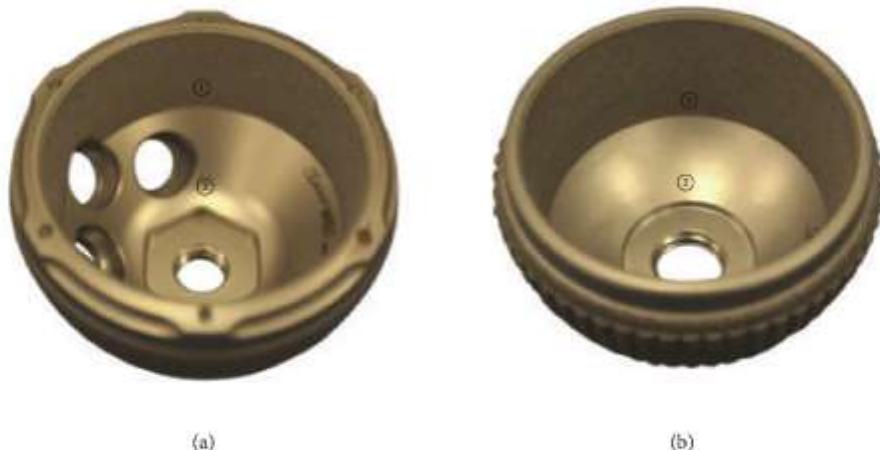
FIGURE 1: (a) P-Cup and (b) P-Fit metallic shell with grit blasted rough titanium conical inner surface at the rim ① and milled-drilled smooth surface on the concave area ②.

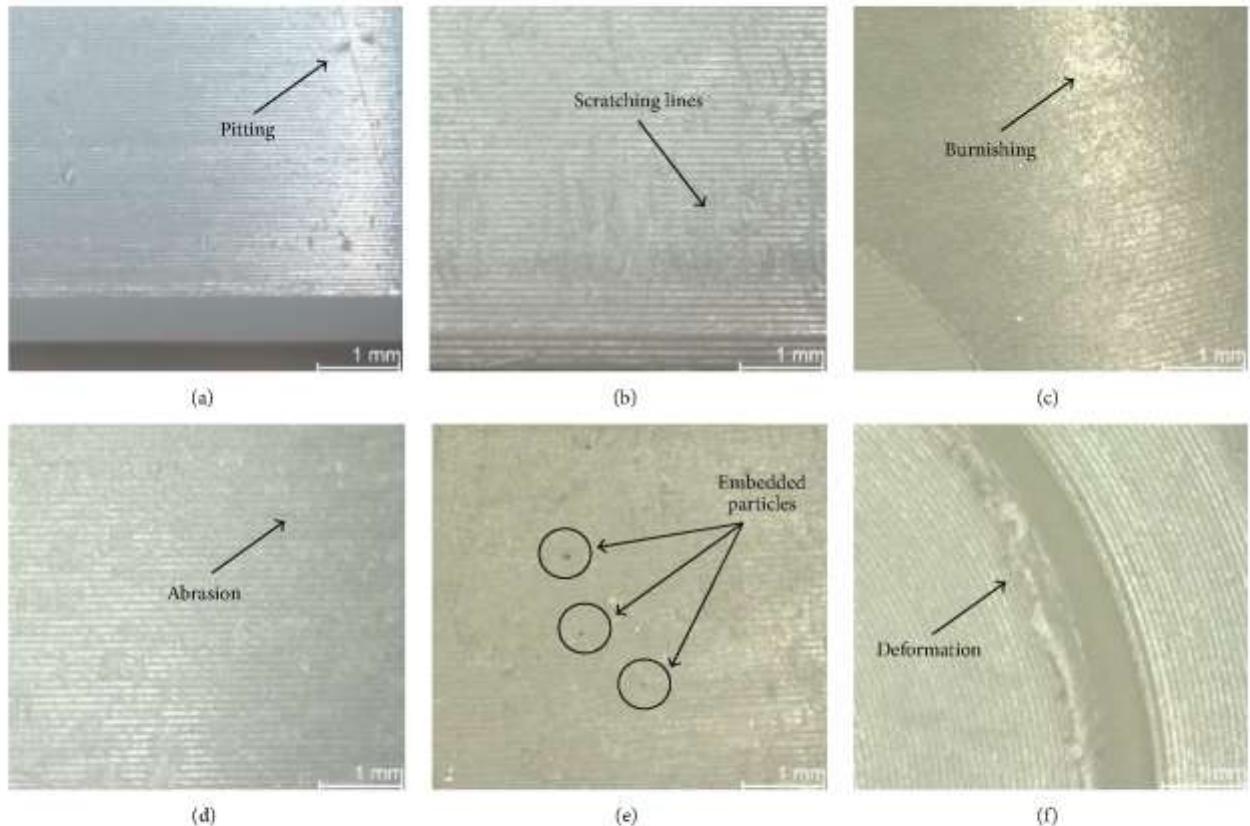
FIGURE 2: Images from each wear mode: (a) pitting, (b) scratching, (c) burnishing, (d) abrasion, (e) embedded particles, and (f) deformation. No image of delamination was taken, as this wear mode was not present in any of the inserts.

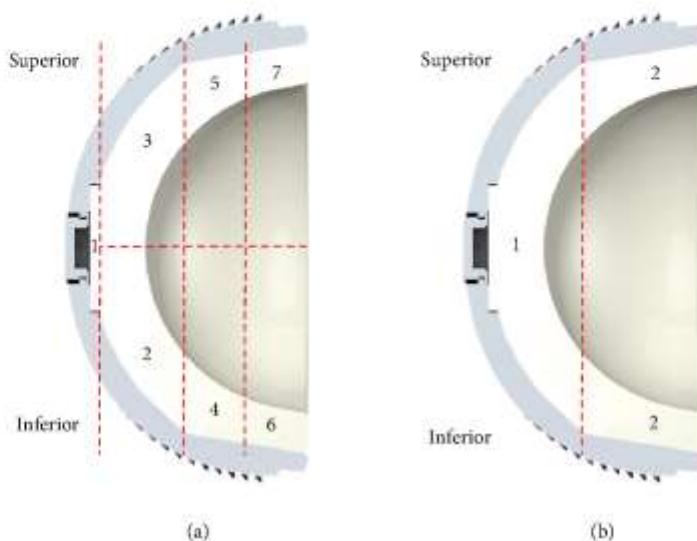
FIGURE 3: Sketch from a cross section of a P-Fit liner with its titanium alloy shell; (a) backside sections for wear analysis; (b) backside sections for screw indentation analysis.

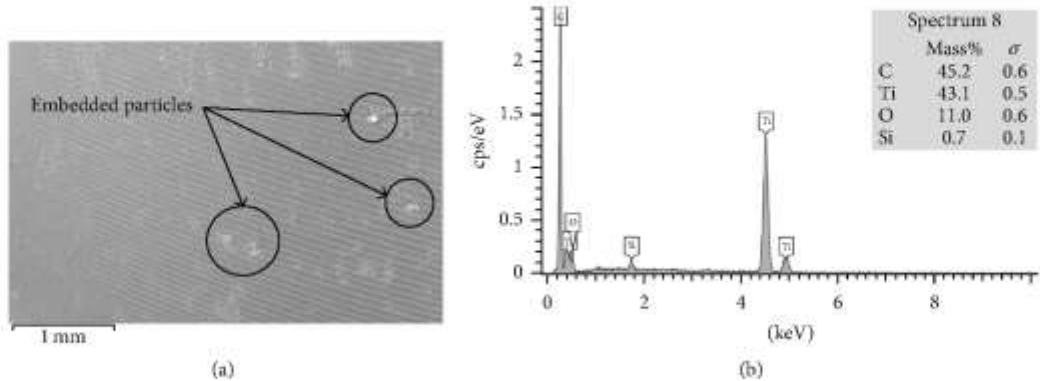
FIGURE 4: (a) SEM image with embedded particles in Section 5 from P-CupD<sub>PW\_VAE</sub> retrieval; (b) EDX analysis of the selected particle, which apparently consists of titanium alloy. The carbon spectrum corresponds to the surrounding polymer of the liner.

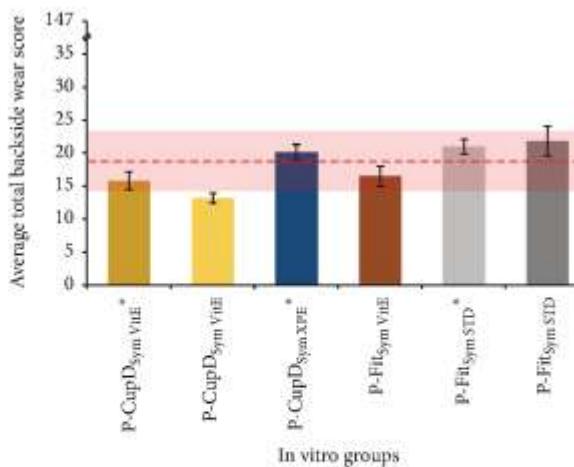
FIGURE 5: Summary of the average total backside wear score for in vitro tested liners. The dashed red line represents the average total backside wear score for the retrieved liners, while the red shadow shows the 95% confidence interval. The groups with “\*” were articulated against CoCr femoral heads and the others against ceramic femoral heads. Maximum total backside wear score possible = 147.

ceramic femoral heads, the P-Cup group ( $13.17 \pm 0.75$ ) showed a significantly lower average total backside wear score than the P-Fit group ( $16.50 \pm 1.52$ ) ( $p = 0.0215$ ). However, no significant difference ( $p = 0.9755$ ) was found if the liners were manufactured with XPE or STD and articulated against CoCr femoral heads ( $20.17 \pm 0.75$  for P-Cup versus  $21.00 \pm 1.15$  for P-Fit). Finally, no statistically significant difference in the average total backside wear score was found regarding the material of the articulating femoral head. For the P-Cup liners with VitE, the group articulated against CoCr had an average total backside wear score of  $15.83 (\pm 1.33)$ , while the group articulated against ceramic had  $13.17 (\pm 0.75)$  ( $p = 0.1049$ ). In case of the P-Fit liners with STD, the group articulated against CoCr had an average total backside wear score of  $21.00 \pm 1.15$ , while the group articulated against ceramic had  $21.83 (\pm 2.23)$  ( $p = 0.9755$ ).

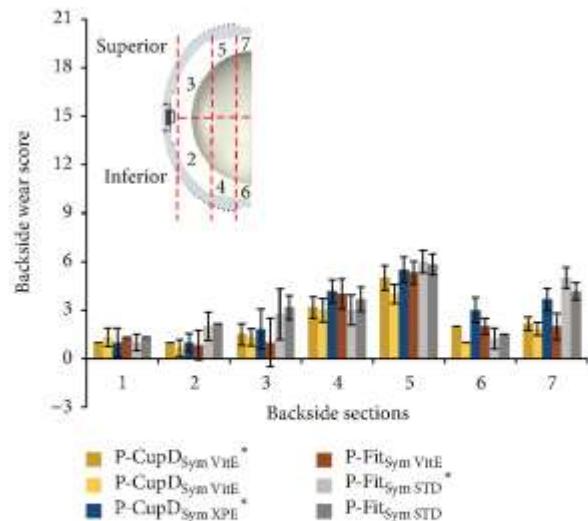
FIGURE 6: Backside wear score per backside section for in vitro wear tested liners. The groups with “\*” were articulated against CoCr femoral heads and the others against ceramic femoral heads. Maximum backside wear score per zone = 21.

The most damaged areas were Sections 4 through 7 (Figure 6), corresponding to the area against the roughened titanium surface of the acetabular metallic shell, with backside wear scores between  $1.00 (\pm 0.00)$  and  $6.00 (\pm 0.71)$  from a maximum score of 21. In these sections, the mode of wear mostly observed was multiple small scratches produced by the roughened inner surface during the repeated insertion and removal of the polyethylene liner in the acetabular shell (Figures 7(c), 7(e), and 8(a)). Section 5, corresponding to the limit between the roughened and milled-drilled section of the metallic acetabular shell on the superior orientation, showed the most wear marks overall, with a backside wear score between  $4.00 (\pm 0.58)$  and  $6.00 (\pm 0.71)$ . It was observed that, in this section, the multiple scratches produced abrasion of the liner and the machining marks were not more seen in some areas of the section (Figures 7(d) and 8(b)). However,

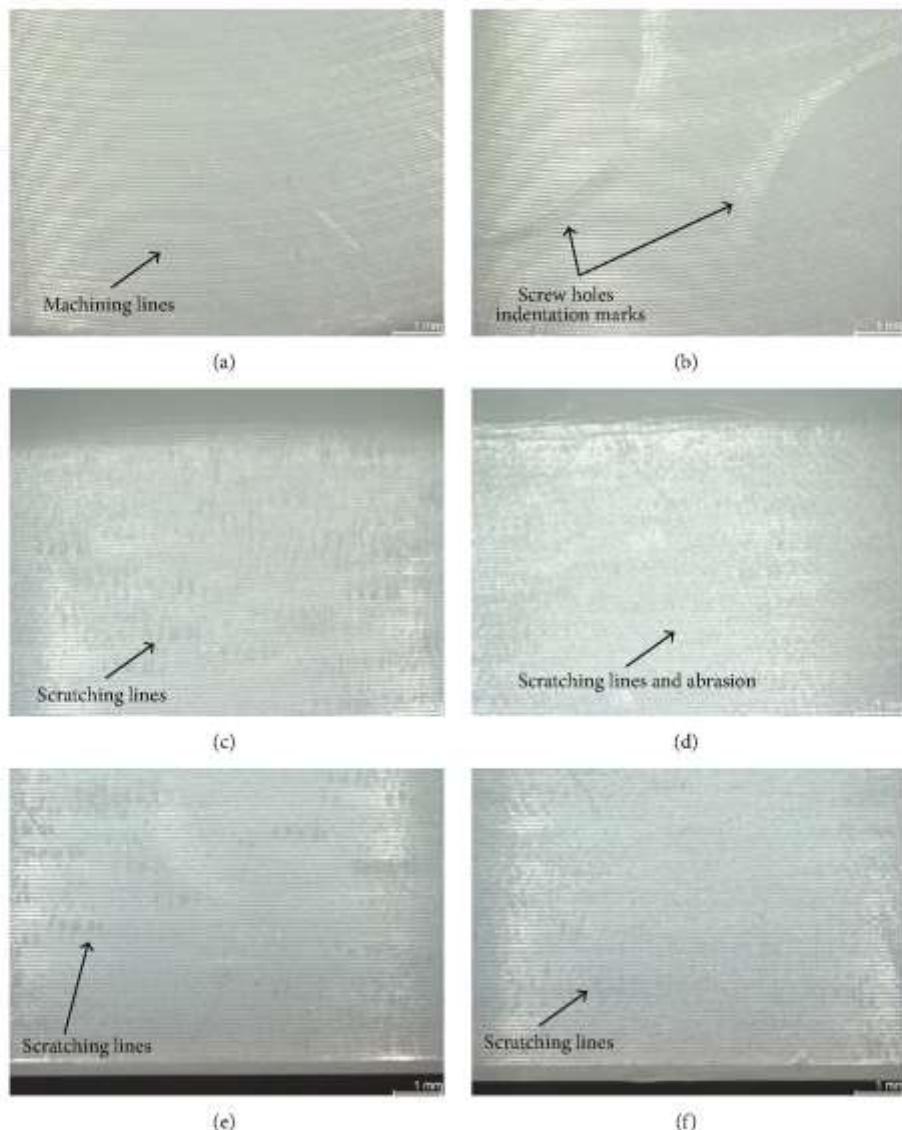
FIGURE 7: Photographs with microscope from in vitro wear tested liners. (a) P-CupD<sub>Sym</sub> VIE group, Section 2, machining lines clearly visible with no wear marks; (b) P-CupD<sub>Sym</sub> VIE group, Section 3, screw holes indentations marks and machining lines still visible; (c) P-CupD<sub>Sym</sub> VIE\* group, Section 4, small scratching lines; (d) P-CupD<sub>Sym</sub> VIE\*, Section 5, scratching lines and slight abrasion; screw hole is visible; (e) P-CupD<sub>Sym</sub> VIE\*, Section 6, small scratching lines; (f) P-CupD<sub>Sym</sub> VIE\*, Section 7, small scratching lines.

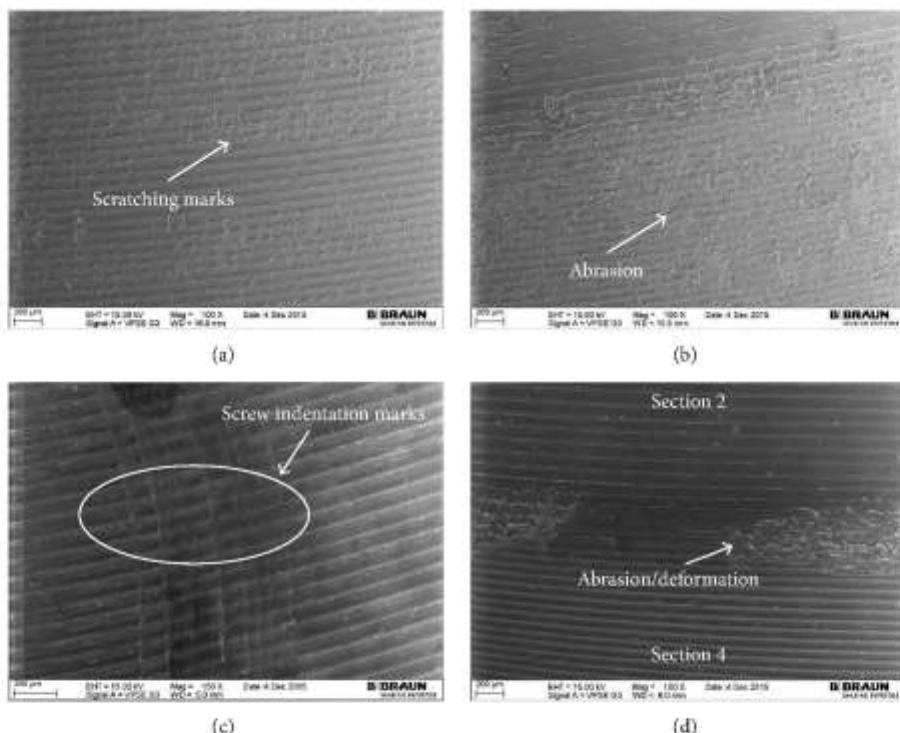
FIGURE 8: SEM images from the backside of the liners. (a) In vitro tested liners P-Fit<sub>Sym VIE</sub>, Section 7 with scratches and visible machining marks; (b) in vitro tested liner P-Fit<sub>Sym VIE</sub>, Section 5 with apparently considerable abrasion but with machining marks still visible; (c) in vitro tested liner P-CupD<sub>Sym VIE</sub>, Section 3 with multiple screw indentations and clear machining lines on both sides of the hole; (d) retrieval P-CupD<sub>PW VIE</sub>, edge between Sections 2 and 4 with small abrasion/deformation.

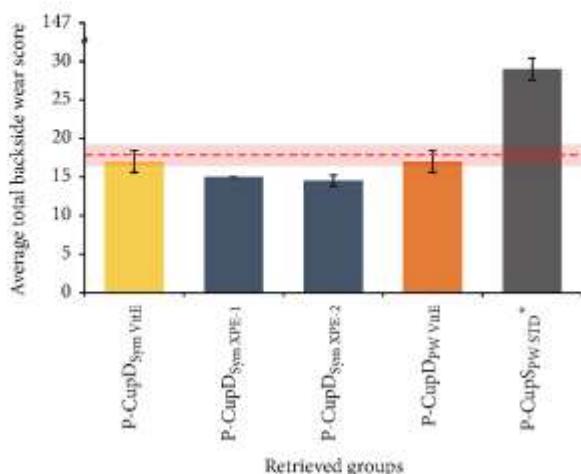
FIGURE 9: Summary of the total average wear score for retrieved liners. The dashed red line represents the total average backside wear score for the in vitro tested liners, while the red shadow shows the 95% confidence interval. The liner with “\*” was articulated against a CoCr femoral head; the others were articulated against ceramic femoral heads. Maximum total backside wear score possible = 147.

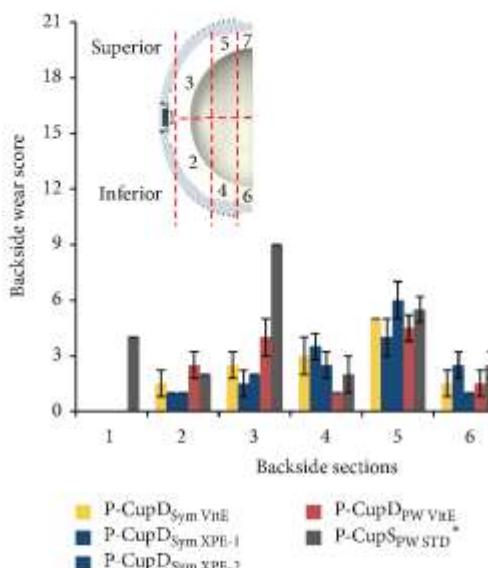
FIGURE 10: Wear score per backside section for retrieved liners. The liner with “\*” was articulated against a CoCr femoral head; the others were articulated against ceramic femoral heads. Maximum backside wear score per zone = 21.

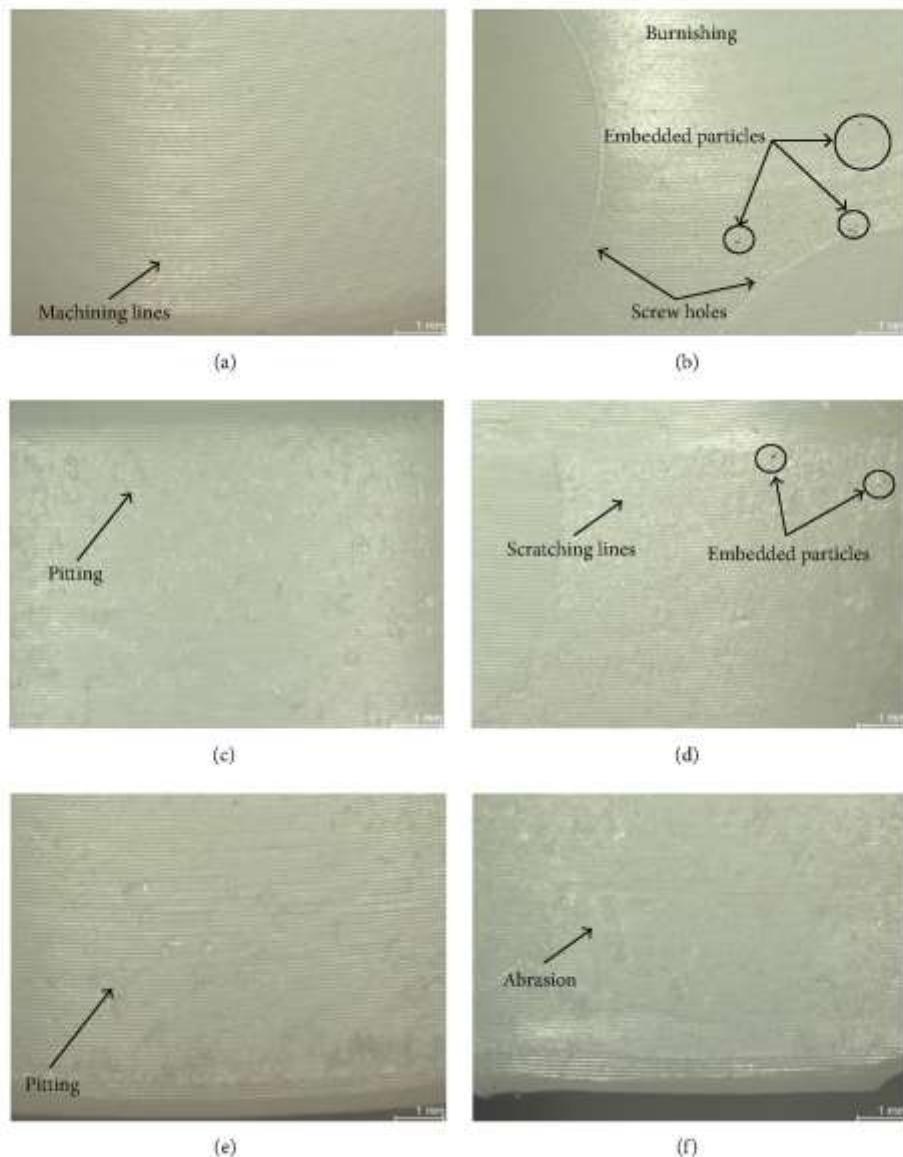
FIGURE 11: Photographs with microscope from P-CupS<sub>PW STD</sub>\* retrieved liner after 37 months in situ; (a) Section 2: machining lines clearly visible with no major wear marks; (b) Section 3: screw holes visible but not palpable, with machining lines clearly visible and the periphery scratched and burnished with embedded particles; (c) Section 4: pitting and machining marks still visible; (d) Section 5: area with embedded particles and covered with scratches, machining marks partially visible; (e) Section 6: small pitting visible; (f) Section 7: area with abrasion marks.

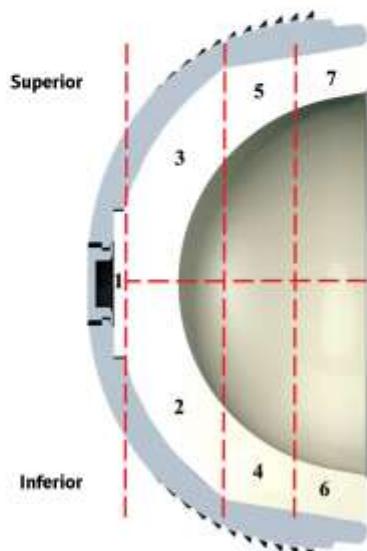
**Fig. 1.** Sketch from a cross-section of a Plasmafit® liner with its titanium alloy shell and the corresponding sections for backside wear analysis [11]

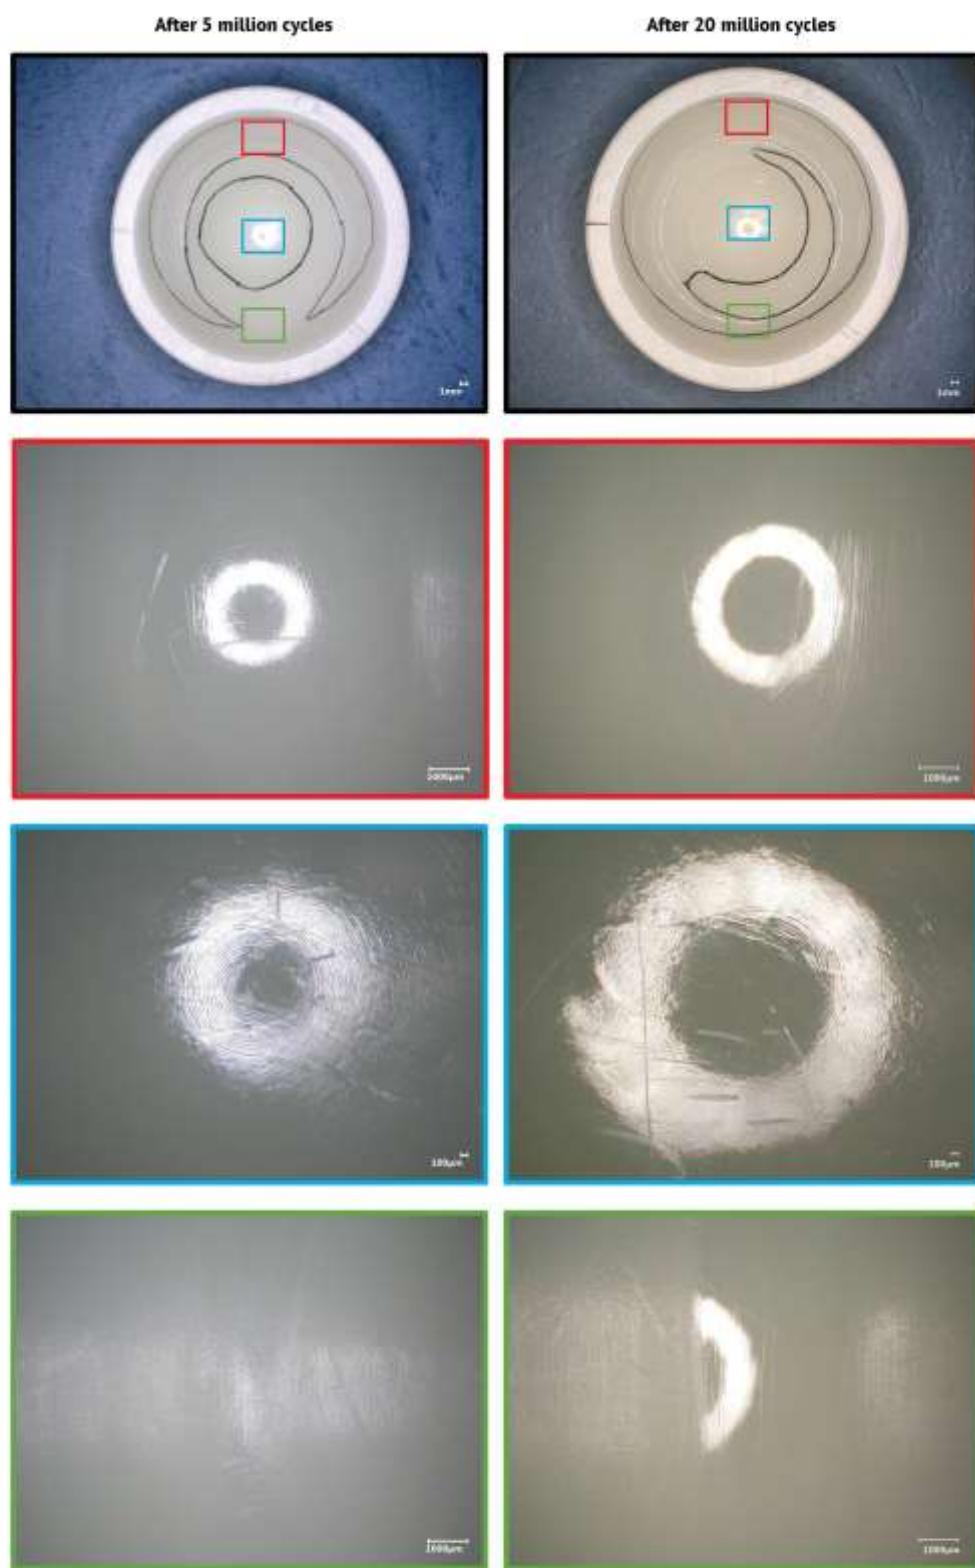
Fig. 2. Wear patterns at the articulation surface of a "Wear simulated" liner (subjected to axial load and movement) after 5 and 20 million cycles showing polishing and slight scratches. Black: overview of the wear areas; red: superior side of the liner in anatomical position; blue: wear at the pole; green: wear at the inferior side

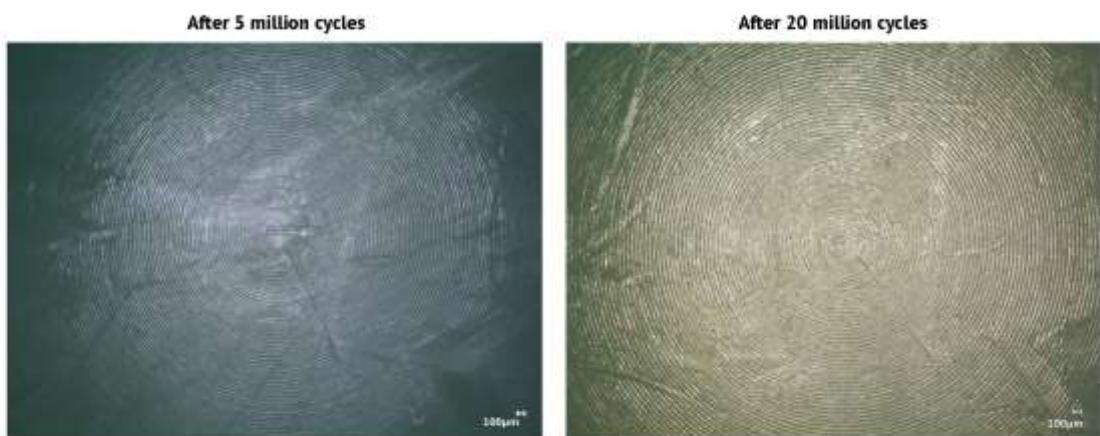
Fig. 3. Articulation surface of a "Reference" liner subjected just to axial load after 5 (left) and 20 (right) million cycles with machining marks still visible

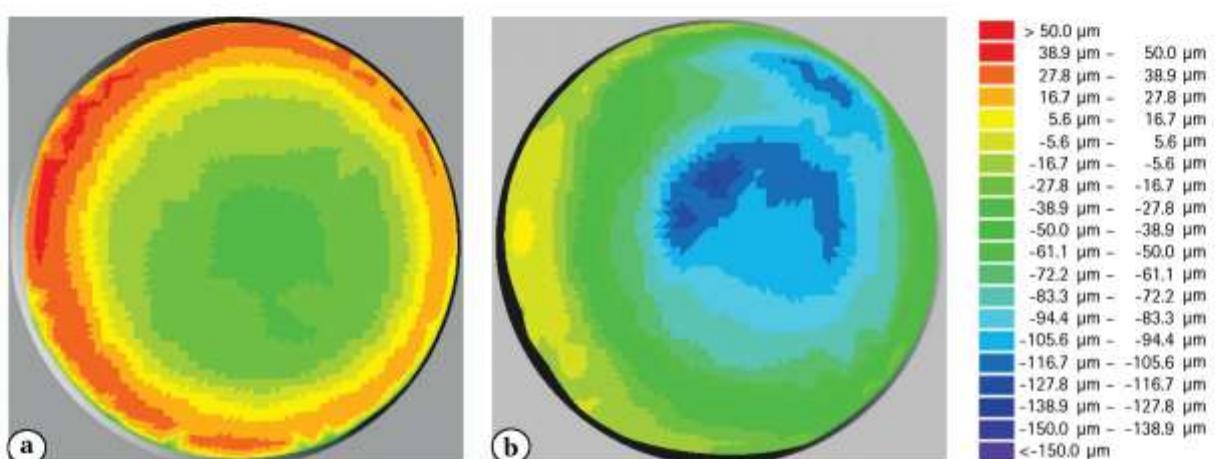
Fig. 4. Geometrical changes after 20 million cycles of a "Reference" liner subjected only to axial load (creep) (a) and a "Wear simulated" liner subjected to axial load and movement (creep and wear) (b)

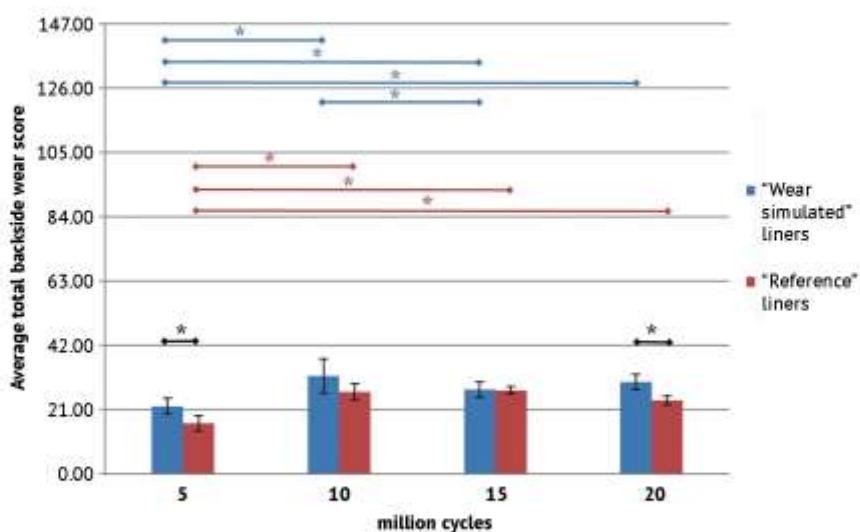
Fig. 5. Average total backside wear score of the "Wear simulated" liners (subjected to axial load and movement) and "Reference" liners (only axial load) after 5, 10, 15 and 20 million cycles. Maximum total backside wear score possible = 147.  
\* Indicates statistical difference ( $p < 0.05$ )

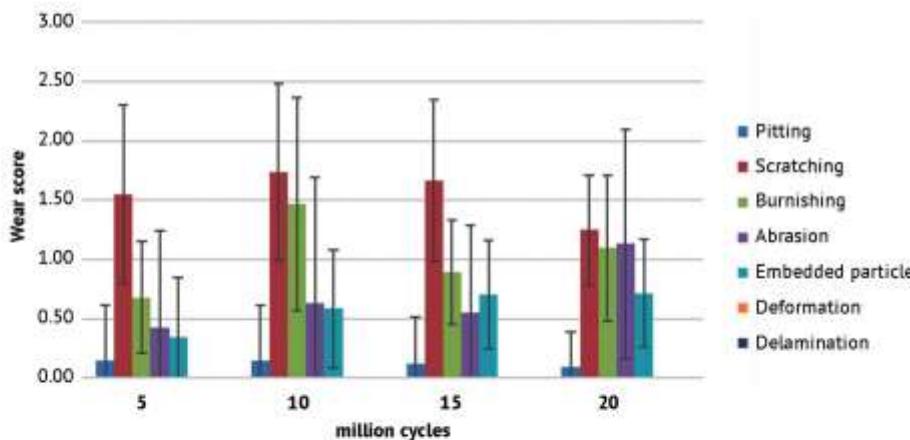
Fig. 6. Average score per wear mode of all backside sections of the "Wear simulated" liners after 5, 10, 15 and 20 million cycles. Maximum possible score per wear mode = 3

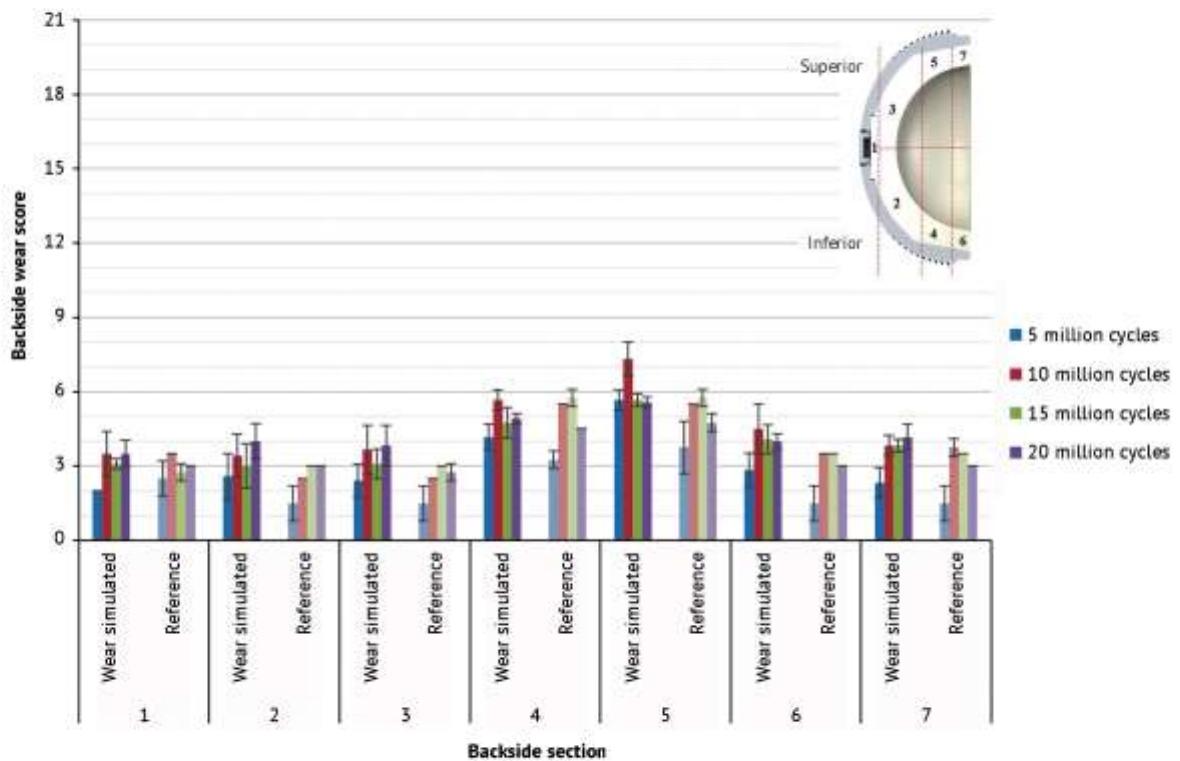
Fig. 7. Backside wear score per backside section for the "Wear simulated" (axial load and movement) and "Reference" liners (only axial load) after 5, 10, 15 and 20 million cycles. Maximum backside wear score per zone = 21

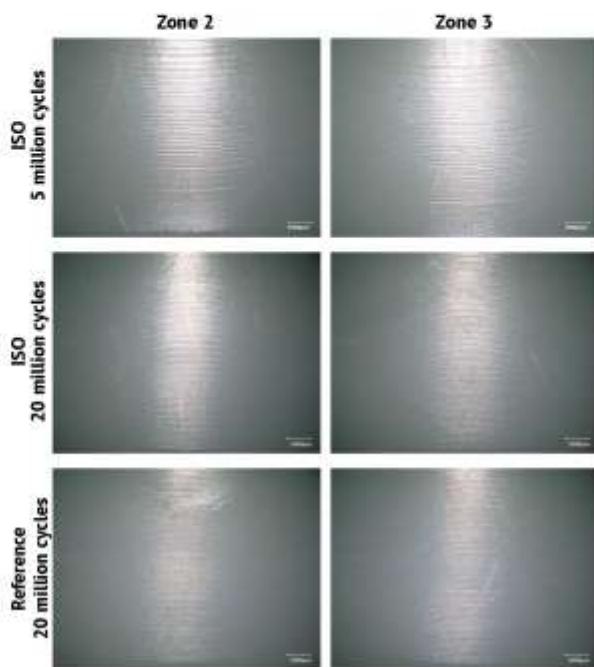
**Fig. 8.** Representative images of backside zones 2 and 3 of a "Wear simulated" liner after 5 and 20 million cycles (axial load and movement) and a "Reference" liner after 20 million cycles (only axial load). Machining marks were always visible

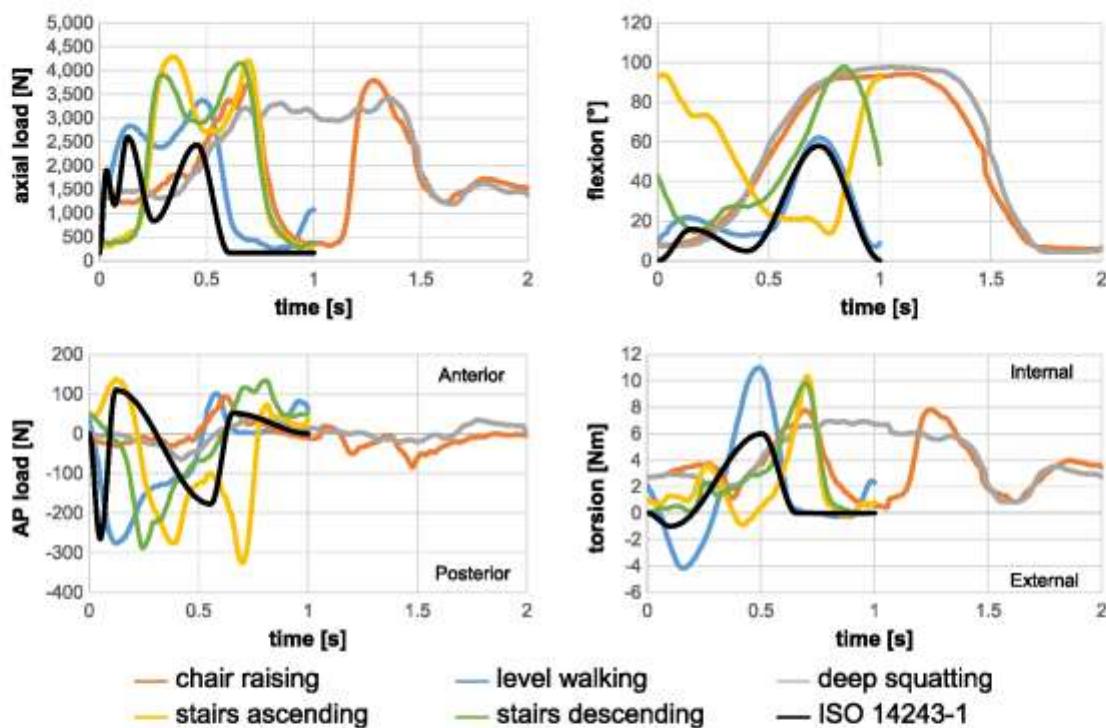
**Fig. 1.** Axial load, flexion angle, anterior-posterior load (AP load), and rotational torque applied during the simulation of the different high demanding activities (chair raising, level walking, deep squatting, stairs ascending, and stairs descending) in comparison with the ISO 14243-1:2009(E) profile. Figure adapted from Schwiesau et al. (2014).

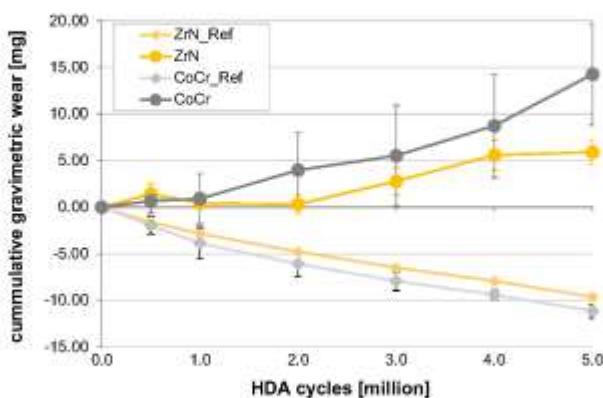
**Fig. 2.** Wear behavior of the polyethylene gliding surfaces from the ZrN and CoCr groups after 5 million HDA wear cycles.
