# **Long-term biotribological evaluation of total hip and knee arthroplasty implants**

Thesis  
Submitted for a Doctoral degree in Human Biology  
at the Faculty of Medicine, Ludwig-Maximilians-Universität zu München

by  
Ana Laura Puente Reyna

2019

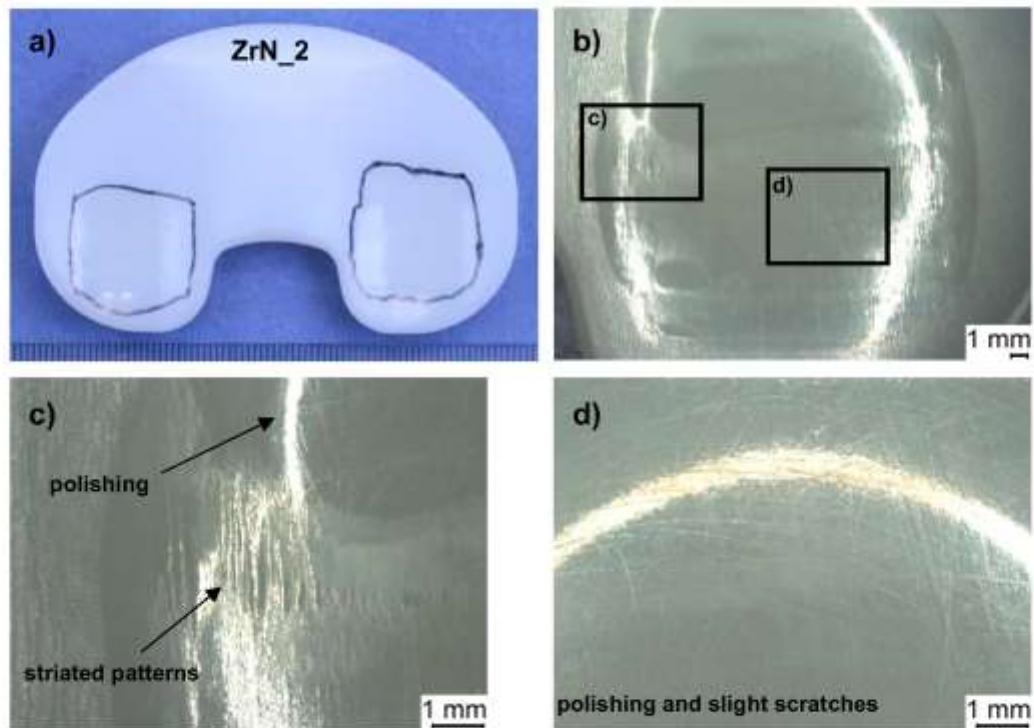
**Fig. 3.** Characteristic wear patterns of the polyethylene gliding surface of the ZrN group after 5 million HDA cycles. (a) Overview of the wear areas; (b) wear area in articulation with the medial condyle showing polishing, scratches and striated patterns; (c) striated patterns seen in the internal position and polishing in the rest of the area; (d) polishing and slight scratches seen at the center of the articulation area.

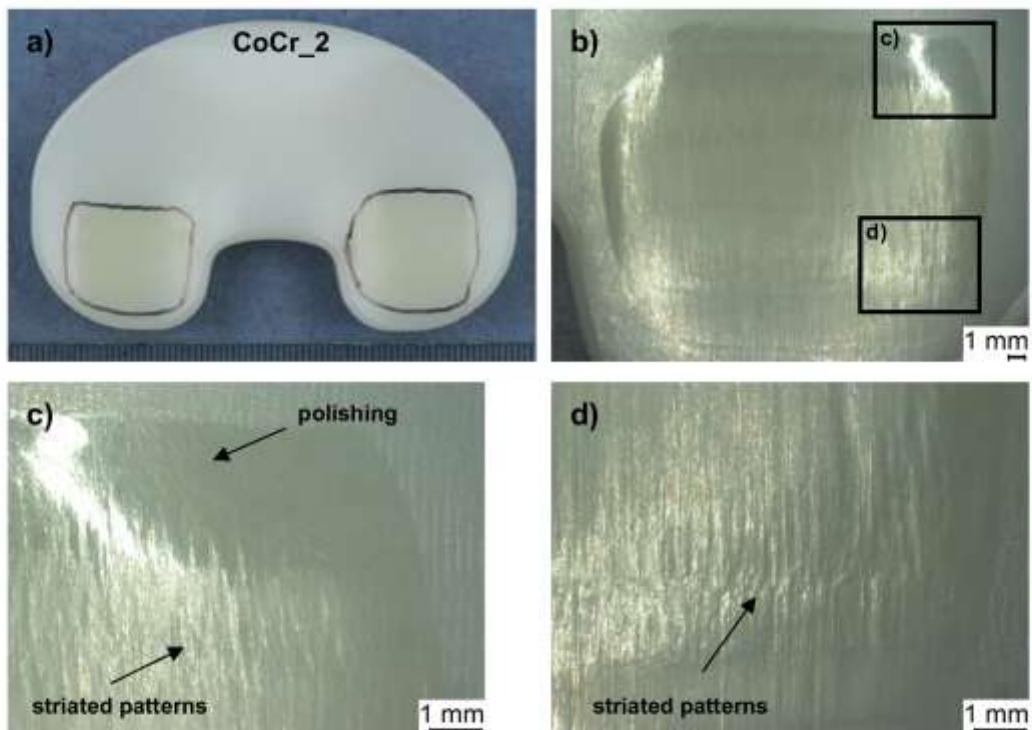
**Fig. 4.** Characteristic wear patterns of the polyethylene gliding surface of the CoCr group after 5 million HDA cycles. (a) Overview of the wear areas; (b) wear area in articulation with the medial condyle showing polishing, scratches and striated patterns; (c) polishing in the most anterior area and striated patterns in the rest of the area; (d) striated patterns seen at the external side of the articulation area.

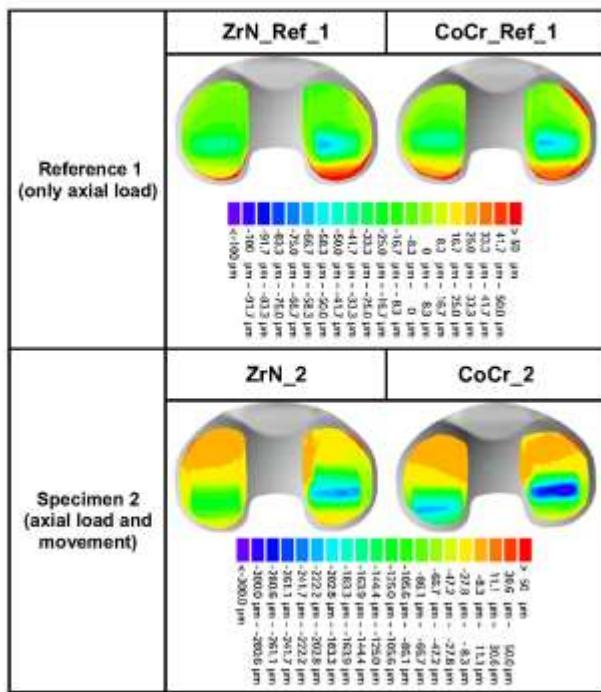
**Fig. 5.** Geometrical changes after 5 million HDA wear cycles of the polyethylene gliding surfaces from the ZrN and CoCr groups. The geometrical changes of the reference specimens were due to creep (only axial load was applied), whereas the changes in the testing specimens were due to creep and wear (axial load and movement were applied). The green and blue areas from the ZrN\_2 and CoCr\_2 specimens represent the wear areas marked in Figs. 3a and 4a respectively, while the yellow and orange areas represent plastic deformation.

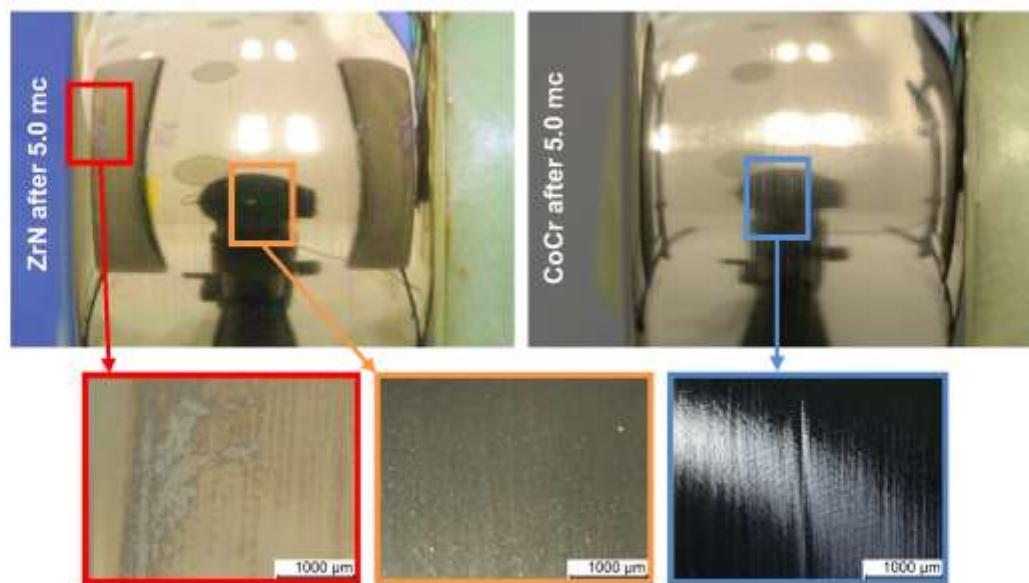
**Fig. 6.** Wear characteristics of the femur components after 5 HDA million cycles. The ZrN femurs remained polished after the wear simulation, demonstrated by the clear reflection of the camera and lights, and no scratches nor layer breakage were seen at the center of the articulation area. However, oxidation marks at the edges and articulation area after 5 million HDA cycles (highlighted in red) were seen. On the other hand, slight scratches were seen at the articulation area of the CoCr femurs (highlighted in blue), demonstrated by the blurred reflection of the camera and lights.

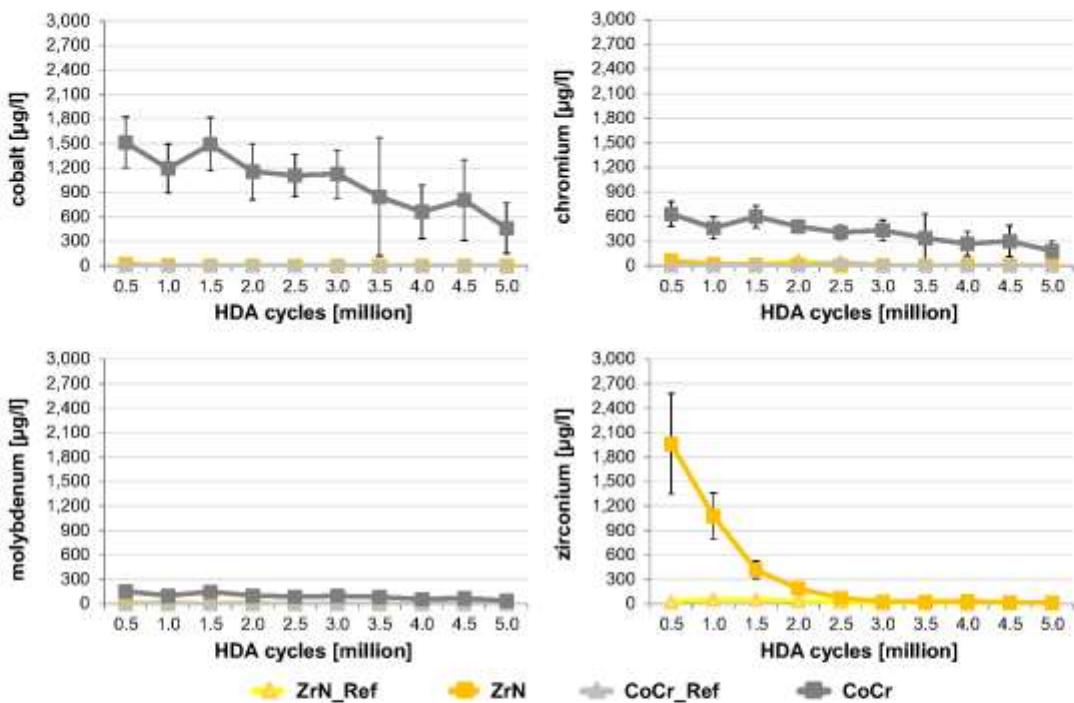
**Fig. 7.** Metal ion concentration analysis of the ZrN and CoCr groups (subjected to axial load and movement) and their references (Ref = subjected just to axial load) during 5 million HDA cycles. The reference stations represent basic contamination of the environment and corrosion of the implant, whereas the wear testing groups include the articulation-induced metal ion release.

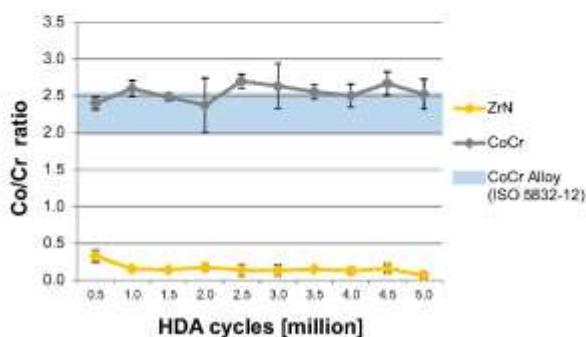
**Fig. 8.** Co/Cr ratio of the metal ion concentrations found in the test serum through the entire test in comparison with the range of Co/Cr ratio from the substrate material according to ISO 5832-12:2007.
