# Thermo-Mechanical Degradation and Mitigation by Molten Volcanic Ash Wetting on Thermal Barrier Coatings of Jet Engine Turbine Blades

Siddharth Lokachari

Dissertation zur Erlangung des Doktorgrades an der Fakultät für Geowissenschaften der Ludwig-Maximilians-Universität München

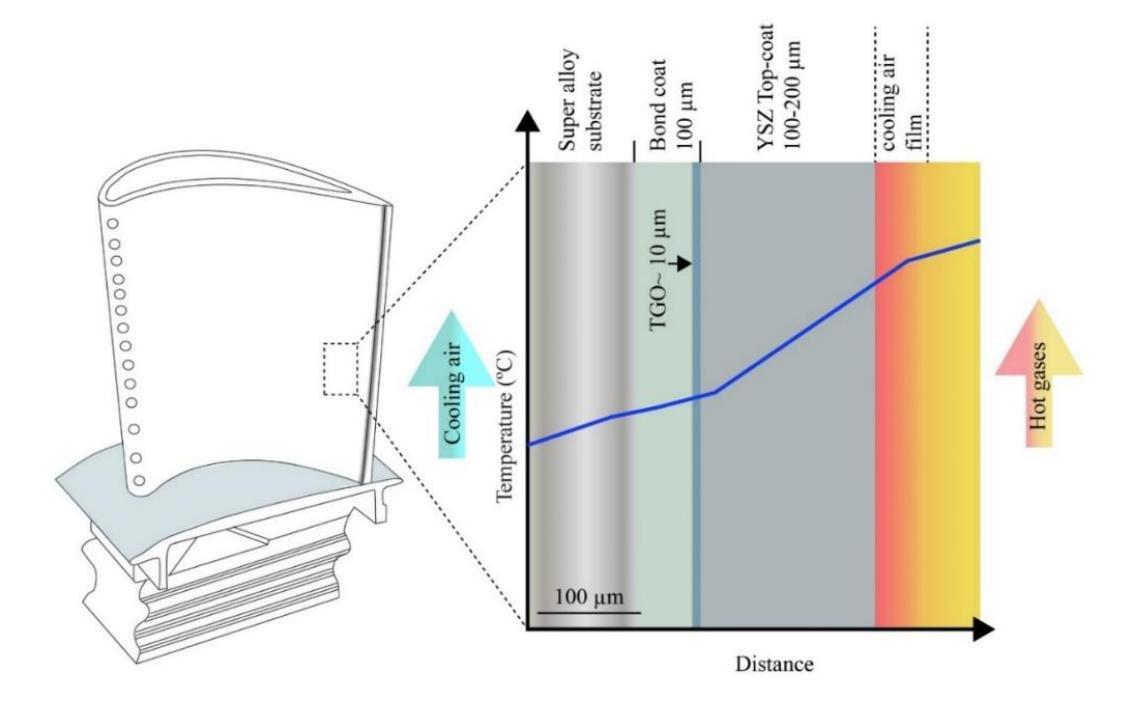
Figure 2. Schematic illustration of the structure of TBCs

Conventional TBCs consists of a porous ceramic top-coat (typically made of tetragonalphase ZrO<sub>2</sub> ceramic stabilized by 7 wt.% Y<sub>2</sub>O<sub>3</sub>, commonly referred to as 7YSZ) and a middle metallic bond coat (MCrAIY) which improves adhesion of TBC to the substrate, and is specially designed to protect the underlying superalloy engine parts against corrosive gases present under the routinely harsh operating environment. Thermally grown oxide (TGO,  $\alpha$  Al<sub>2</sub>O<sub>3</sub>), is formed as a resultant of the Al-rich bond coat and acts as an oxidation barrier to the superalloy substrate. The superalloy substrate is essentially composed of Nickle based superalloy, it offers mechanical resistance by taking the structural loads, during the operational cycle of the engine. The superalloy is resistant to creep, fatigue, and intense thermo-mechanical cycles (Fig.2). Thermal flux difference of ~170 °C is estimated from the topcoat to the substrate, spallation and delamination resistance of the top-coat can occur due to the thermal cycling during heating and cooling cycles (Clarke & Levi, 2003).

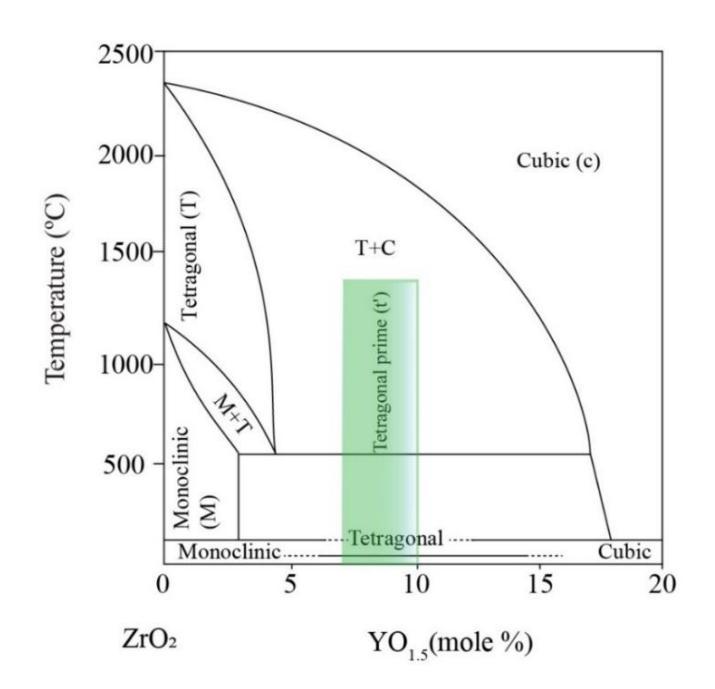
Figure 3. ZrO<sub>2</sub> YO<sub>1.5</sub> phase diagram

$ZrO_2$  is stabilized into its cubic, tetragonal phases, and unique metastable tetragonal prime (*t'*) phase as shown in figure 3. The stabilization of Zirconia is achieved by the addition of Yttria (Y<sub>2</sub>O<sub>3</sub>)-YSZ, which also introduces oxygen vacancies to the system. The choice of 7 wt. % Y<sub>2</sub>O<sub>3</sub> stabilized ZrO<sub>2</sub> (7YSZ) as the thermal barrier coating material is due to the ferroelastic toughening mechanism (Mercer, Williams, Clarke, & Evans, 2007), at high operating temperatures and thermal stress generated in the system.

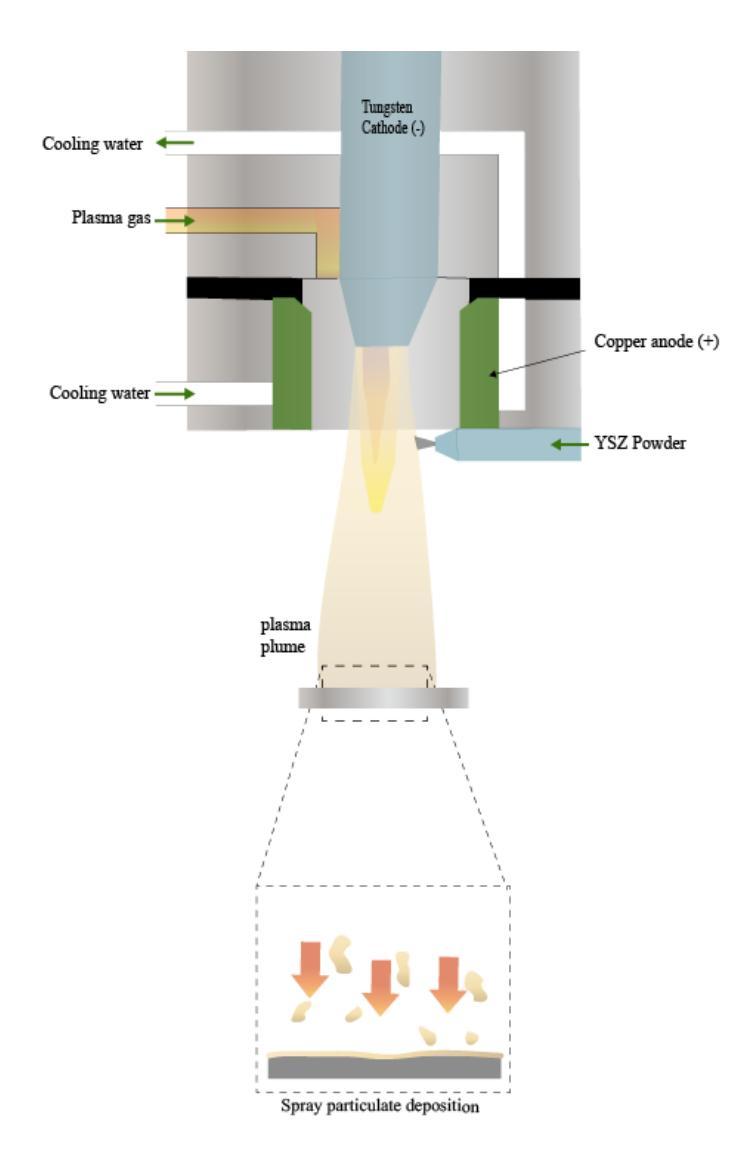
Figure 4. Schematic illustration of atmospheric plasma spraying

Atmospheric plasma-spraying (APS) is commonly used to fabricate ceramic coatings with the desired tolerances and properties (e.g., low thermal conductivity) onto vulnerable surfaces of components in the hot sections of jet engines. The air plasma spray process is a thermal spray deposition method in which the YSZ is heated to a semi-molten state by an electric heat source and deposited on the substrate. APS process can be performed in both atmospheric and vacuum conditions. Fig. 4 shows the schematic representation of the APS spray process, where the top-coat material in semi-molten form is carried along with a stream of argon/nitrogen and flows through a cylindrical nozzle onto the substrate propelled through the plasma jet. Parameters like the Spray velocity, powder size, and distance of the substrate from the nozzle influence the APS spray process.

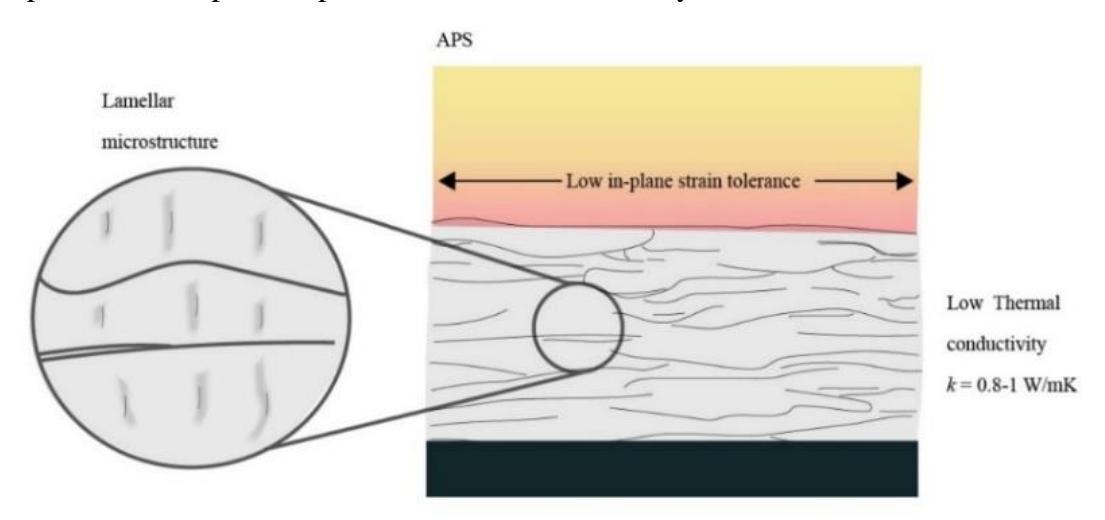
Figure 5. Schematic illustration of APS TBCs microstructure

The YSZ powder is deposited in the form of splat overlay (Fig.5) and consists of inter splats and intra splat voids. The coating is formed by rapid solidification of the splats and each splat is deposited parallel to the direction of spraying (Sevostianov & Kachanov, 2009). APS method is cost-effective, compared to the electron beam physical vapor deposition. The topcoat possesses low thermal conductivity, high strain tolerance, and provides thermal insulation to the metallic substrate. Phase transition at higher temperatures of topcoat is pivotal for structural stability.

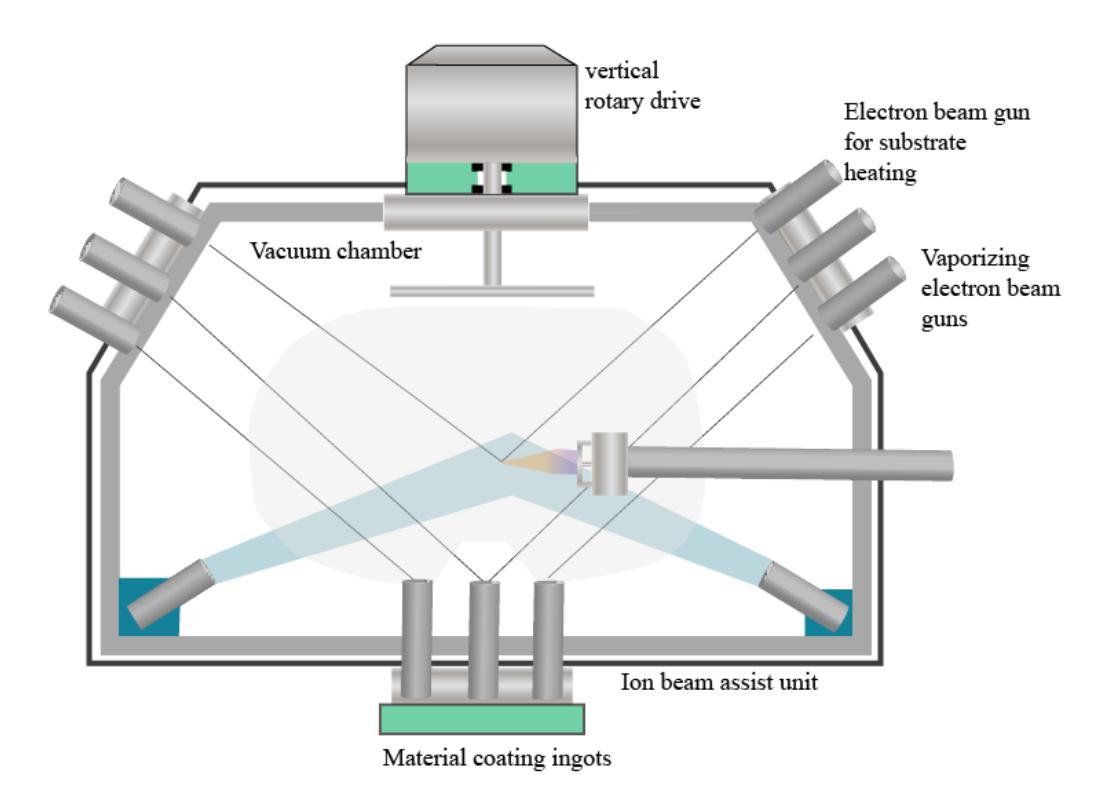
Figure 6. Schematic illustration of electron beam physical vapor deposition

The basic principle of the EB-PVD process is the creation of a melt pool consisting of YSZ feedstock, by heating it in an evacuated chamber with a high-energy electron beam, as shown in Fig. 6. The melt pool generates vapor. The vapor generated from the melt pool is coated on the target material, by means of the deposition of molecules present in the vapour. The EB-PVD process offers extensive advantages such as a smoother surface finish when compared to the APS spray process (Bernard et al., 2017).

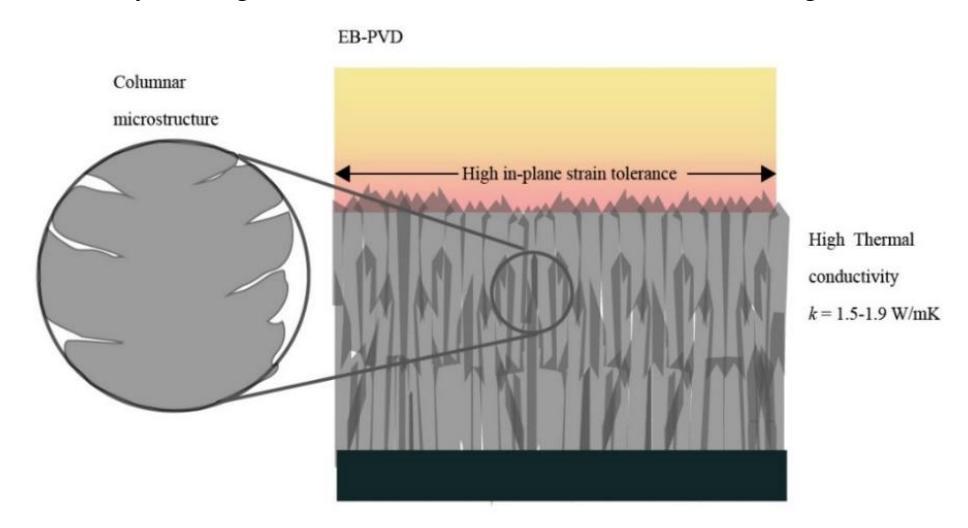
Figure 7. Schematic illustration of the microstructure of EB-PVD TBC

EB-PVD coating is composed of columnar grain structure YSZ generated perpendicular to the coating direction (Fig. 7), architectural modification can be achieved during the fabrication of EB-PVD coatings. In this thesis, both APS and EB-PVD coatings are employed to study the degradation, due to molten volcanic ash wetting.

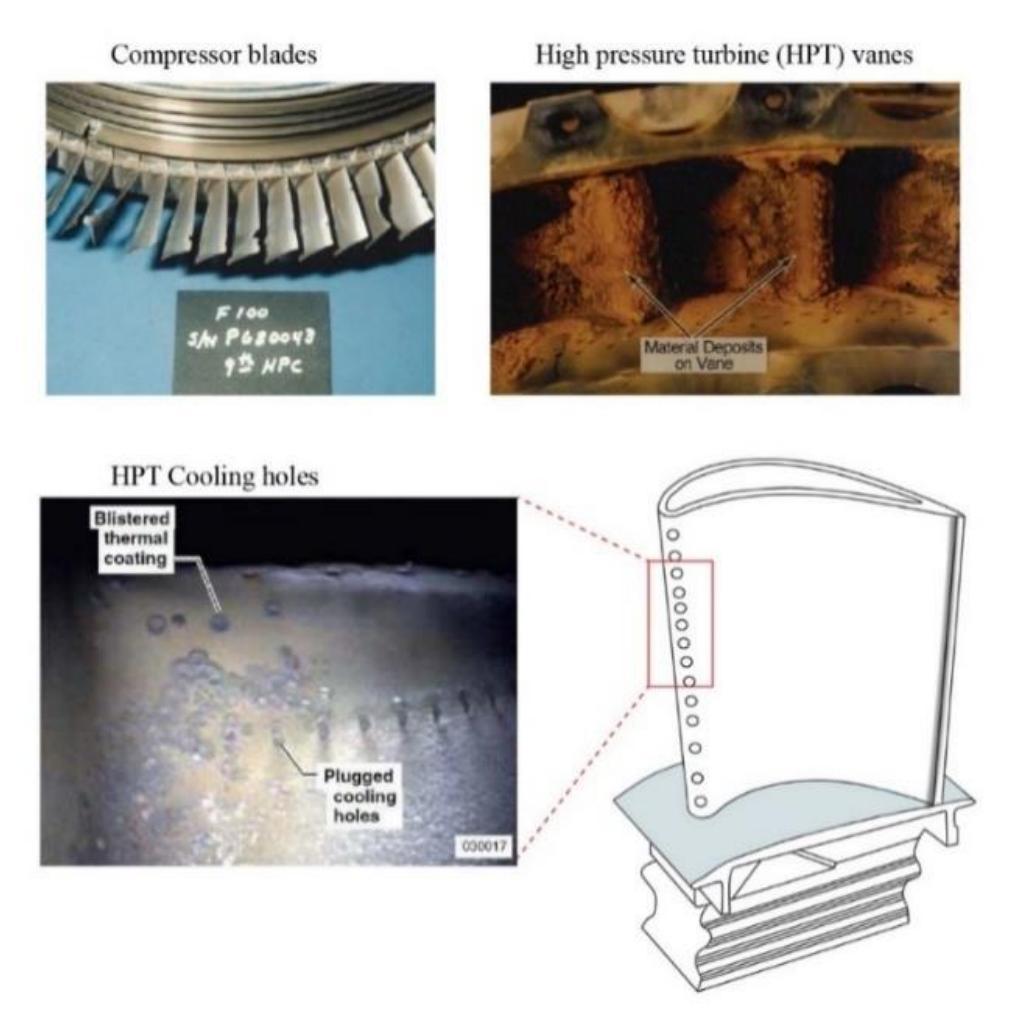
Figure 9. Deposition of volcanic ash on the compressor blades, high-pressure turbine vanes (W. R. Chen & Zhao, 2015)

When volcanic ash is ingested into a modern jet engine, it may initially erode/abrade compressor blades, leading to a reduction in operational efficiency, the ash subsequently enters the combustion chamber where peak flame temperatures can reach 2000 °C. Such temperatures far exceed the glass transition (~600-800 °C) and melting temperatures (~900-1300 °C) of the (glassy versus mineral) constituents of volcanic ash (Song et al., 2016). As a result, the ingested ash particles liquify (by one or both of by glass softening or mineral melting) and may adhere to, and flow across (i.e., impaction, spreading, and wetting) (Song et al., 2019). Spreading of molten volcanic ash on these components may physically clog cooling holes (as shown in Fig. 9), thereby blocking air intake and causing heat accumulation. Molten volcanic ash deposits can also infiltrate and chemically react with TBCs at operating temperatures, causing subsequent spallation of the coating upon cooling and ultimately exposing the underlying metal to corrosive gases (Vidal-Setif et al., 2012). As a result, jet engine performance may deteriorate substantially, leading to catastrophic failure (Xia et al., 2019). In chapter 3, for the first time, lab-scale simulation of the deposition of molten volcanic ash droplets was performed and, the penetration of the molten volcanic ash micro-globules was tracked by *in-situ* high-temperature dilatometry.

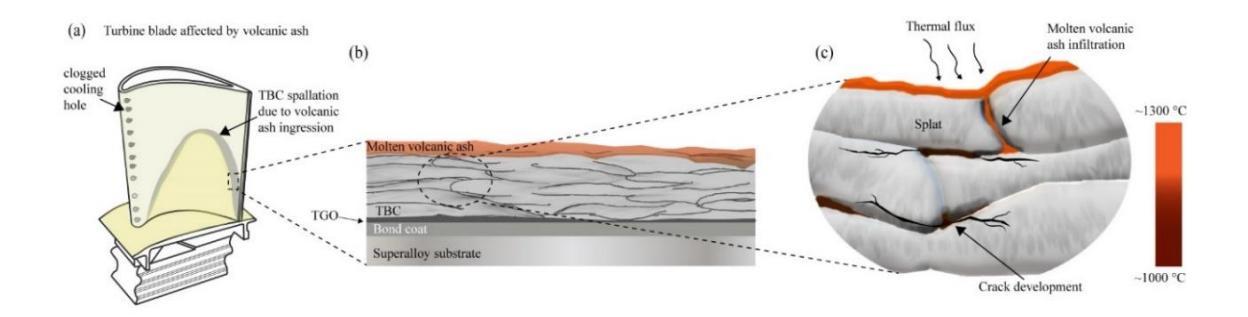
Failure mechanisms in which the APS TBCs have also been observed to eventually buckle due to the thermal stress caused by the infiltration of molten silicates raised serious concerns over the mechanical longevity of APS TBCs. The phase de-stabilization in YSZ TBCs occurs due to the infiltration of molten volcanic ash, via dissolution of initial metastable tetragonal (t') YSZ grains followed by precipitation of Y-depleted monoclinic zirconia (m-ZrO<sub>2</sub>) (Zhou et al., 2019), it must be noted that the formation of monoclinic phase is detrimental to the structural property of the coating and plays a crucial role in the durability. Siliceous environmental debris (including volcanic ash) is commonly simulated using a chemically simplified CMAS (calcium-magnesium aluminum-silicate) analog (Padture, 2019).

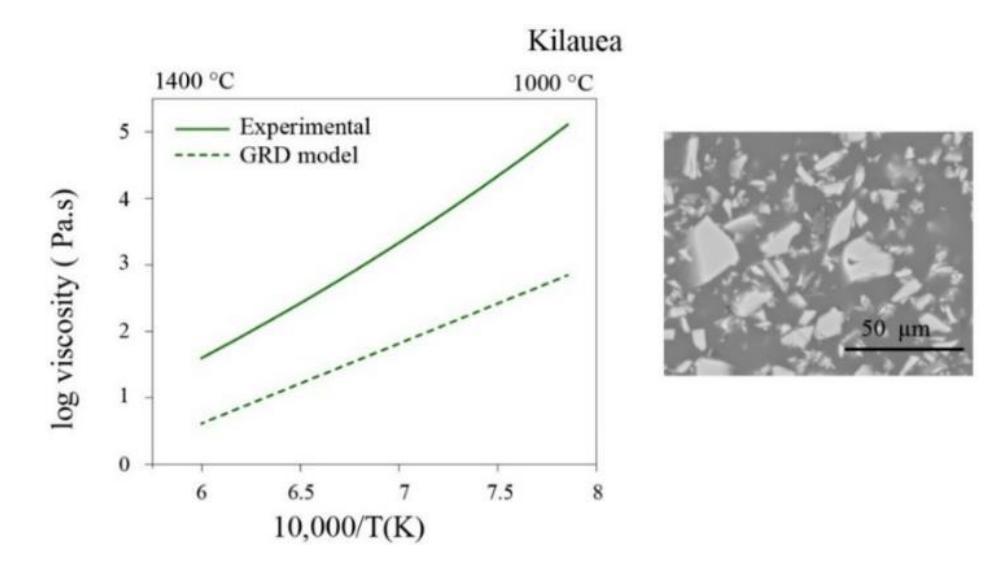
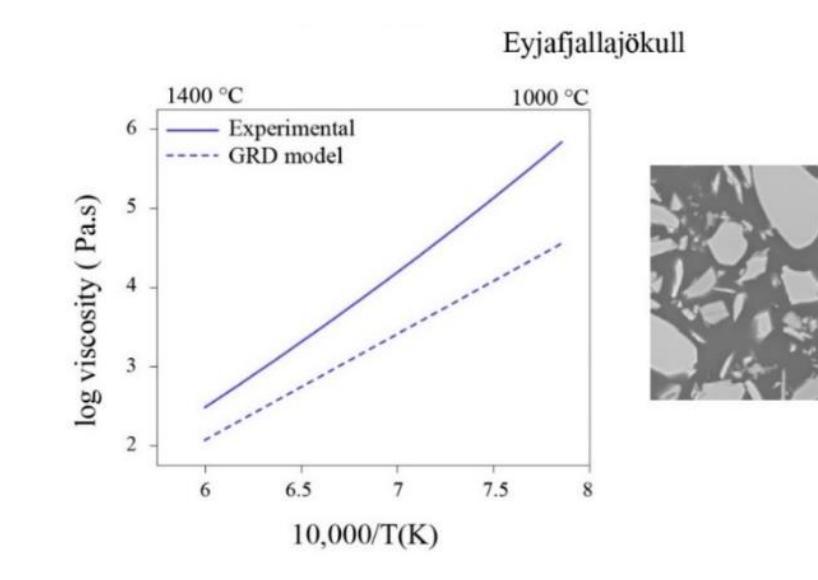
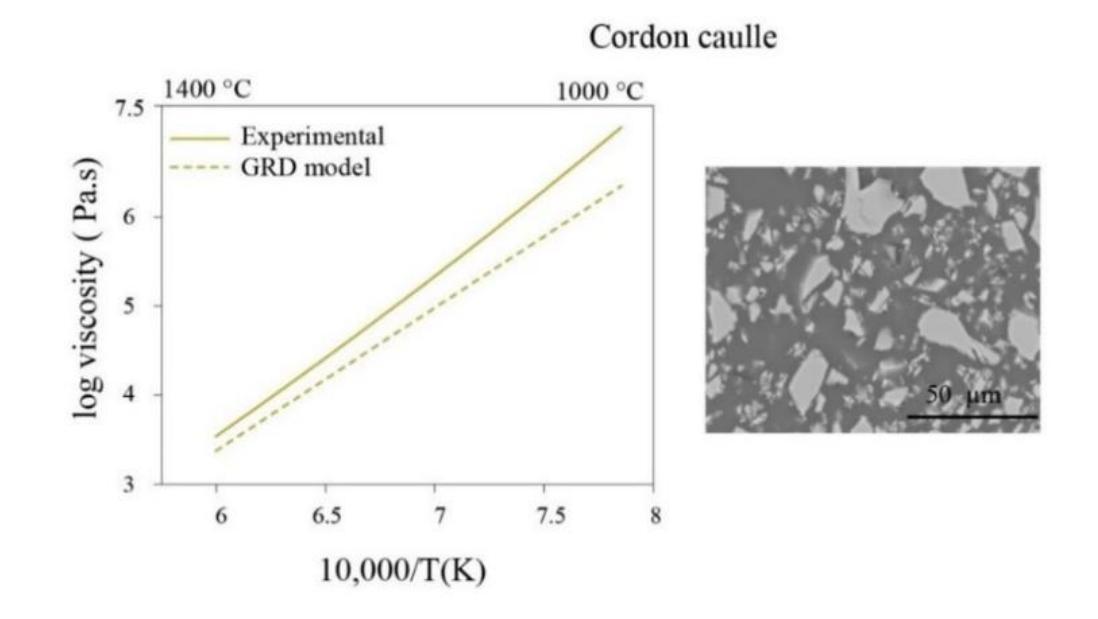
Figure 11. Viscosities of the volcanic ash samples over the temperature range of 1000–1400 C and the corresponding BSE images.

viscosity at a constant temperature. As a final step, the sample is reheated to 1500 °C to check for instrumental drift. At 1500 °C the rotation speed is 40 rpm; this value is then automatically halved every time that torque exceeds 100% as the temperature is decreased, down to 0.3 rpm. The multi-component viscosity evaluation model by Giordano model et.al (Giordano, et al., 2008) was used to estimate the viscosity as a function of temperature. The resultant viscosities of the volcanic ashes are plotted in figure 11.

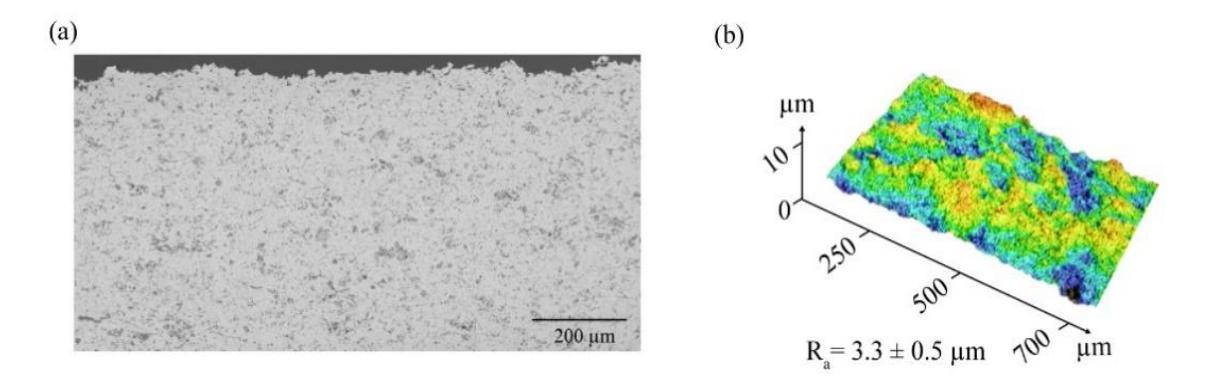
Figure 12. (a) BSE image of the cross-section of 7YSZ TBC (b) Surface profile of the 7YSZ.

7YSZ TBCs were fabricated by the APS method, at the German Aerospace Center (DLR) in Köln (Fig. 12a).

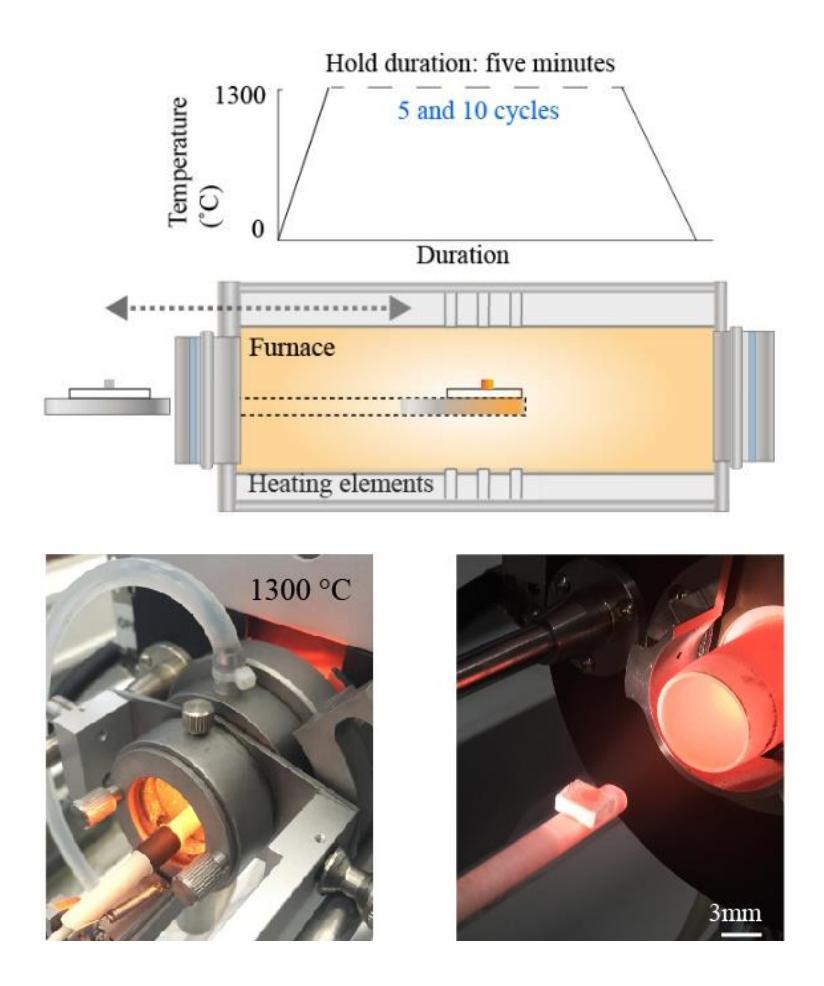
Figure 13. Schematic illustration of the furnace and heating cycle for the thermal shock process, and photograph of the coating post the thermal shocking at 13000 °C for a hold time of 5 minutes.

The use of a state-of-the-art optical dilatometer enabled us to observe the *in-situ* thermal shocking of molten volcanic ash spreading on free-standing 7YSZ TBCs. The dilatometer furnace was held at a constant temperature of 1300 °C. The free-standing YSZ TBC and VA compact assembly into the furnace at 1300 °C for five minutes duration and then rapidly quenched to room temperature. The samples were subjected to thermal shock treatments of five and ten cycles, respectively. The change in the cylindrical morphology
of the volcanic ash pellet was observed during the first cycle of thermal shock regime, using a charge-coupled camera (Fig.13).

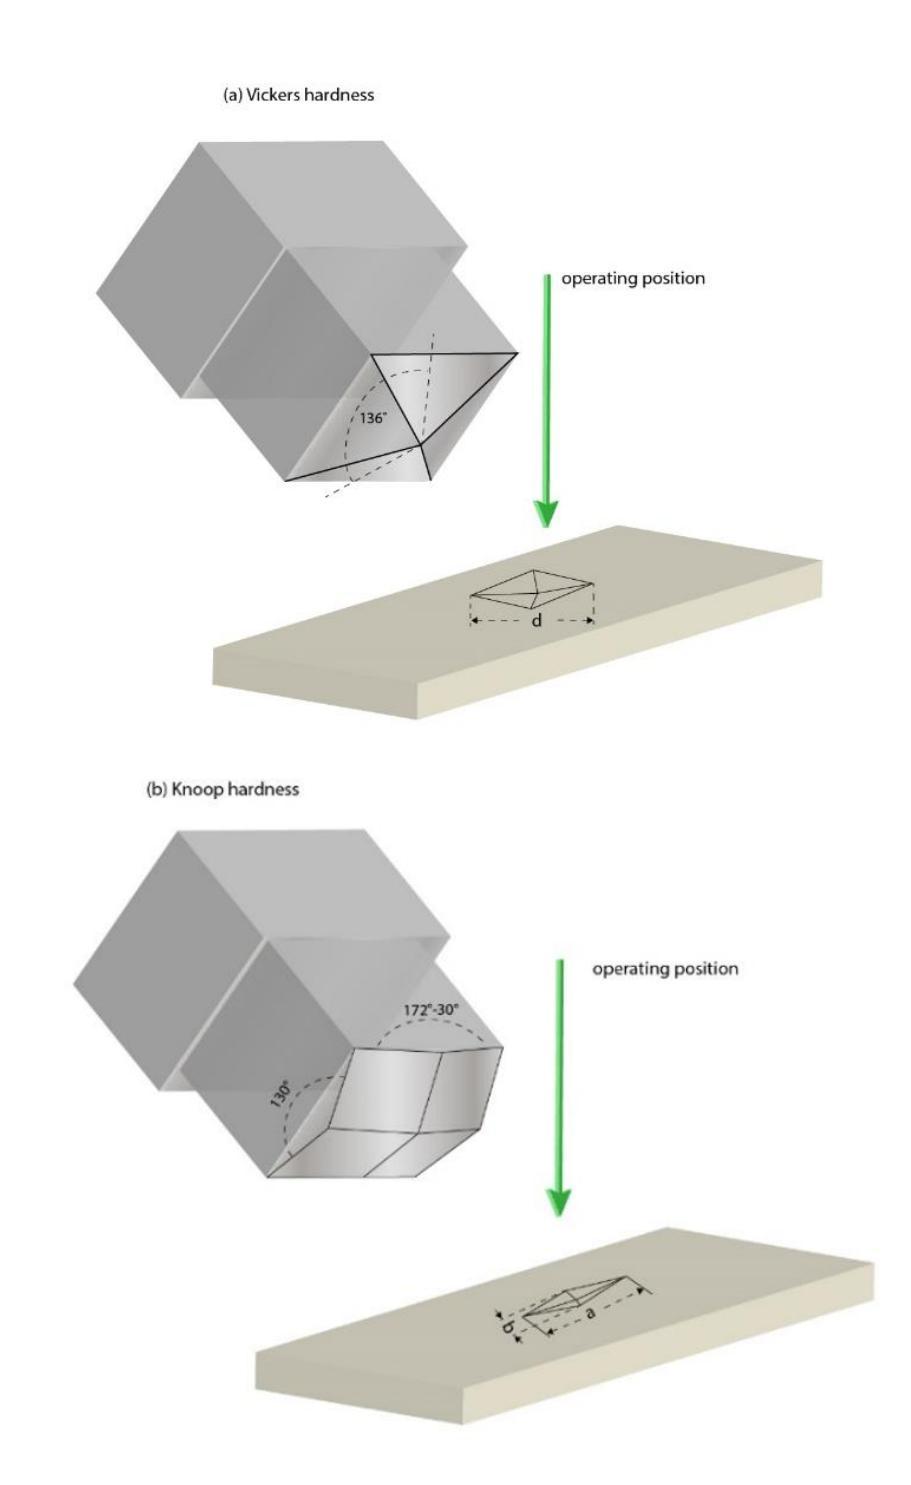
Figure 14 (a) Schematic illustration of Vickers hardness (b) Schematic illustration of Knoop hardness

where F is the indentation load (N) and S is the indented surface area ( $mm^2$ ) (Fig. 14 a). Fracture toughness ( $K_{IC}$ ) is evaluated by the Anstis relation (Anstis, et al., 1981):

Where, a is the diagonal length (mm) and c the crack length (mm).

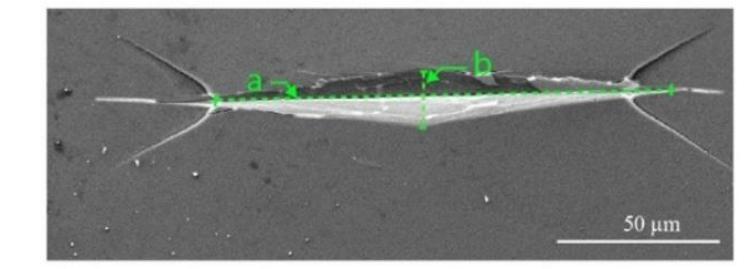
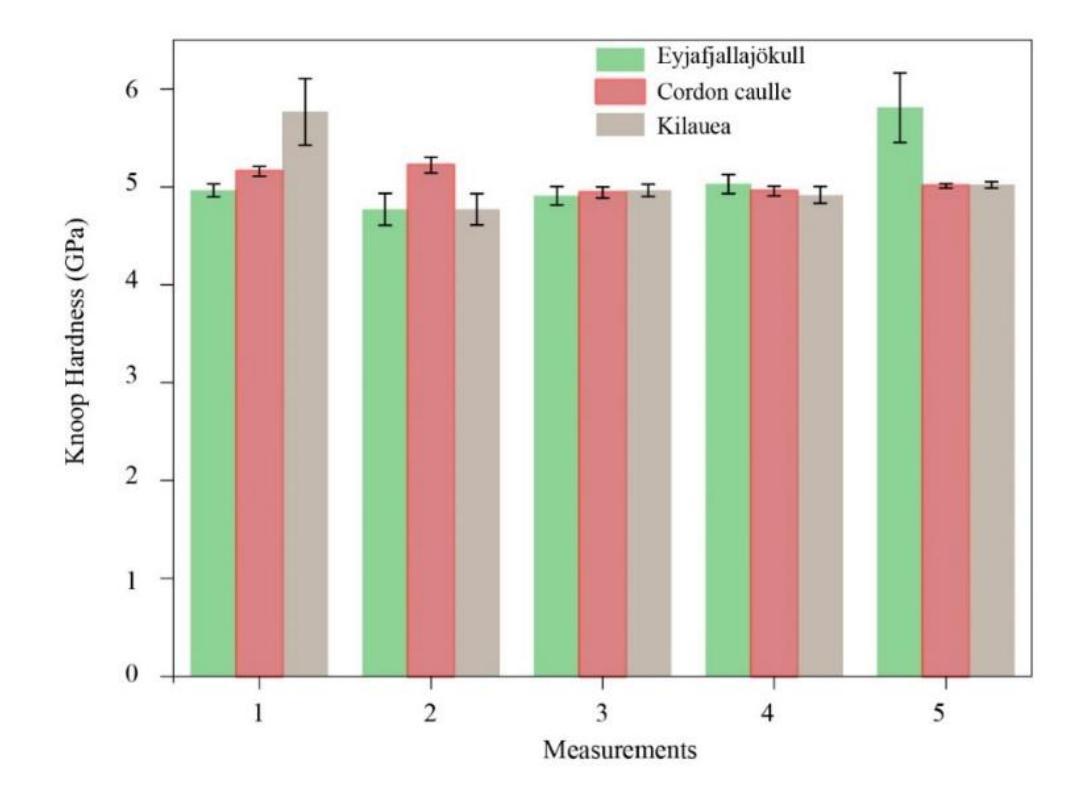
Figure 15. Knoop micro hardness of the volcanic ash glasses and an example of the indent impression generated on the Eyjafjallajökull glass shard

Firstly, the Knoop micro hardness of the volcanic ash glasses was determined using equation 3 and it was found that there was no significant difference in the micro hardness  $(H_k)$  of the glass shards. Average  $H_k$  of Eyjafjallajökull was  $5.09 \pm 0.154$  GPa, Cordon Caulle was  $5.05 \pm 0.052$  GPa and Kilauea was  $5.05 \pm 0.135$  GPa (Fig. 15). Based on the values of micro hardness, elastic modulus was calculated by using equation 4. Image analysis was performed based on the impression of the indents for determining the diagonal lengths (b,a).

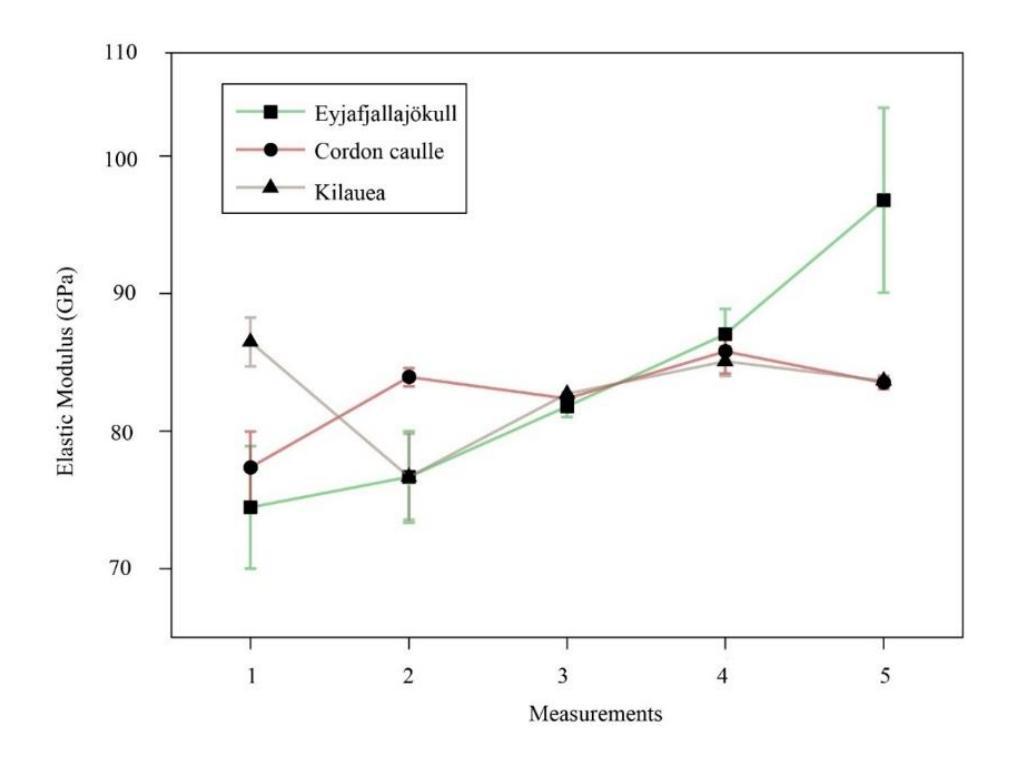
Figure 16. Elastic modulus data of the volcanic ash glasses

The average elastic modulus of Eyjafjallajökull was  $83.33 \pm 1.54$  GPa, Cordon Caulle was  $82.5 \pm 1.08$  GPa and Kilauea was  $82.1 \pm 1.29$  GPa. It was observed that the value of elastic modulus of the Eyjafjallajökull glass shard (referred as VA) was higher (Fig. 16). In chapters 2 and 3, Eyjafjallajökull was thereby chosen to analyze its effect on thermomechanical aspect of TBCs.

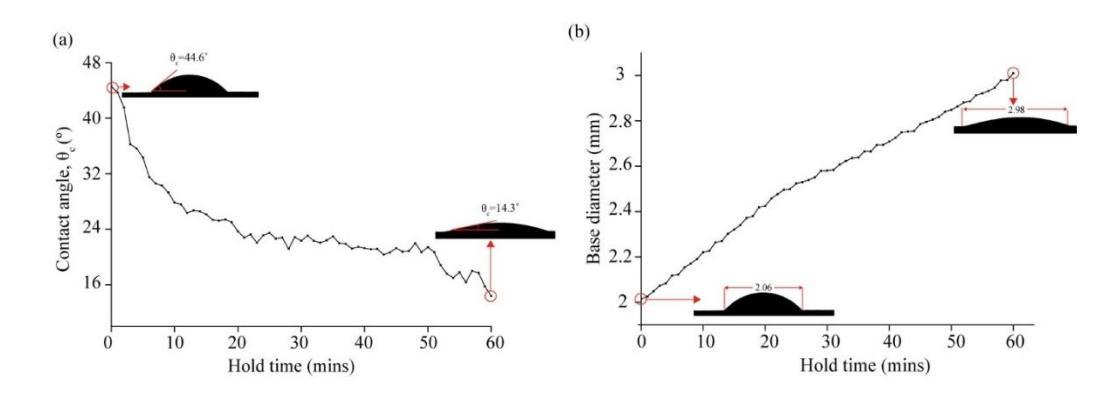
Figure 17. Change in the equilibrium contact angle and spreading diameter of molten VA on the surface of YSZ at 1250 °C, during a hold time of 60 minutes.

The properties of VA was determined by Song et.al (2019). The DSC (differential scanning calorimetry) result revealed that the melting point of VA was 1164 °C. Molten VA readily spreads the surface of TBCs at elevated temperatures above their melting point, followed by infiltration into the lamellar structure of TBC. As noted above, the morphological transition of VA during transition into the wetting regime was observed by tracking *in-situ* silhouette images recorded at different temperatures. For one hour of thermal dwell time, molten VA ultimately spread on the surface of 7YSZ TBC, making a contact angle of  $\theta_c = 14.3^\circ$  as shown in Fig. 17. At 1250 °C, it was observed that the contact angle of molten VA decreased from 44.6° to 14.3°, during the thermal dwell time of 60 minutes (Fig. 17).

and  $\Delta t$  is the difference in time during hold duration. Molten VA wetted the surface of TBC at a rate of 0.25 µm/sec during the thermal dwell time. Compilations of documentation of volcanic ash encounters with jet engines provide evidence that a minor exposure of 2-4 minutes of volcanic ash in the engines led to their failure (Guffanti, et al., 2011). Here, the *in-situ* wetting of the VA pellet on the surface of TBCs during thermal shock regime was observed.

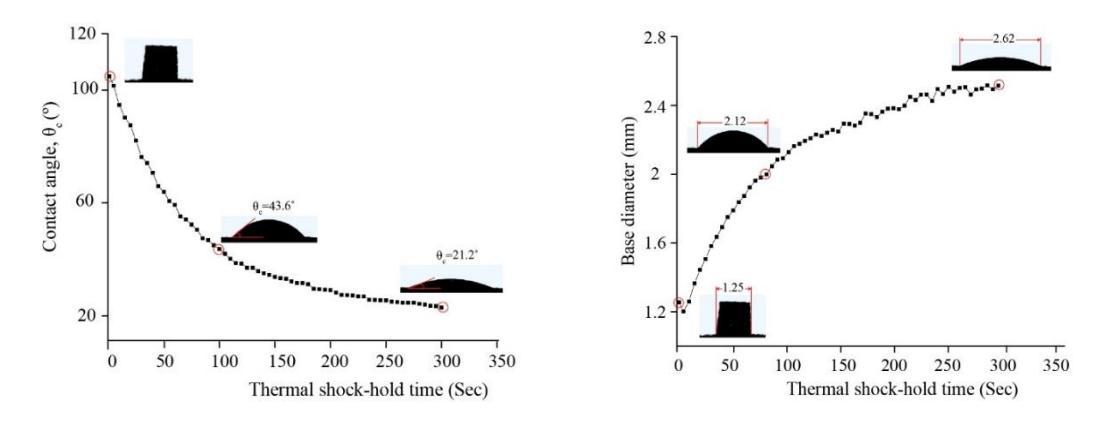
Figure 18. Effect of thermal shocking on the rapid change in the equilibrium contact angle and spreading diameter of molten VA on the surface of TBC at 1300 °C.

The spreading behavior of molten VA during the first cycle, with a hold time of five minutes is illustrated in Fig. 18. It was observed that wetting was relatively unimpeded when compared with preliminary thermal ageing tests for a constant hold-time: the average change in contact angle was estimated to be 0.1 degrees per second during thermal shock regime whereas  $0.16 \times 10^{-2}$  degrees per second, during constant hold time.

The spreading diameter of the VA pellet (1.25 mm) to molten VA (2.62 mm), was rapid during the hold-time of the initial thermal shocking cycle Molten VA spread on the surface of TBC with an average spreading rate of molten VA on the TBC was  $1.92 \,\mu$ m/sec (Video related to the wetting process is made available online in: Lokachari et al., 2020). At 1250°C, molten VA infiltrates into the APS TBC, as observed from the wetting and spreading characteristics. Maximum infiltration depth of molten VA into the TBC was found to be 159  $\mu$ m, as determined by the elemental mapping of Si and Al across the cross-section as shown in Figs. 19a and 19b.

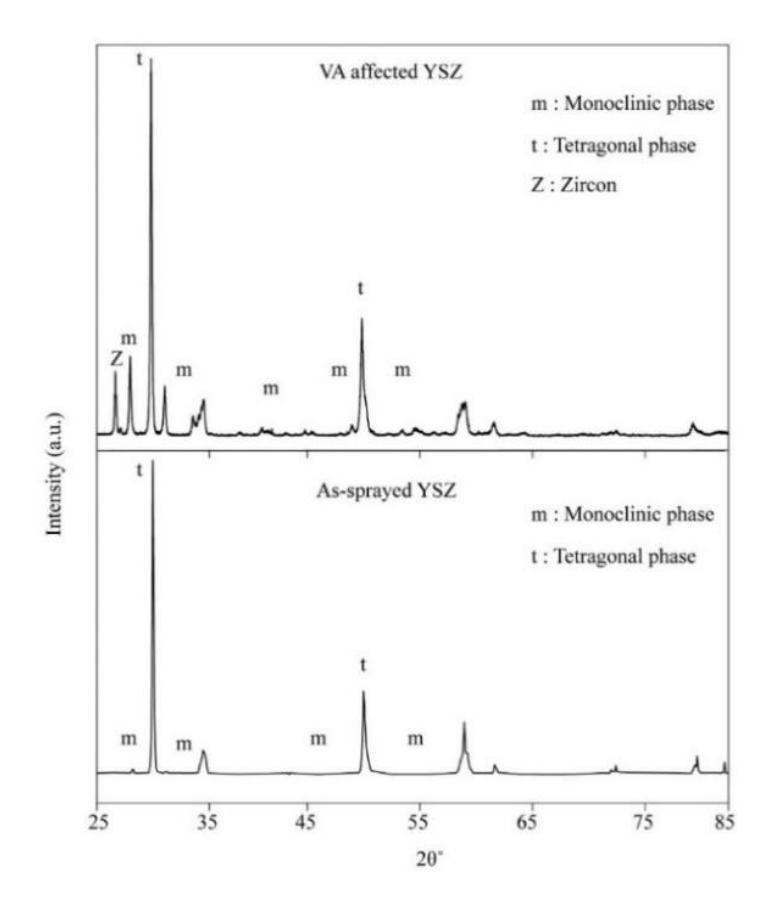
Figure 20. XRD patterns of as-sprayed YSZ TBC and VA affected TBC

The phase transformation from tetragonal 7YSZ to monoclinic Zirconia (m-ZrO<sub>2</sub>) was observed in the spectra shown in Fig. 20. The presence of Zircon (ZrSiO<sub>4</sub>), as a resultant of Zr–Si reaction was evident in the spectrum of VA affected TBC. Previous studies have shown that the phase destabilization is majorly responsible for a volume change of 4 - 5%, leading to the generation of cracks in the TBCs (Schulz et al., 2004). The percentage of monoclinic phase (% m) was evaluated by using equation 5 (Toraya, et al., 1984):

Where  $I_m$  is the monoclinic intensity and  $I_t$  is the tetragonal intensity corresponding to the signal from the XRD pattern. The increase in monoclinic content after VA was infiltrated in the TBC was found to be 17 % and the as-sprayed TBC was 3 %. The objective of stabilizing Zirconia, by addition of Yttria is to avoid the phase transformation from tetragonal to monoclinic phase, which leads to a volume change of 3–5% due to cooling. Subsequent infiltration and phase transformation due to the reaction of molten VA with 7YSZ TBC deteriorates the mechanical properties.

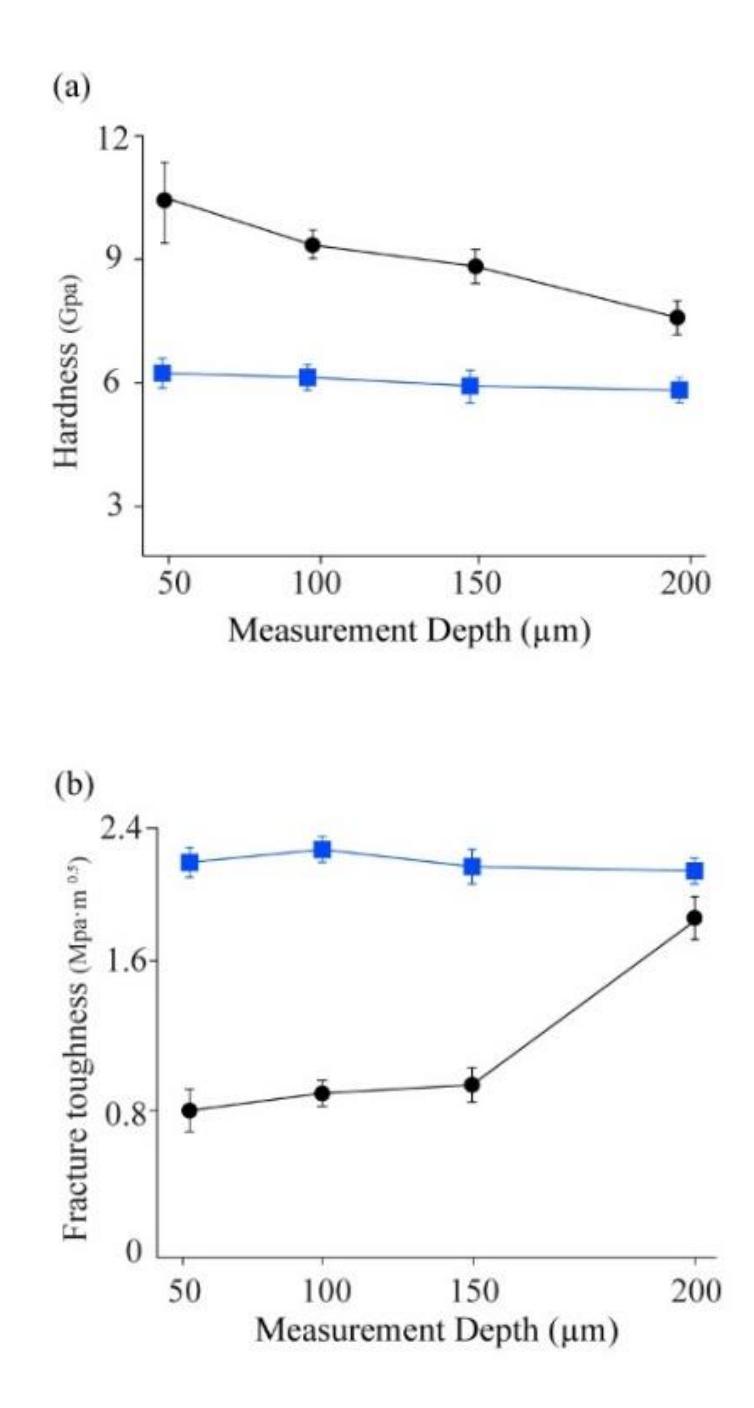
Figure 21. (a) Change in the Vickers microhardness (GPa), (b) Fracture toughness (MPa $\cdot$ m<sup>0.5</sup>), at 50, 100, 150 and 200  $\mu$ m.

The average Vickers micro-hardness values of the as-sprayed conventional YSZ was 6.2  $\pm$  1.2 GPa. Corresponding micro-hardness values of VA infiltrated 7YSZ was measured at 50, 100, 150 and 200 µm respectively. From Fig. 21a, it was evinced that the region of the VA affected TBCs at 50 µm has a hardness value higher than the as-sprayed TBC (11.1  $\pm$  3.2 GPa). VA glass shard had an elastic modulus of 83.33  $\pm$  1.54 GPa (Fig. 16), whereas the micro-hardness of artificial volcanic glass (CMAS) was determined to be 84.3 GPa (Bansal et al., 2015).

The infiltration of the molten VA or CMAS into the splat-like lamellar microstructure of TBC, and further solidification during the cooling phase is responsible for the increase in hardness value of the penetrated region. High fracture toughness is one of the essential criteria for a TBC, fracture toughness value of the as-sprayed TBC at 50  $\mu$ m is 2.2 ± 0.08 MPa·m<sup>0.5</sup>, which was higher than VA infiltrated TBC corresponding to the same measurement depth (0.8 ± 0.1 MPa·m<sup>0.5</sup>) as seen in Fig. 21b. The elastic modulus is plotted in Fig. 21c, as-sprayed TBC had an elastic modulus of 166.5 ± 1.9 GPa at 50  $\mu$ m, whereas the elastic modulus of VA infiltrated YSZ was 262 ± 4 GPa. The increase in elastic modulus at 50  $\mu$ m, is again attributed to the solidified VA accumulation in the splats of YSZ TBCs (Kang et al., 2017). Low fracture toughness and high elastic modulus is responsible for the generation of micro-cracks in the TBCs.

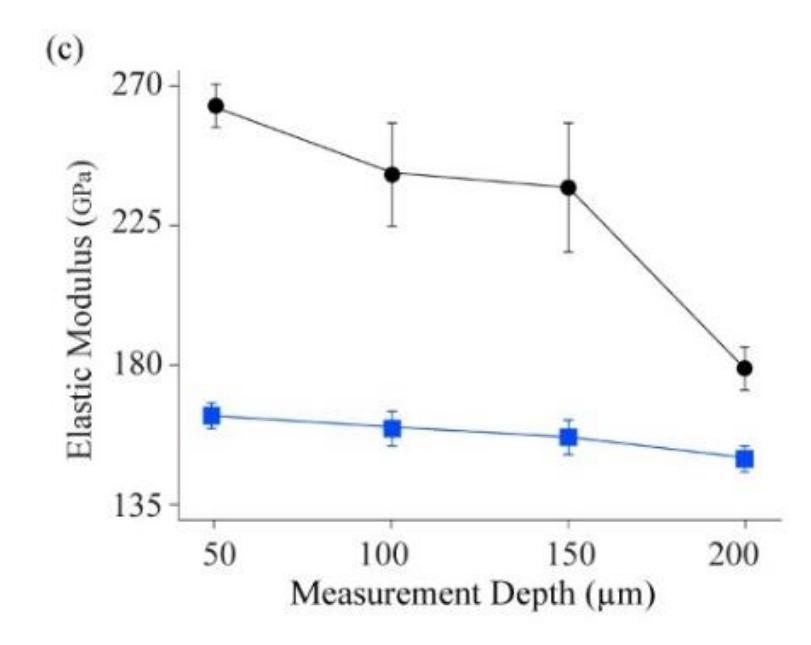
Figure 22. (c) Elastic modulus (GPa) of as-sprayed and VA affected TBCs, measured at 50, 100, 150 and 200  $\mu$ m.

Where,  $\sigma$  is the thermal stress, E is the elastic modulus of TBC affected by VA (262 ± 4 GPa),  $\Delta \alpha$  is the difference in thermal expansion coefficients of the TBC and VA ( $\alpha_{TBC}$ = 11×10<sup>-6</sup> K<sup>-1</sup> (Fox & Clyne, 2004);  $\alpha_{VA}$ = 7×10<sup>-6</sup> K<sup>-1</sup> (Skinner, 1966),  $\Delta T$  is the temperature difference between the furnace temperature and the temperature assumed at the infiltrated layer (~1150 °C) and v is the Poisson's ratio of YSZ (0.2). The thermal stress of the YSZ at a constant heating rate was estimated to be ~ 0.131 GPa. Qualitative analysis of the damage caused by rapid spreading of molten VA on the surface of TBCs during thermal shock regime was performed by optical observation. Cross-sectional SEM images of the TBC post 5 cycles of thermal shocking is shown in Fig. 22.

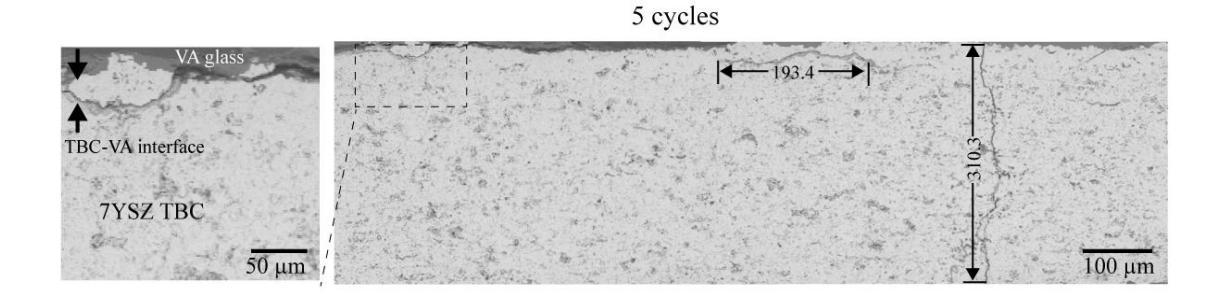
Figure 23. Cross-section and topography SEM images of VA infiltrated 7YSZ TBCs post thermal shocking for 5 cycles.

Horizontal and vertical cracks of length 193.4 µm and 310.3 µm were evinced from the cross-sectional image. Cracks were also observed to have originated from the TBC-VA interface. Low fracture toughness and high elastic modulus of the infiltrated region are primary causal factors for the generation of micro-cracks. For 10 cycles thermal shocking, the cracks appeared to be denser than the coating subjected to 5 cycles exposure and branched out, as they propagated across the coating from the topographical image in Fig. 23, crack coalescence with adjacent micro-cracks were evident in the cross-section. Krämer et al studied the effect of CMAS on TBC-bond coat system under thermal shocking condition, and a similar crack behavior was observed and categorized based on their presence in the sub-level CMAS-TBC interface. The increase in the monoclinic phase content was primarily responsible for the depletion of Yttria and destabilization of Zirconia, which led to the mechanical degradation of the coating. The thermal shock stress was evaluated by equation 6, considering the elastic modulus of the infiltrated region (E=  $262 \pm 4$  GPa),  $\Delta \alpha = 4 \times 10^{-6}$  K<sup>-1</sup>,  $\Delta T = 1275$  °C and  $\nu = 0.2$ , the thermal shock stress was estimated to be ~1.67 GPa. This is 12.74 times higher than the thermal stress generated in the infiltrated layer during isothermal exposure, and this aspect gives rise to a demanding emphasis on the mechanical properties of solidified VA melt during the quenching regime. The solidification of the VA melt and the emanation of cracks from it while cooling are crucial factors responsible for the mechanical degradation of the TBCs. Colombier et al. have estimated the value of thermal stresses in natural VA melt-water interaction to be 0.308 GPa, where the system was subjected to an extremely high cooling rate. High thermal stresses and rapid crack growth in VA glass during the thermal shock regime (~190 m/s) (van Otterloo, Cas, & Scutter, 2015).

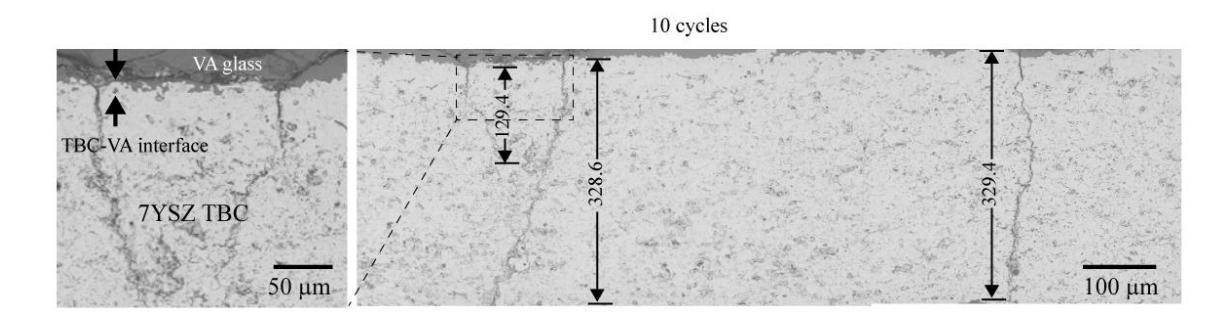
Figure 24. Cross-section and topography SEM images of VA infiltrated 7YSZ TBCs post thermal shocking for 10 cycles.

It can be observed from topographical cracks in Fig. 24 that the crack spacing for the TBC subjected to 5 cycles of thermal shock exposure, increased from 6.4 - 20.7  $\mu$ m, as one progresses towards the coating. However, the crack pattern in the TBC exposed for 10 cycles revealed channeling of adjacent micro-cracks and an increase in the crack density compared to 5-cycle thermal exposure, as observed in figure 24.

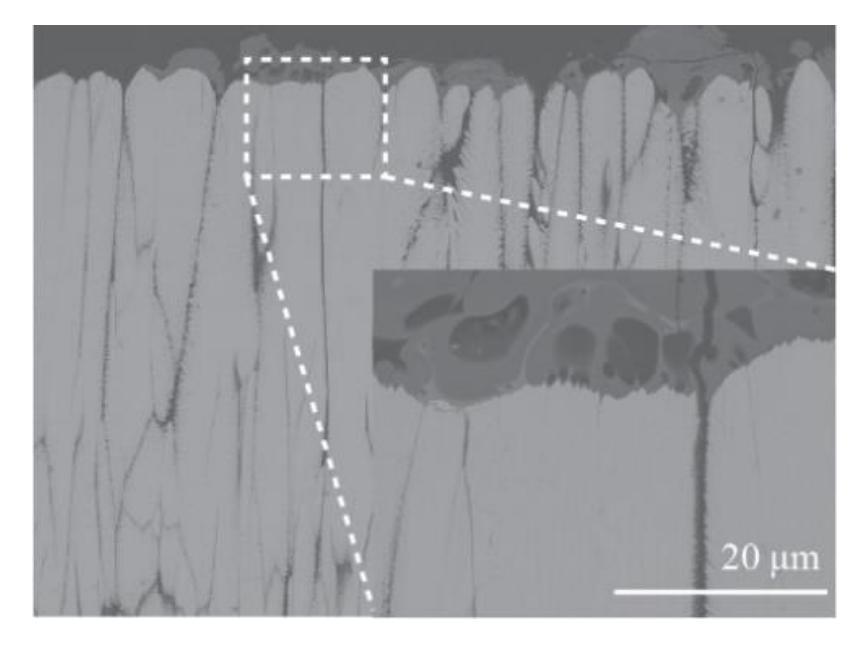
Figure 47. BSE images of molten VA impacted EB-PVD TBCs subjected to thermal shocking In order to observe the generation of micro cracks due to the infiltration of molten VA impaction in a thermal shock condition, the EB-PVD TBC was subjected to thermal shocking (by following section 2.1.4) for five cycles and a hold-duration of five minutes

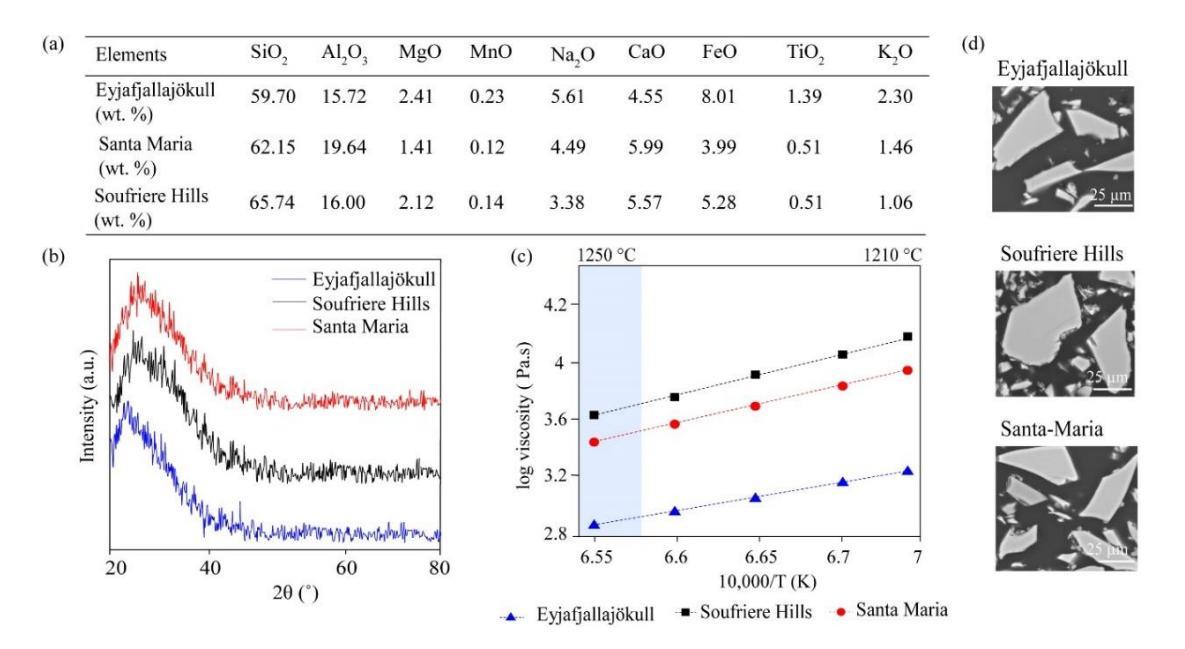
Figure 48. Characterization of volcanic ashes. (a) Bulk chemical composition of volcanic ashes. (b) XRD spectra of the re-melted volcanic ashes showing only the amorphous silica shoulder, further confirming the amorphous character of the ash samples. (c) Viscosity of the ash samples
