# Thermo-Mechanical Degradation and Mitigation by Molten Volcanic Ash Wetting on Thermal Barrier Coatings of Jet Engine Turbine Blades

Siddharth Lokachari

Dissertation zur Erlangung des Doktorgrades an der Fakultät für Geowissenschaften der Ludwig-Maximilians-Universität München

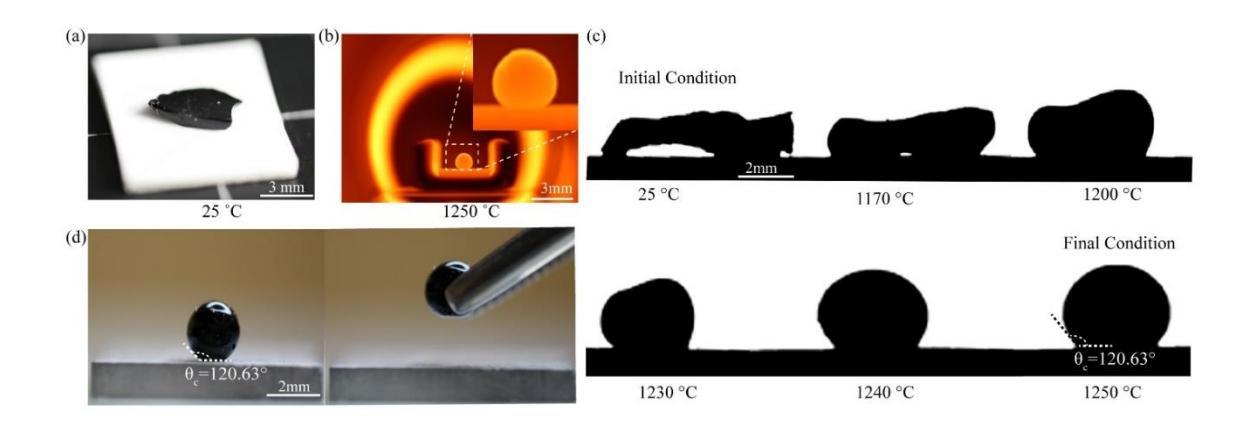
Figure 49. Non-wetting behavior of hexagonal-boron nitride (*h*-BN) thin film substrate. (a) Quenched Eyjafjallajökull melt shard before thermal treatment on *h*-BN thin film substrate ( $12 \times 12 \text{ mm}$ ) at 25 °C. (b) Real time photograph of the geometrically transitioned spherical melt at 1250 °C, in-vacuo condition (<10-5 Pa). (c) Sequential In-situ silhouette morphological transition of the irregular shard to a sphere from 25 °C to 1250 °C. (d) Macroscopic images showing the non-wetting behavior (left) and non-adhesion property (right) of solidified melt on the surface of *h*-BN substrate.

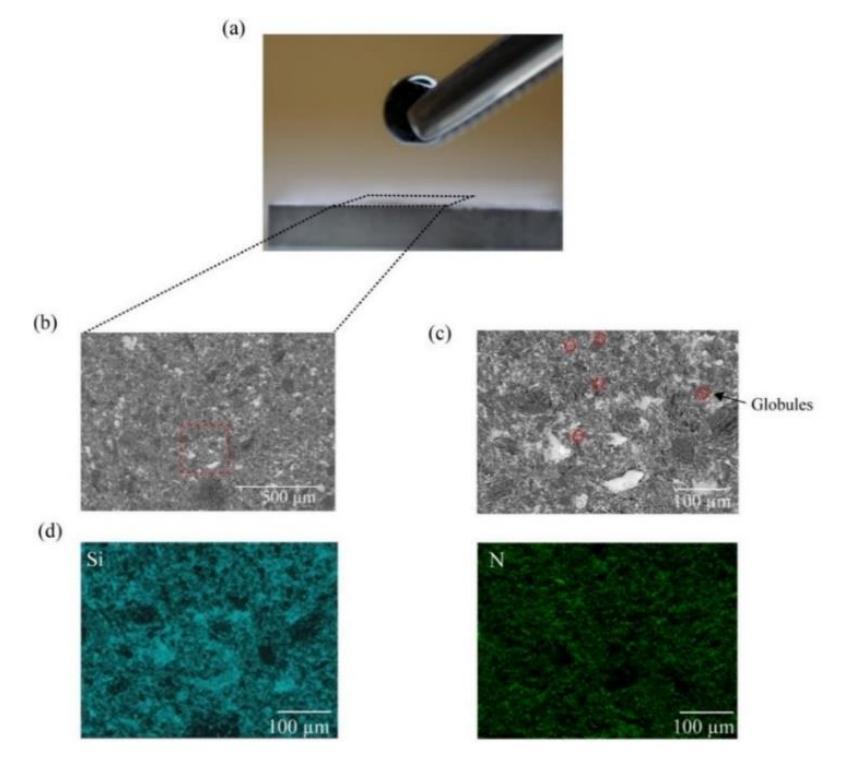
Figure 50. (a) The topography of *h*-BN substrate (b) SEM image of the substrate topography (c) Magnified BSE image indicates high contrast globules on the topography (d) Topographical EDS maps of Si and N

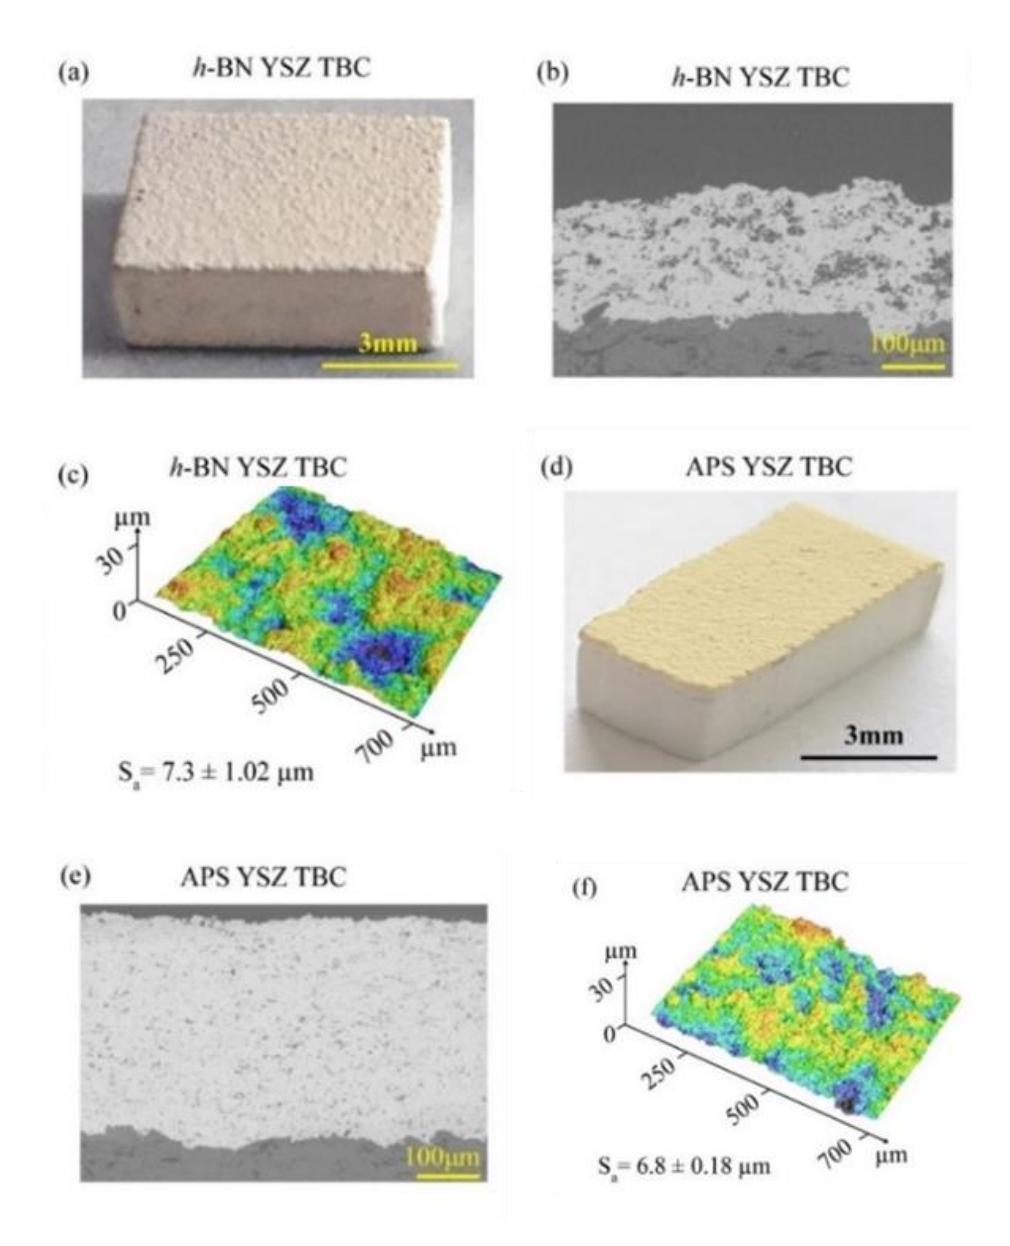
Figure 51. Properties of *h*-BN YSZ and conventional APS YSZ coatings. (a) Photograph of *h*-BNYSZ coating ( $6 \times 3$  mm) fabricated by thermal spay deposition on an alumina substrate. (b) Cross-sectional SEM image of *h*-BN YSZ coating (thickness: ~ 200µm). (c) Surface roughness profile of *h*-BN YSZ coating topography evaluated by confocal laser microscopy. (d) Photograph of conventional APS YSZ coating ( $6 \times 3$  mm) on an alumina substrate. (e) Cross-sectional SEM image of APS YSZ coating (thickness: ~ 400µm) (f) Surface roughness profile of APS YSZ coating topography evaluated by confocal laser microscopy.

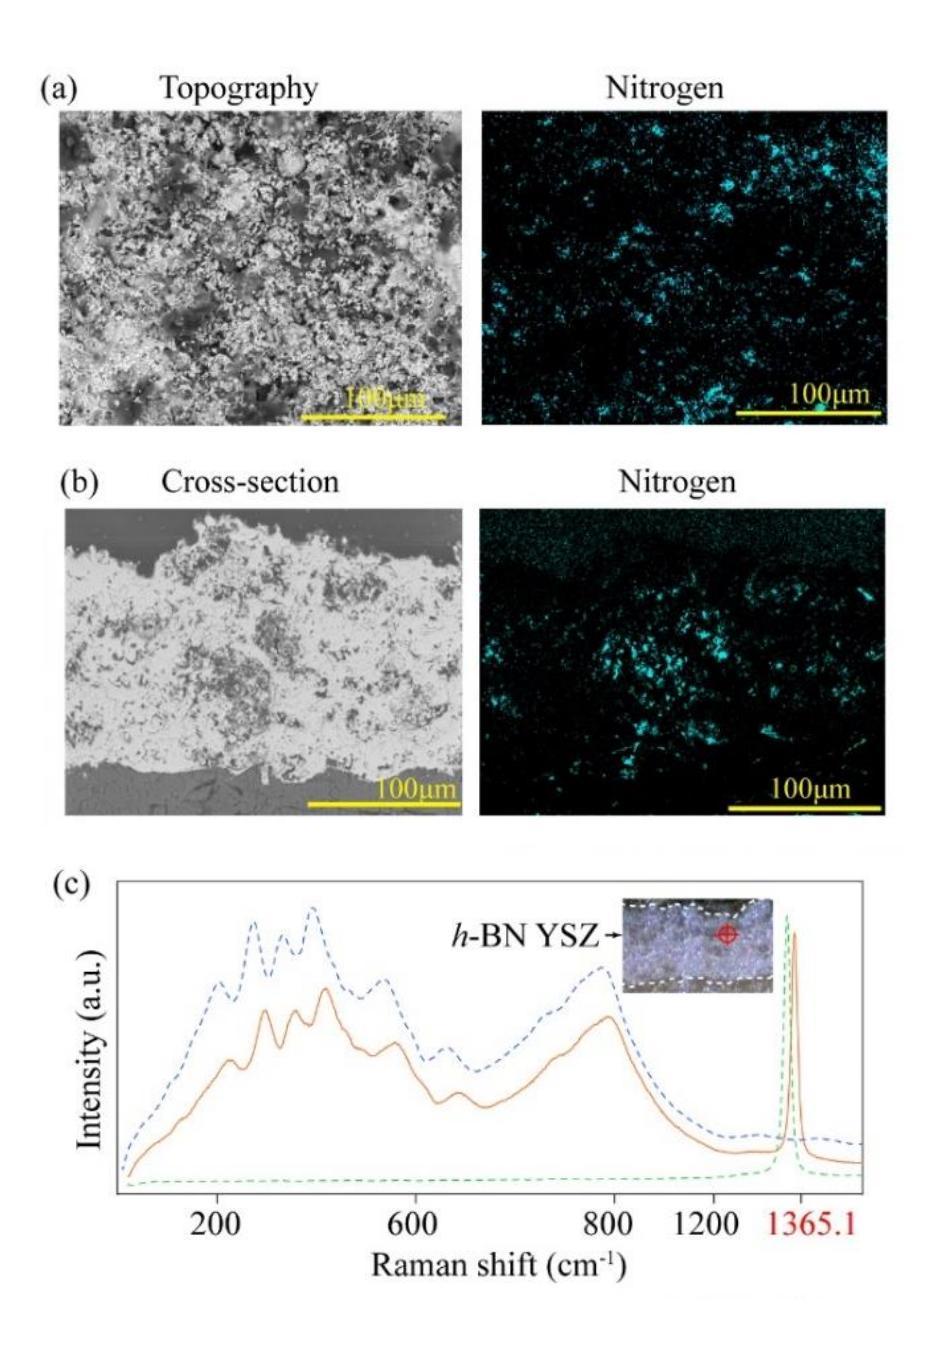
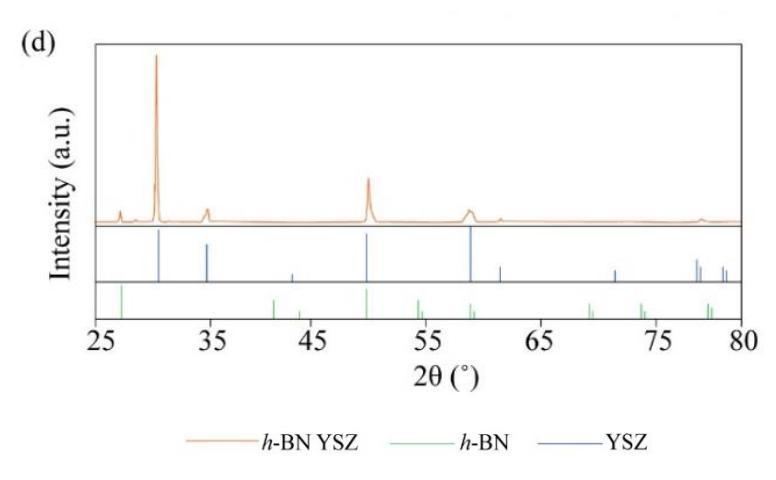
Figure 52. Characterization of *h*-BN YSZ. (a) SEM image of *h*-BN YSZ coating surface and the corresponding distribution of nitrogen obtained by EDS. (b) Cross-sectional SEM image of *h*-BN YSZ coating and the corresponding nitrogen distribution obtained by EDS. (c) Raman spectra acquired at the cross-section of YSZ, *h*-BN YSZ coating and cross-section of *h*-BN substrate.

Figure 52. Characterization of *h*-BN YSZ. (d) X-ray diffraction pattern of the *h*-BN YSZ TBC indicates the presence of *h*-BN and t-YSZ, as compared to standard *h*-BN (crystallography open database (COD): 2016170) and t-YSZ (COD: 1521477) XRD profile data.

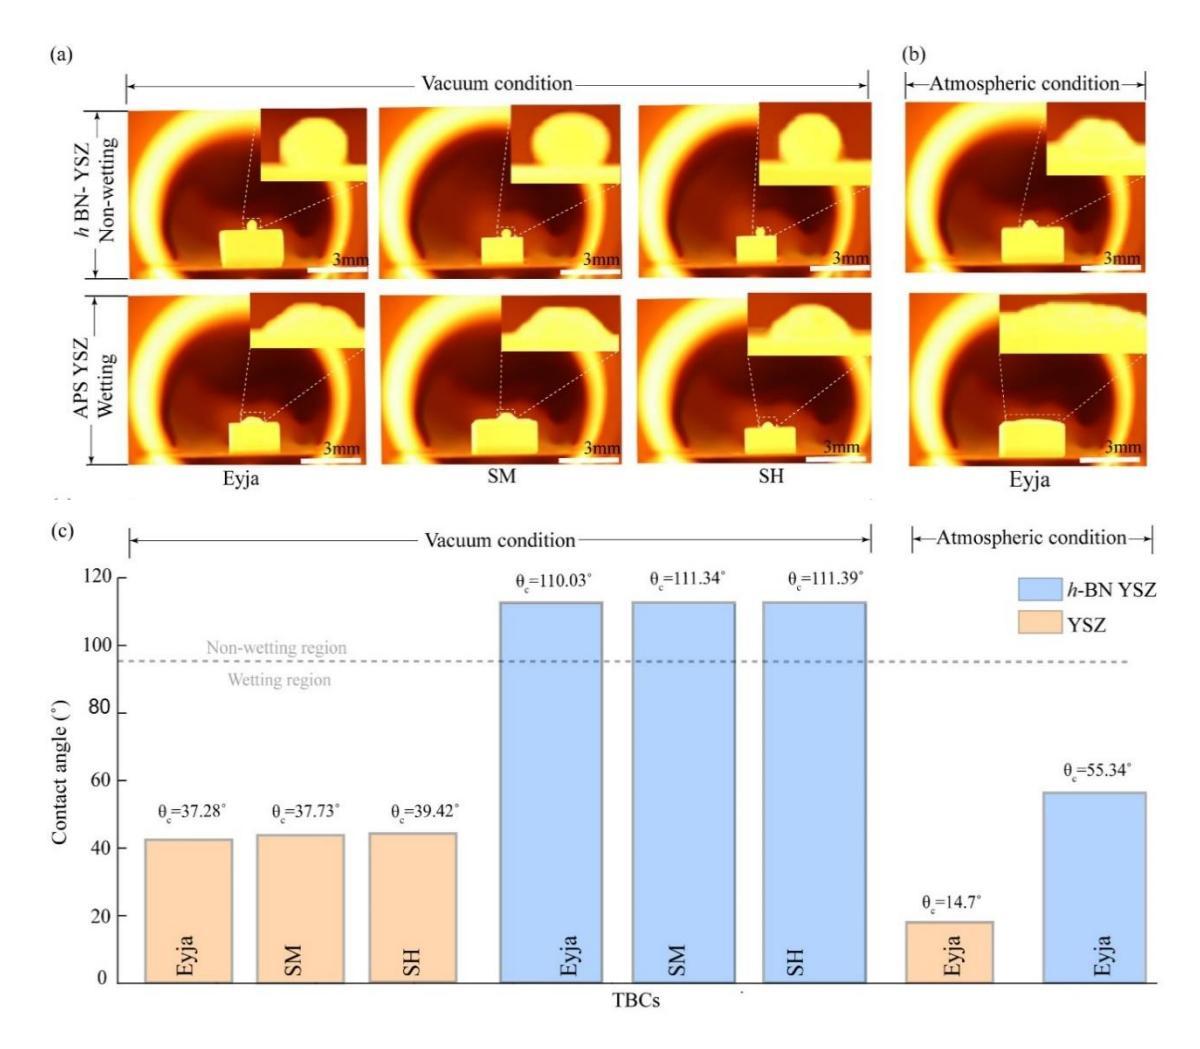
Figure 54. Wettability of volcanic ash on conventional YSZ and novel *h*-BN YSZ coatings. (a) Photographs of the three volcanic ash droplets with variable wetting degrees on the surface of *h*-BN YSZ and YSZ coatings in-vacuo at 1250 °C. (b) Photographs of molten Eyja ash droplets on the *h*-BN YSZ and YSZ coatings at 1250 °C, in oxidizing condition. (c) Comparison of the contact angles resultant from the wetting of molten volcanic ash onto *h*-BN YSZ and conventional YSZ coatings in vacuum and atmospheric oxidizing conditions at 1250 °C.

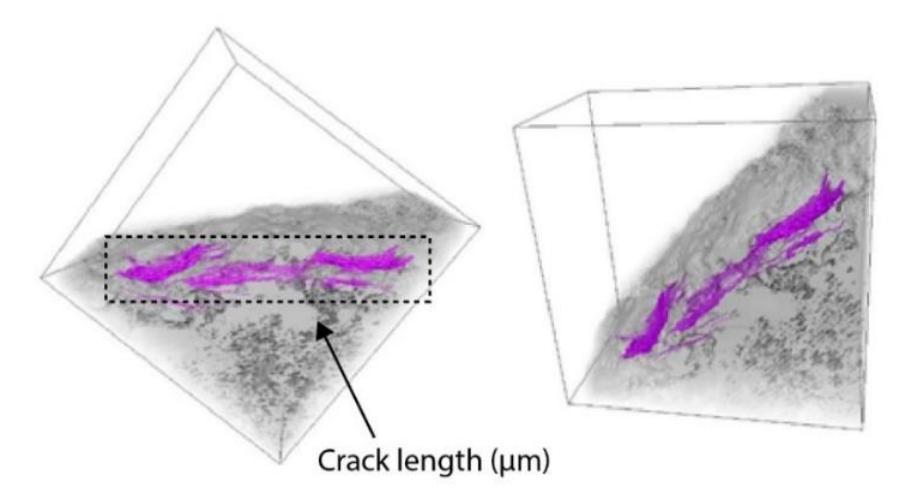
Figure 69. Tomographic images- Crack length tracking in Kilauea volcanic ash affected APS TBC The micro cracks generated in the APS TBCs due to thermal shocking by the influence of molten volcanic ash wetting was observed by micro computed tomography, and it was evinced that micro cracks were evident in Kilauea affected APS TBCs whereas there were no crack generated in the Cordon Caulle and Eyja ash affected APS TBCs. Crack behavior was tracked across the cross-section of the coating and the crack spread horizontally across the APS TBCs, crack coalescence was also observed (Figure 69). From cross-sectional SEM image shown in Fig. 70, it was evinced that there were no micro cracks
